Ultime da Fukushima

Stato delle unità all'11 marzo

On Thursday, 2 June 2011, the IAEA provided the following information on the status of nuclear safety in Japan:

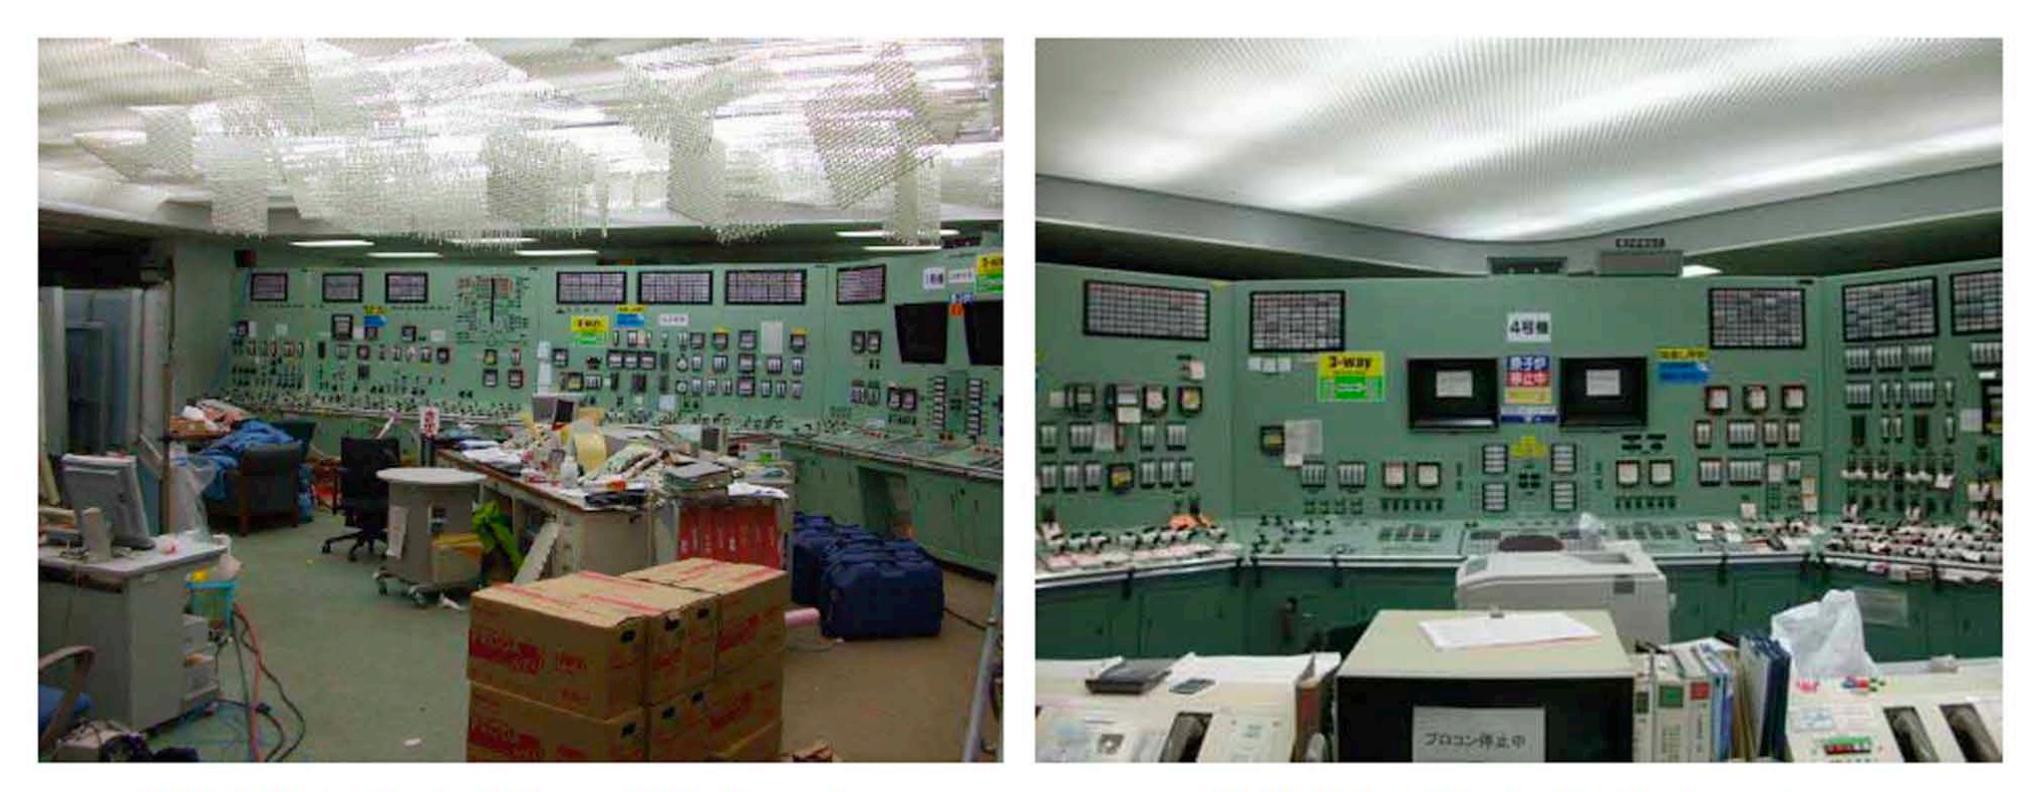
Recovery Status (Main Control Room)

Main Control Room Power recovered as the first step of restoration
 March 22 at 22:45 Unit 3 Main Control Room lights turned on
 March 24 at 11:30 Unit 1 Main Control Room lights turned on
 March 26 at 16:46 Unit 2 Main Control Room lights turned on
 March 29 at 11:50 Unit 4 Main Control Room lights turned on

Unit 1 Main Control Room lights turned on

Unit 4 Main Control lights turned on

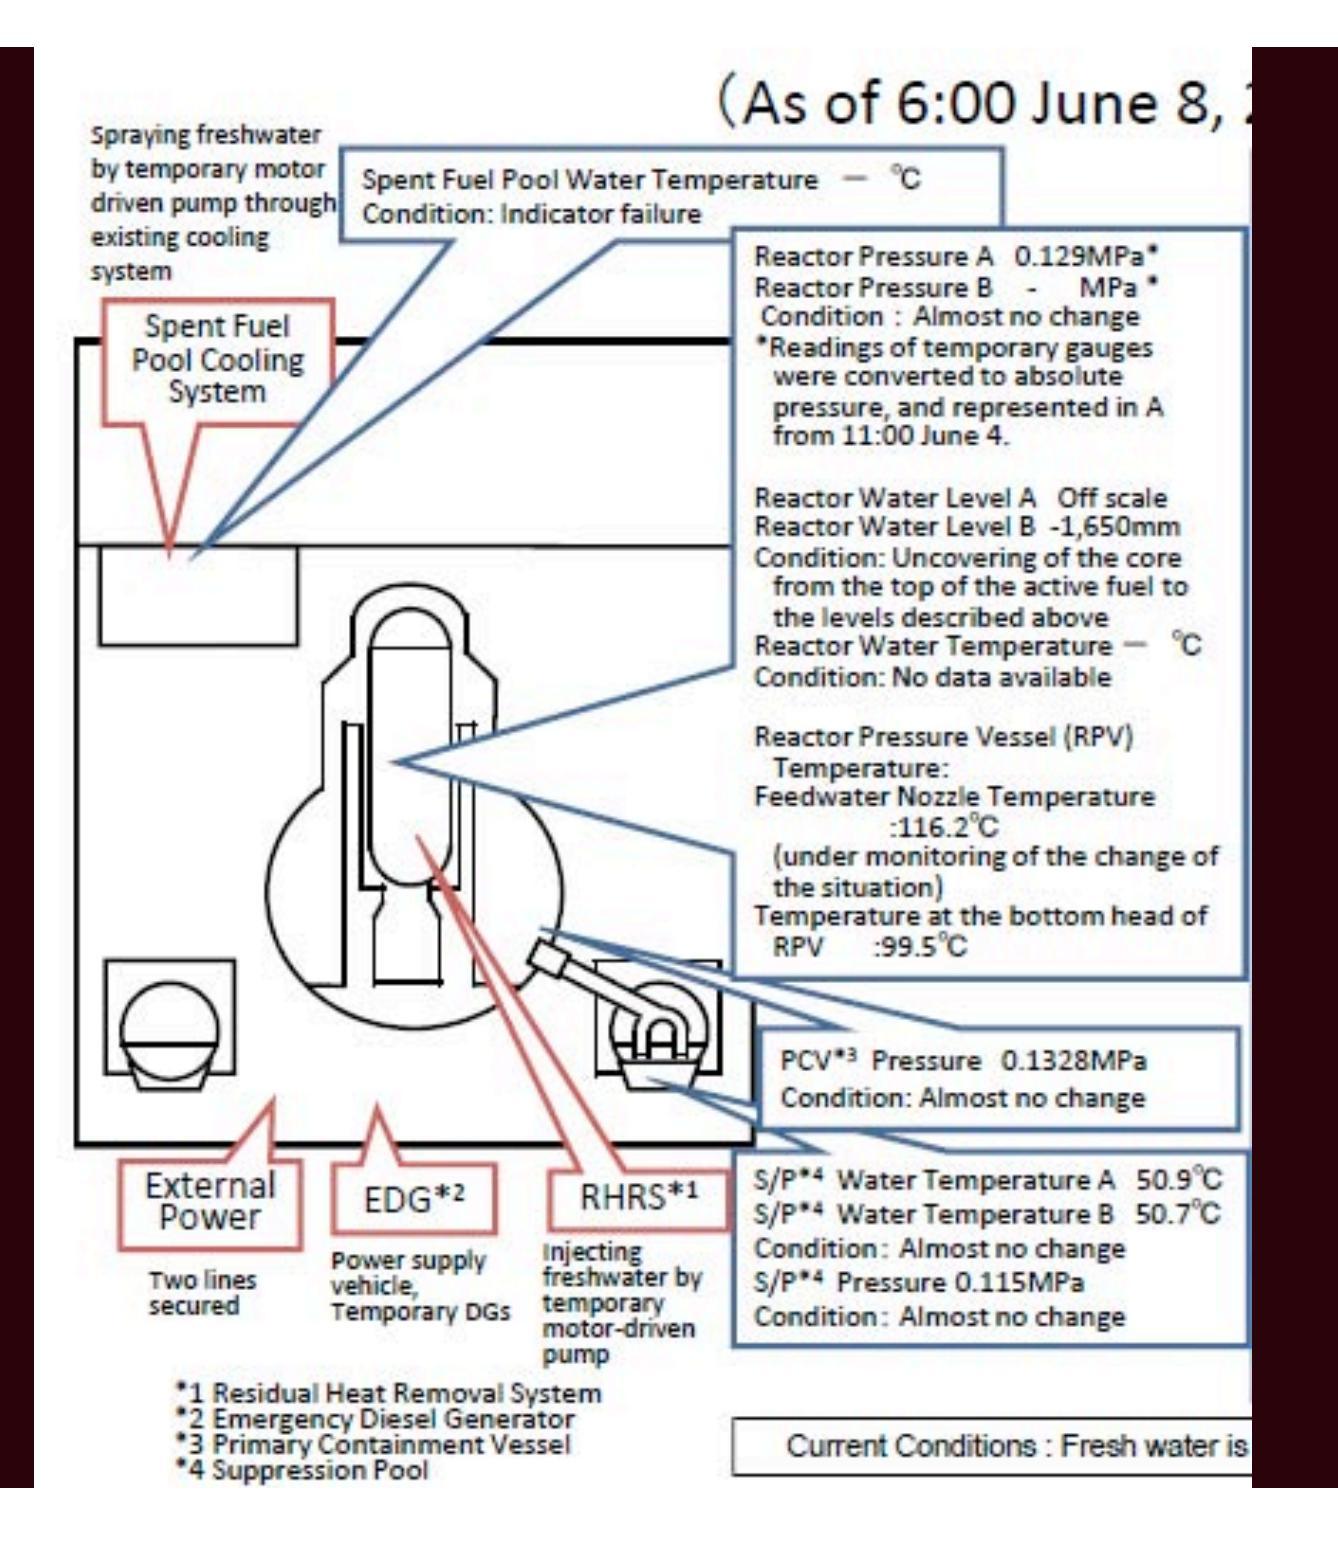
UNIT 1 - REACTOR: FUKUSHIMA DAIICHI NUCLEAR POWER PLANT:

Necessary safety function and conditions	Observation	Evaluation of safe state	TEPCO Roadmap countermeasures
Control of Reactivity	Reactor is subcritical and sub- criticality is demonstrated and maintained	 No power spike or power increase No significant neutron flux measured and reported Short lived fission products (e.g. La-140) are not reported at present 	ACHIEVED Caution: Continue detection of neutrons and short-lived isotopes. Continue the evaluation of need for Boron injection.	No additional countermeasures reported <u>Boric acid injection is being</u> <u>considered by TEPCO</u>
Residual heat removal	 Stable cooling shall be assured: Keep the coolant temperature sufficiently below the boiling point at atmospheric pressure Cover the damaged core adequately with water Off-site and back-up power supply shall be available Achievement of long term closed-loop heat removal capability 	 The rate of water injection into the reactor pressure vessel of Unit 1 was changed from <u>6 m3/h to 6.2 m3/h at 21:00 UTC 29 May.</u> Reactor vessel temperatures are: <u>112 °C at feedwater nozzle and 95.4 °C at the lower head.</u> Reactor pressure: (<u>A) 6.66 atm / (B) 16.24 atm</u> based on available measurements. <u>Changes in temperature and pressure are not significant.</u> In accordance with TEPCO information, after calibration of the reactor water level gauges, the actual water level in Unit 1 reactor pressure vessel has been lower than was indicated. The results of provisional analysis show that fuel pellets melted and fell to the bottom of the reactor pressure vessel. TEPCO also reported that leakage of cooling water from the reactor pressure vessel is likely to have occurred Off-site power supply and backup power from portable diesel generators are available Fresh water injection is provided; however, closed-loop heat removal is not yet established 	NOT ACHIEVED Establishment of a long term closed- loop heat removal circuit is advised	Nos 1, 3, 4, 7, 8, 9, 13, 14, 16 and 17 Actions aimed to establish closed-loop cooling are in progress: 1.Installation of primary and secondary closed-loop cooling systems (planned for 31 May). No completion <u>reported</u> 2.Flooding of the containment to provide water supply for the primary system

Containment integrity	 Containment is leak-tight Containment pressure maintained below design limits Hydrogen explosion to be prevented 	 Pressure in the primary containment vessel <u>stabilized</u> at about <u>1.29 atm</u> which is well below the design operating pressure of 4.85 atm. Nitrogen injection is maintained 	 NOT ACHIEVED Caution: Pressure and H2 concentration of the containment to be further monitored if the RPV is melted through, the containment integrity could be endangered 	Nos 2, 6, 11 and 15
Confining radioactive material	 Reactor pressure vessel (including connected systems) should not leak; or if so the leakage shall be confined Leakages from the containment should be prevented or controlled, or shall be confined 	 Reactor pressure vessel is assumed to be leaking. The location of the leak is not clear as the level in the reactor is not known. It might be either the possible damaged bottom of the reactor or through the connected recirculation system Exiting gap in pressure containment vessel is assumed (ongoing injection of nitrogen has not led to increase of pressure in pressure containment vessel) TEPCO has reported on 15 May that leakage of cooling water from the reactor pressure vessel due to fuel pellets melted and fell down to the bottom of RPV is likely to have occurred and TEPCO considers that the actual damage to the reactor pressure vessel is limited, on the basis of the temperatures at present measured around the reactor pressure vessel. 	 PARTIALLY ACHIEVED Caution: Radioactive releases including venting operations should be limited, controlled and monitored Among other parameters, indications of radiation monitoring system in the drywell should be followed to identify increase in the radioactivity level if the reactor is damaged at the bottom. 	Nos 5, 10, 29–46, 50, 54 and 55 TEPCO has on 13 May commenced the preparatory work for the installation of a cover for the reactor building of Unit 1.

Limiting effects of releases	 No additional releases shall be anticipated Radiation monitoring measurements shall be available 	 Intermittent releases have been observed Radiation monitors are available Reactor pressure vessel and pressure containment vessel are assumed to be leaking. Opening of the airlock in the reactor building did not lead to measurable increase in the releases to the environment 	 PARTIALLY ACHIEVED Caution: Radioactive releases including venting operations should be limited, controlled and monitored 	Nos 12, 47–49, 51–53, 55– 63 In order to reduce air radiation levels inside the reactor building, a filtered air circulation system and system circulating outside air through the building have been installed

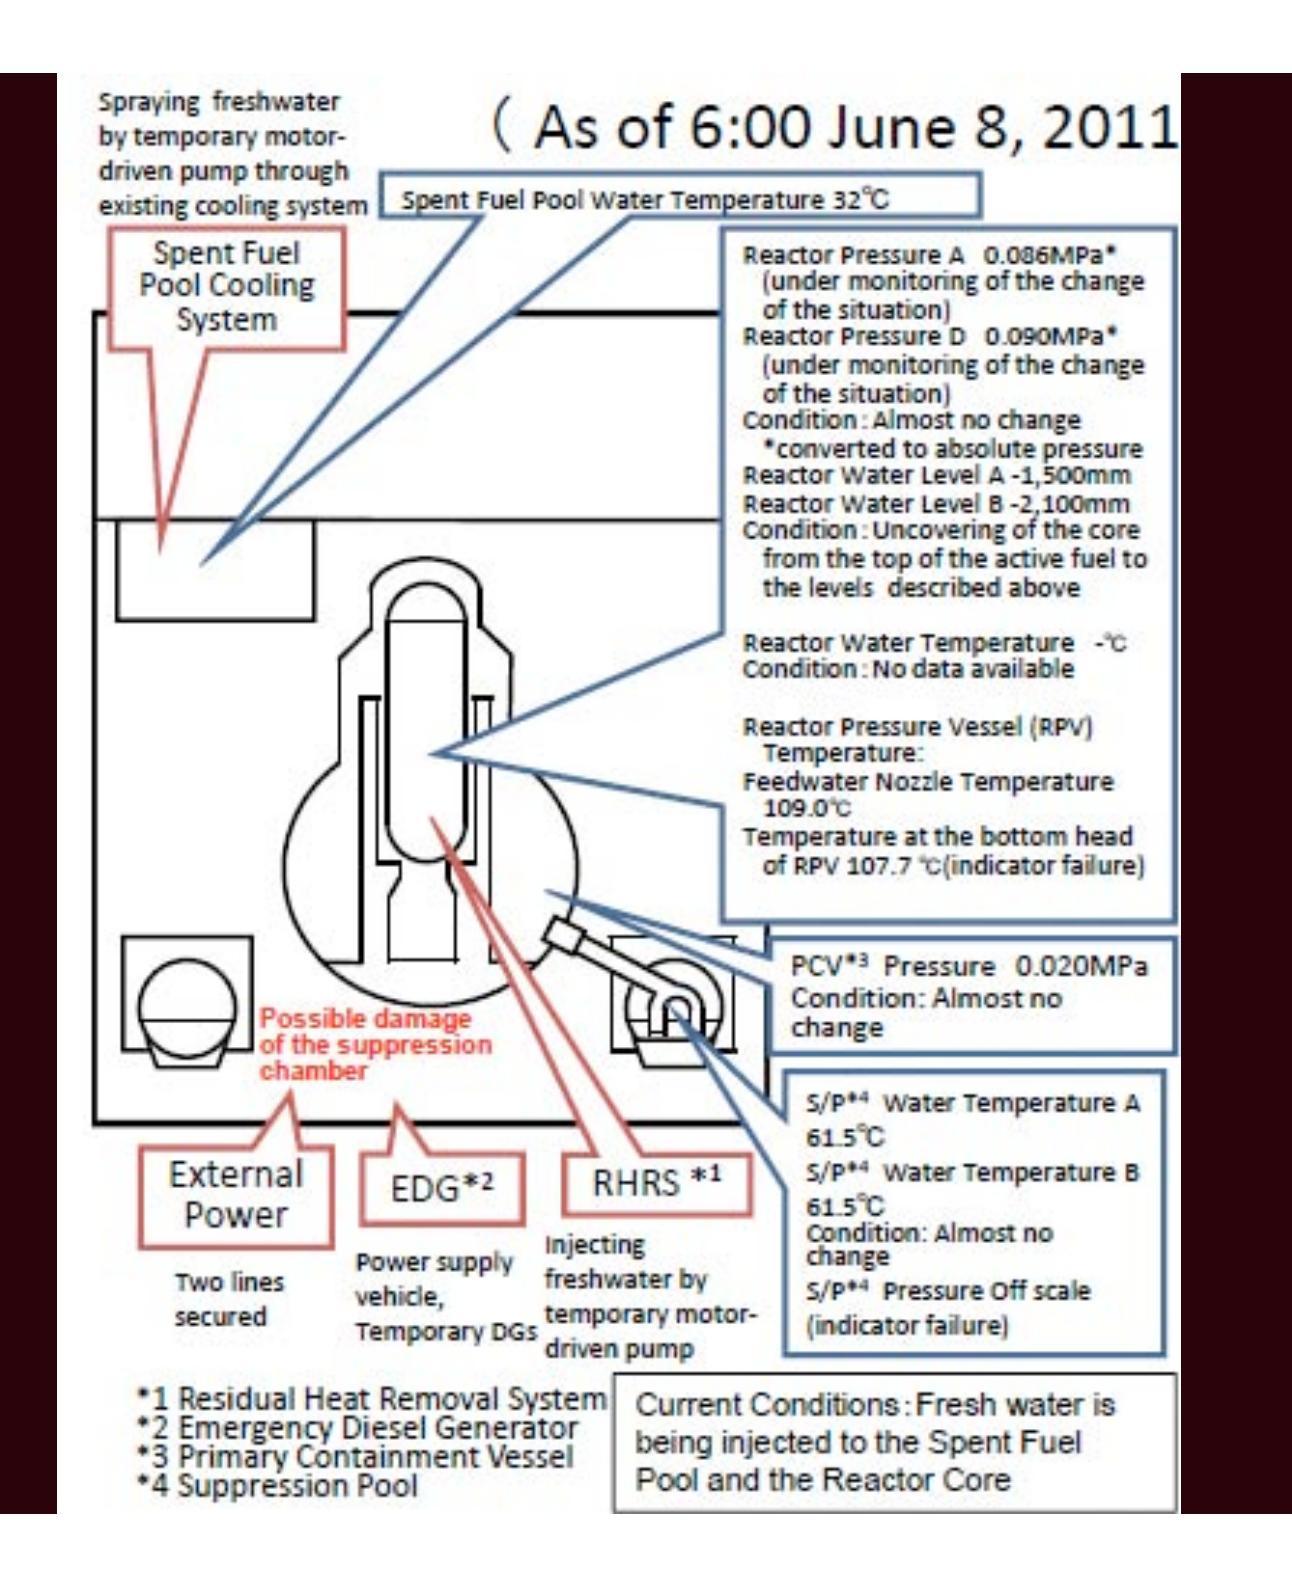
UNIT 2 - REACTOR: FUKUSHIMA DAIICHI NUCLEAR POWER PLANT:

Necessary safety function and conditions	ssary safety function and Observation		TEPCO Roadmap countermeasures
Control of Reactivity	Reactor is subcritical and sub-criticality is demonstrated and maintained	 No power spike or power increase No significant neutron flux measured and reported Short lived fission products are not reported at the moment (e.g. La-140) 	ACHIEVED Caution: • Continue detection of neutrons and short-lived isotopes • Continue the evaluation of need for Boron injection	No additional countermeasures reported <u>Boric acid iniection is being</u> <u>considered by TEPCO</u>
Residual heat removal	 Stable cooling shall be assured Keep the coolant temperature sufficiently below the boiling point at atmospheric pressure Cover the damaged core adequately with water Off-site and back-up power supply shall be available Achievement of long term closed-loop heat removal capability 	 Injection of fresh water into the RPV <u>was changed from</u> <u>7.0 m3/h to 5.0 m3/h at 21:00 UTC on 29 May.</u> Reactor vessel temperature is: (<u>110.7 °C</u> at feedwater nozzle, reactor pressure vessel pressure is <u>around</u> <u>atmospheric</u> based on available measurements) <u>Changes in temperature and pressure are not</u> <u>significant.</u> Water level of reactor core is below about -1500 mm (A) and -2100 mm (B) from the top of active core Off-site power supply and backup power from portable diesel generators are available Fresh water injection is provided; however, closed-loop heat removal is not yet established 	NOT ACHIEVED Establishment of a long term closed-loop heat removal circuit is advised	Nos 1, 3, 4, 7, 8, 9, 13, 14, 16 and 17

Containment integrity	 Containment is leak-tightness Containment pressure is maintained below design limits Hydrogen explosion to be prevented. 	 Containment is believed to be damaged: latest measurements show the containment pressure to be around atmospheric Containment probably damaged following hydrogen explosion at this unit at 21:14 UTC on 14 March 2011 	 NOT ACHIEVED Measures to make the containment leak-tight should be pursued Pressure and H2 concentration of the containment to be further monitored if the RPV is melted through, the containment integrity could be endangered 	Nos 2, 6, 11 and 15
Confining radioactive material	 Reactor pressure vessel (including connected systems) should not leak; or if so the leakage shall be confined within allowable limits Leakages from the containment should be prevented or controlled, or shall be confined 	 Reactor pressure vessel is assumed to be leaking. The location of the leak is not clear as the level in the reactor is not known. It might be either the possible damaged bottom of the reactor or through the connected recirculation system Containment is believed to be damaged: latest measurements show the containment pressure and reactor pressure vessel pressure to be around atmospheric 	NOT ACHIEVED Construction of a cover above the reactor building has to be pursued Among other parameters, indications of radiation monitoring system in the drywell should be followed to identify increase in the radioactivity level if the rector is damaged at the bottom.	Nos 5, 10, 29–46, 50, 54 and 55

Limiting effects of releases	 No additional releases shall be anticipated Radiation monitoring measurements shall be available 	 Intermittent releases have been observed Radiation monitors are available White smoke has been observed but is no longer reported Samples of water in the turbine building floor area show high radioactivity releases from the reactor and the containment to the environment 	PARTIALLY ACHIEVED Measures to prevent radioactive releases and leaking of water with high level radioactivity to the environment should be further pursued	Nos 12, 47–49, 51–53, 55–63 The transfer of stagnant water from the turbine building to the radioactive waste treatment facilities is continuing Work to block the trench pit to prevent release of water with high level radioactivity to the environment is continuing

Spraying freshwater by temporary motor driven pump through existing cooling system

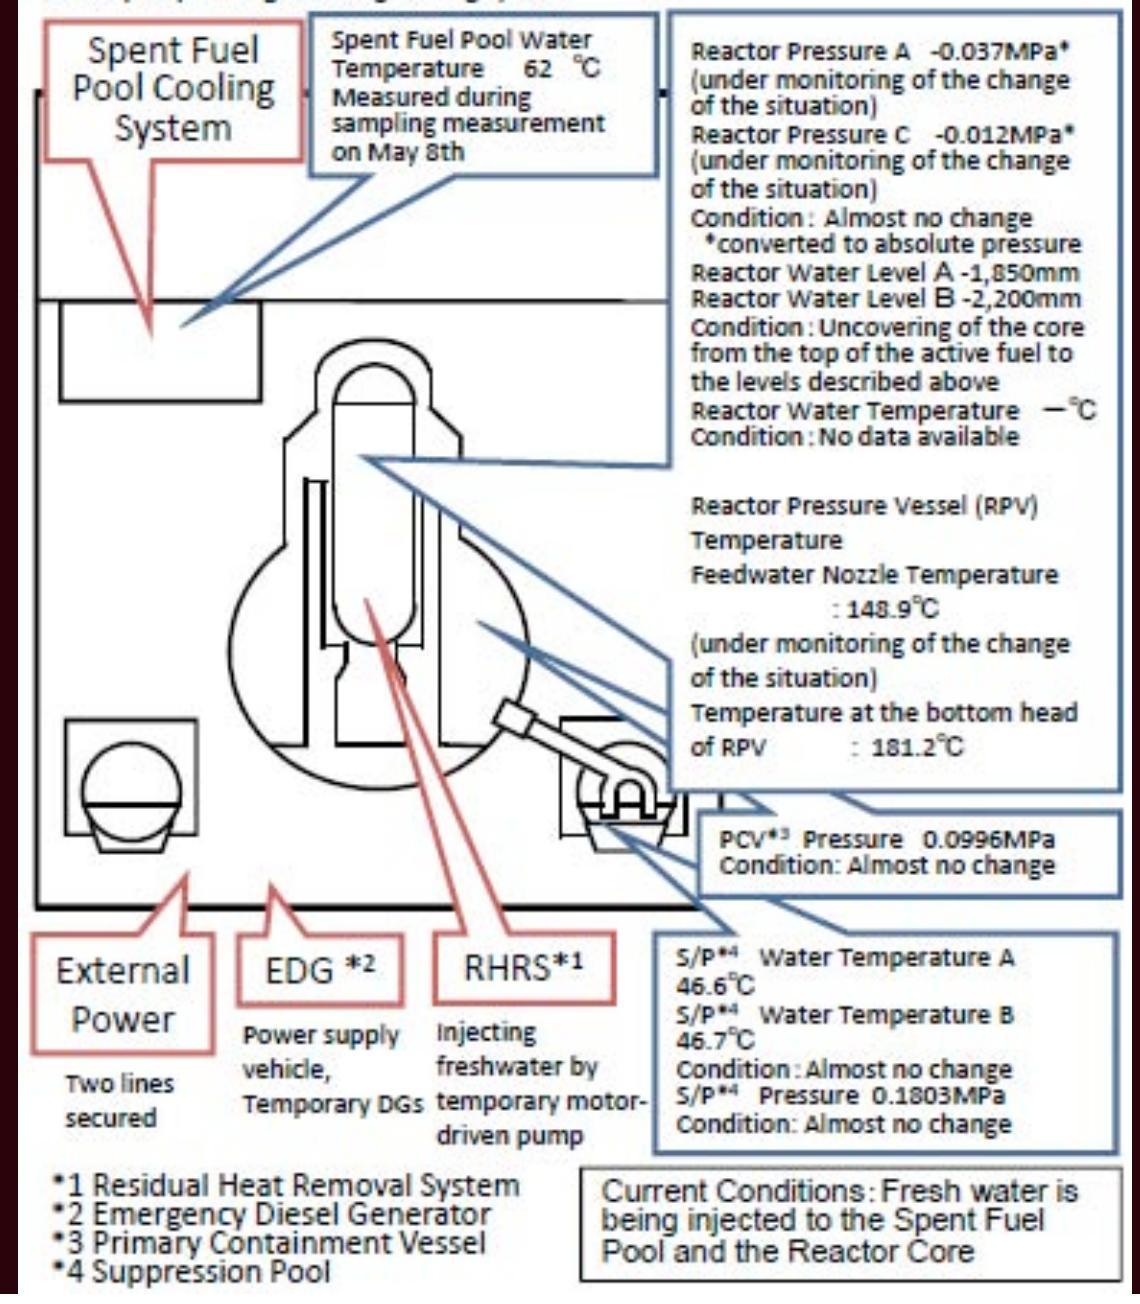
UNIT 3 - REACTOR: FUKUSHIMA DAIICHI NUCLEAR POWER PLANT:

Necessary safety function and conditions	Observation	Evaluation of safe state	TEPCO Roadmap countermeasures
Control of Reactivity	Reactor is subcritical and sub- criticality is demonstrated and maintained	 No power spike or power increase No significant neutron flux measured and reported Short lived fission products (e.g. La-140) are not reported at present 	ACHIEVED Caution: • Continue detection of neutrons and short-lived isotopes • Continue the evaluation of need for boron injection	Boric acid was injected on May 15 as a precautionary measure to preclude criticality a condition
Residual heat removal	 Stable cooling shall be assured: Keep the coolant temperature sufficiently below the boiling point at atmospheric pressure Cover the damaged core adequately with water Off-site and back-up power supply shall be available Achievement of long term closed-loop heat removal capability 	 Stopped injection of fresh water through fire extinguishing lines on May 28. and injection through feedwater system at a rate of 13.5 m3/h (from May 30) Increase in temperature have been measured: 122.4 °C on May 29 at the feedwater nozzle (104.6 °C on 22 May); 128 °C at the lower head on May 29 (114.6 °C on 18 May) Reactor pressure vessel pressure and containment pressure reported are about atmospheric; however, the pressure measured on 29 May in the wet well is 1.84 atm, showing a slight decrease since May 22. Off-site power supply and backup power from portable diesel generators are available Fresh water injection is provided; however, closed-loop heat removal is not yet established 	NOT ACHIEVED Establishment of a long term closed-loop heat removal circuit is advised.	 Nos 1, 3, 4, 7, 8, 9, 13, 14, 16 and 17 Preparation for injection of water through the feedwater system is continuing: The water from the condenser was transferred to the basement of the turbine building on 9 May

Containment integrity	 Containment is leak-tight Containment pressure is maintained below design limits Hydrogen explosion must be prevented 	 The latest measurements show the reactor pressure vessel pressure and containment pressure to be around atmospheric pressure On 20 March a sudden significant drop in pressure in the reactor pressure vessel and a decrease in the containment pressure occurred. The reasons for this are unknown. One possible explanation is a loss of containment integrity; however, the pressure in the containment was decreasing slowly and at present remains stable at around atmospheric. In addition water on the turbine building floor of Unit 3 does not show high level radioactivity Images of Unit 3 showed a crack in the primary containment and steam being released from the reactor building 	 NOT ACHIEVED Measures to make the containment leak-tight should be pursued Pressure and H2 concentration of the containment to be further monitored If the RPV is melted through, the containment integrity could be endangered. 	Nos 2, 6, 11 and 15

Confining radioactive material	 Reactor pressure vessel (including connected systems) should not leak; or if so the leakage shall be confined Leakages from the containment should be prevented, controlled or shall be confined 	 Reactor pressure vessel is assumed to be leaking. <u>The location of the leak is</u> <u>not clear as the level in the reactor is not known.</u> Containment is believed to be damaged; latest measurements show the containment pressure is about atmospheric pressure 	NOT ACHIEVED Construction of a cover above the reactor building should be pursued Among other parameters, indications of radiation monitoring system in the drywell should be followed to identify increase in the radioactivity level if the rector is damaged at the bottom	Nos 5, 10, 29–46, 50, 54 and 55
Limiting effects of releases	 No additional releases shall be anticipated Radiation monitoring measurements shall be available 	 Intermittent releases have been observed Radiation monitors are available Reactor pressure vessel and pressure containment vessel are assumed to be leaking White smoke has been observed but is no longer reported Highly contaminated water flew out into the sea from a pit near the intake channel of Unit 3 (NISA report of May 23) 	PARTIALLY ACHIEVED Measures to prevent radioactive releases should be further pursued	Nos 12, 47–49, 51–53, 55–63

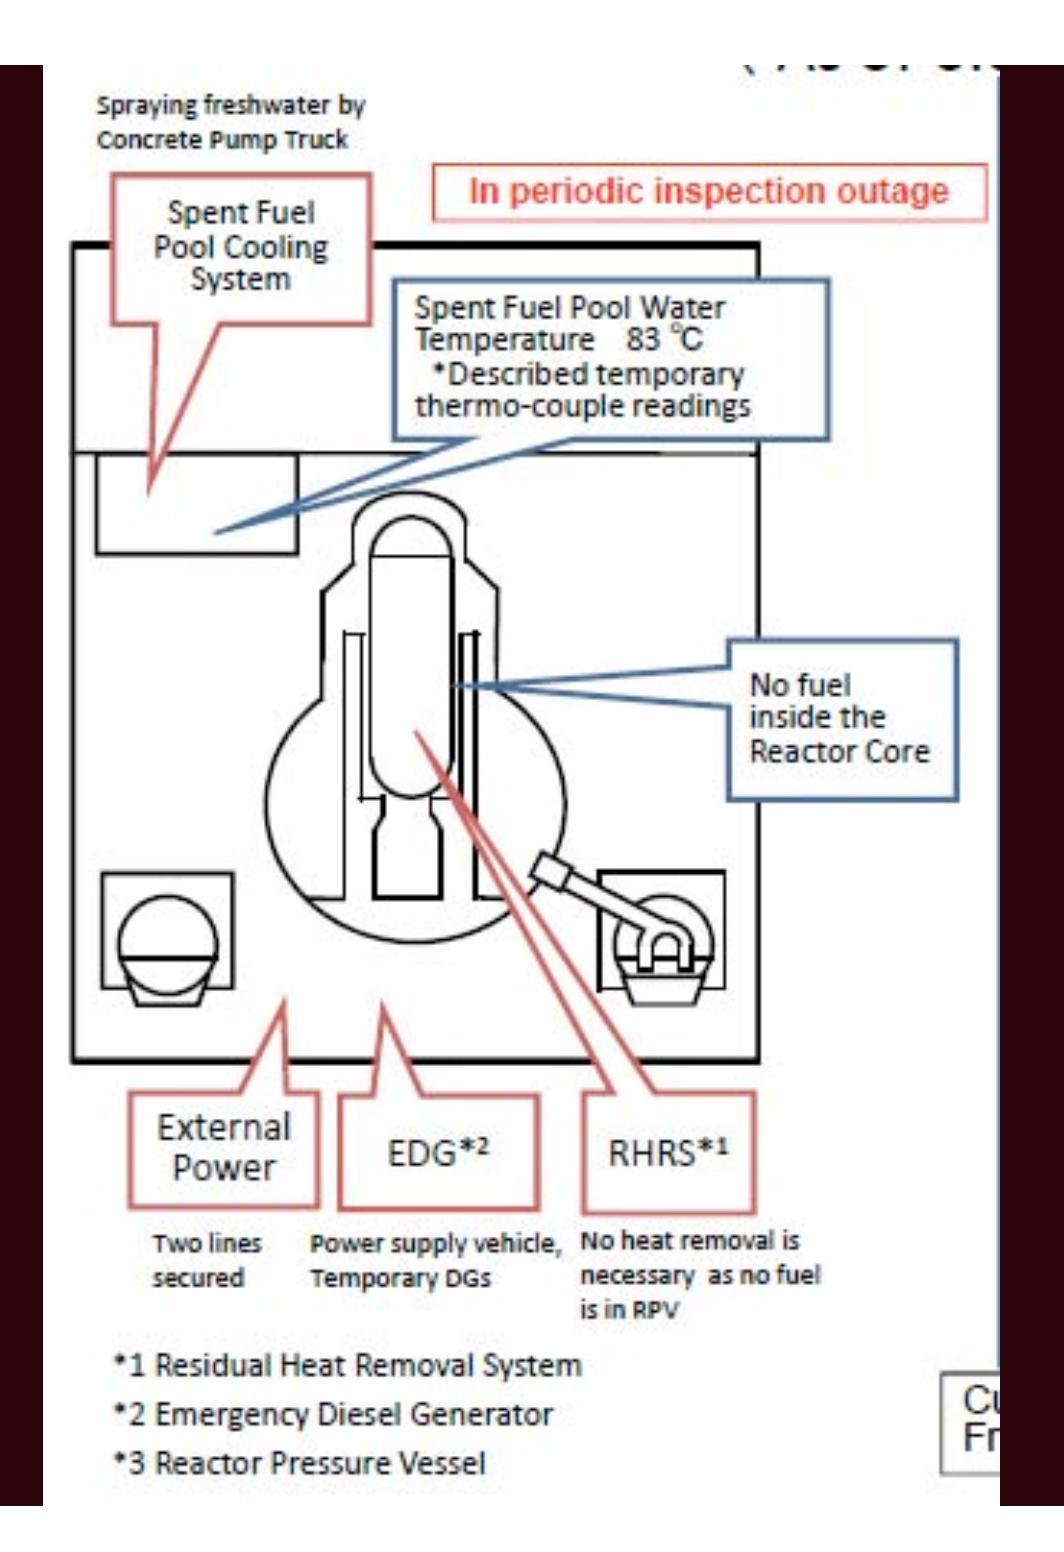
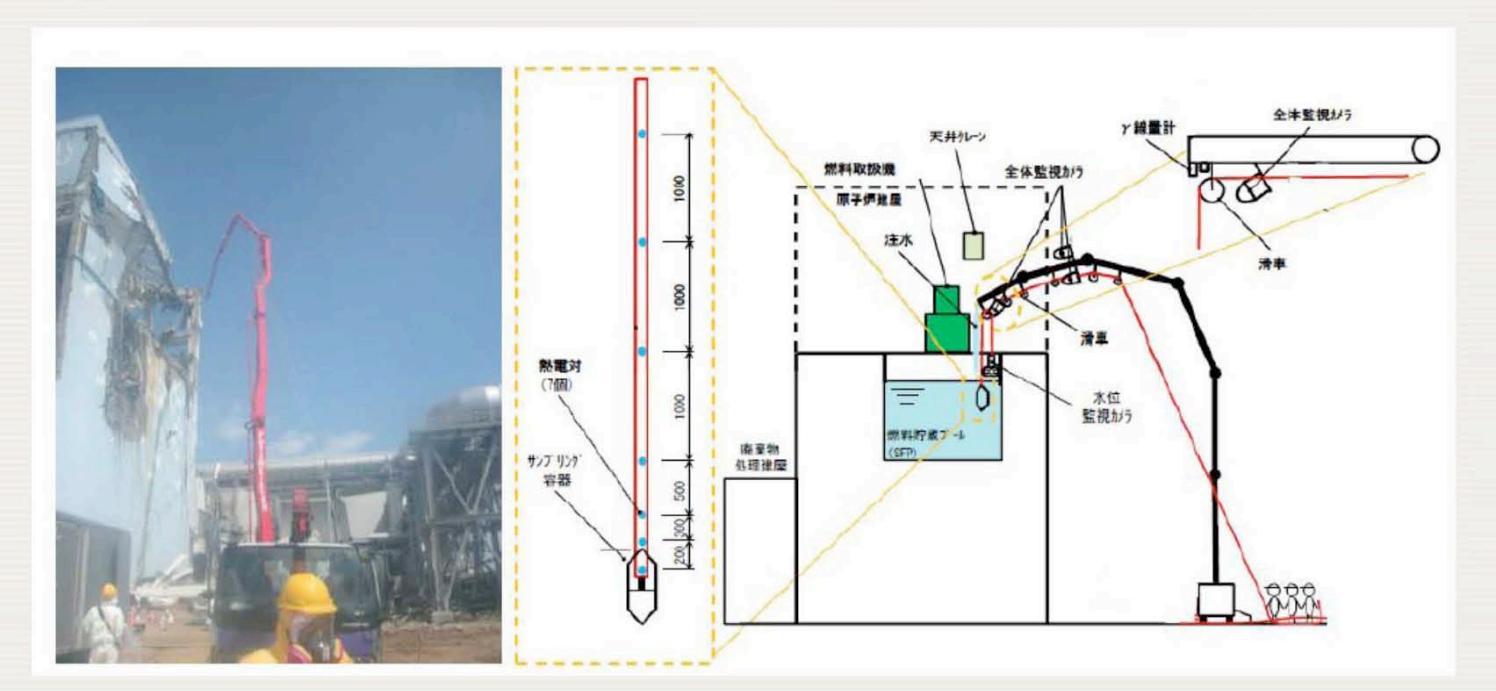
Spent fuel pool of Unit 4

- Total of about 160t of fresh water was sprayed again over the Spent Fuel Pool using a Concrete Pump Truck on May 27 and 28 (method shown the fig. below). Total of about 0.7 m3 of hydrazine was also injected during those days.
 - Periodical fresh water injection serves to reduce the SFP temperature. However cooling through a closed loop circulation must be pursued.

To protect against potential damage as a result of future earthquakes, TEPCO started work on 9 May to install a supporting structure for the floor of the spent fuel pool of Unit 4.

TEPCO has formulated the hypothesis that the damage to the Unit 4 building could have been caused by hydrogen generated at Unit 3 that flowed into Unit 4.

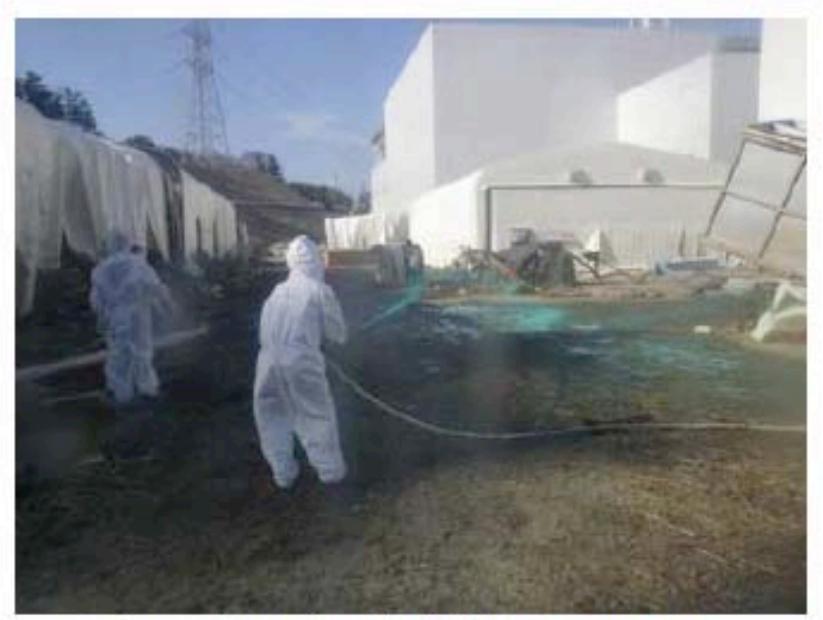
Spraying dust inhibitor agents

- Sprayed dust inhibitor agents to reduce spreading of powder dust containing radioactive materials on the ground. (Had been spraying intermittently since April 1st. Have been spraying at full-scale since April 26).

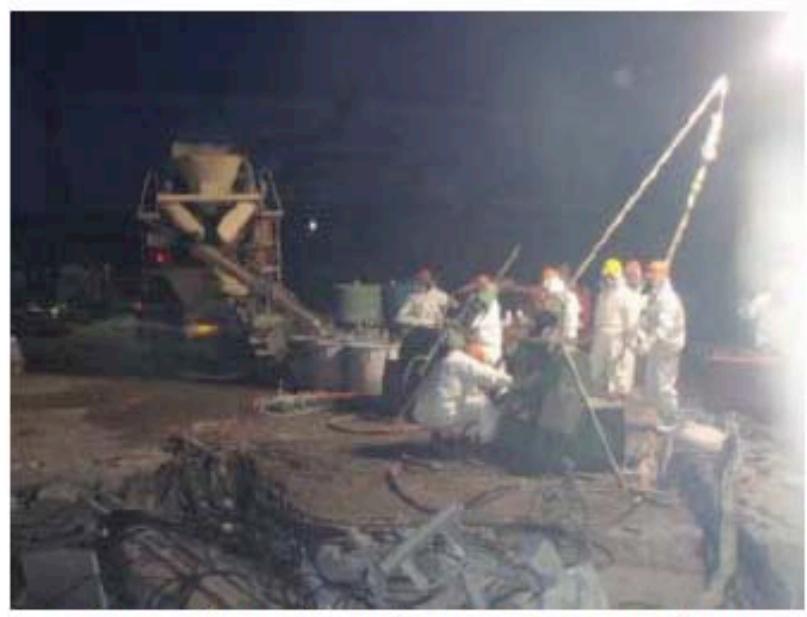
Coagulant injection to stop outflow

- > Took following measures in order to prevent radioactive contaminated water from running off into the sea.
 - Injected coagulants from the holes near the shaft. Have confirmed the outflow from the crack on the concrete wall of the pit stopped. (at 5:38 am, April 6)

- Installed a rubber plate and jig to enhance water sealing.
 - Monitoring continuously for any existence of leakage.
- > Took following measures in order to prevent contaminated water from running off from the plant's port.
