Status of the LHC Machine

J. Wenninger

CERN Beams Department

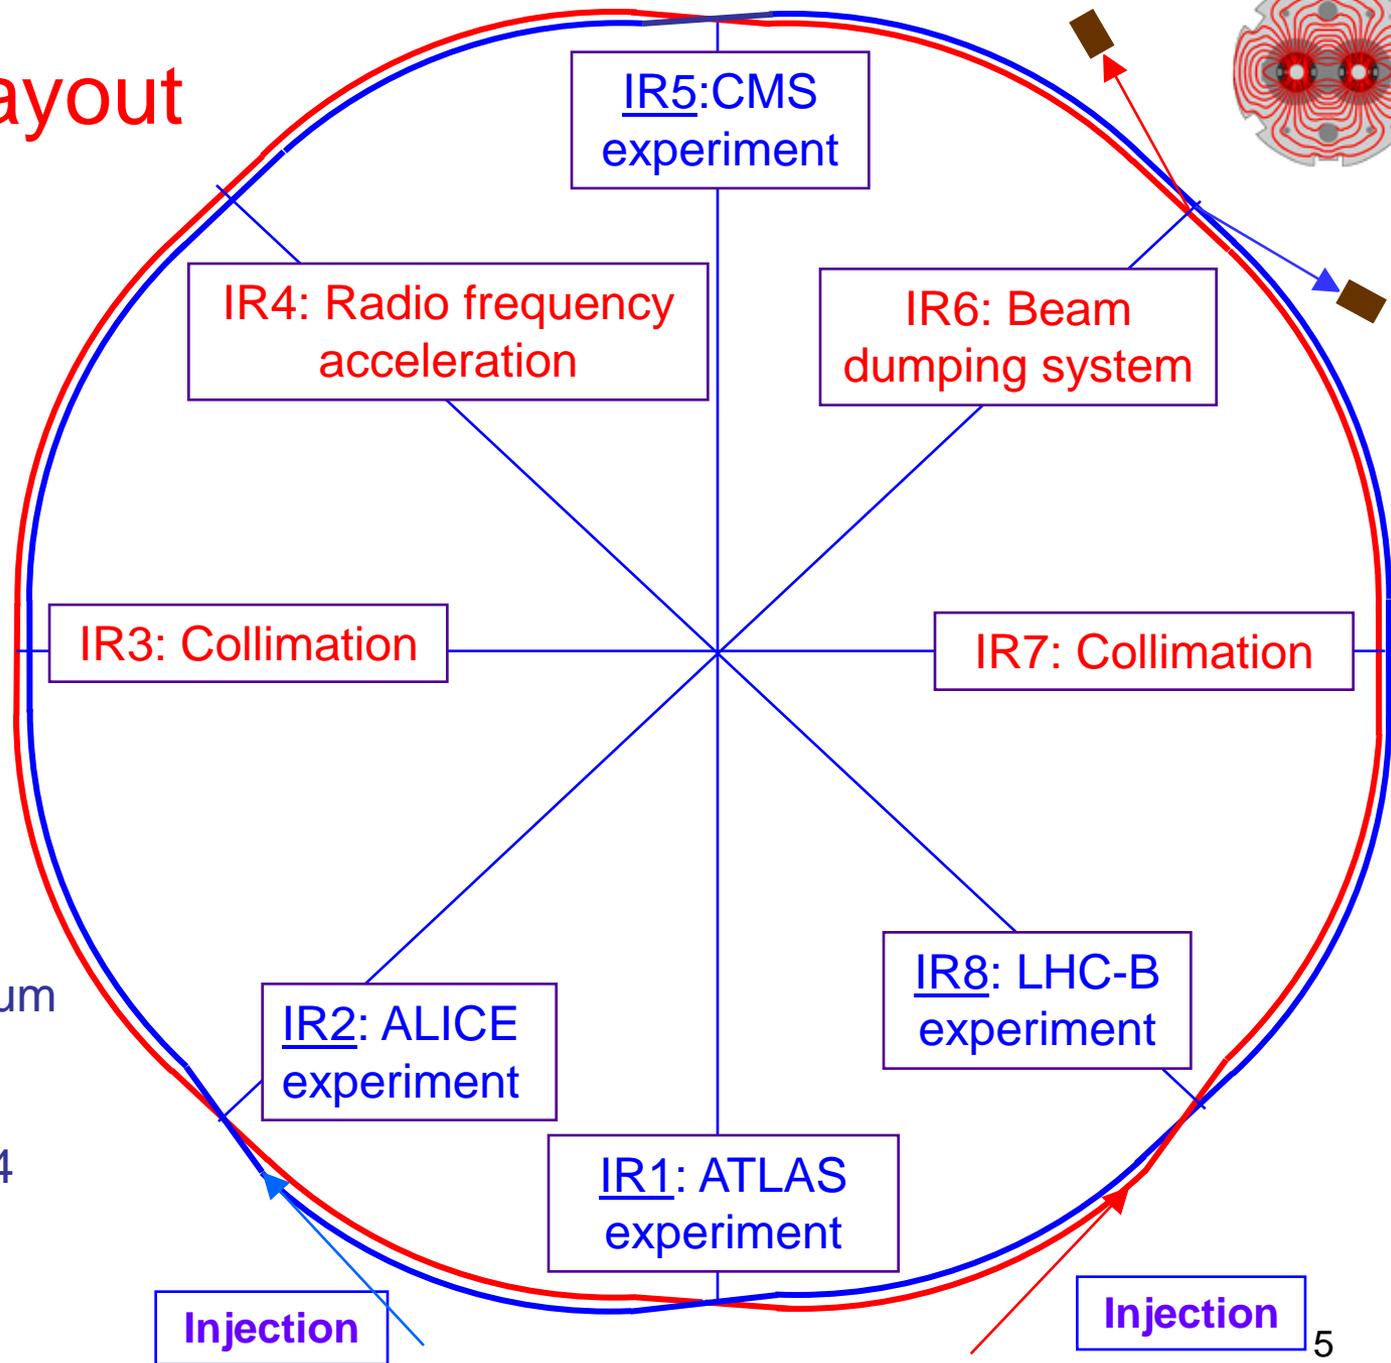
LHC Layout

- 8 arcs (sectors)
- 8 long straight sections (700 m long):
IR1 to IR8

- 2 separate vacuum chambers
- beams cross in 4 points

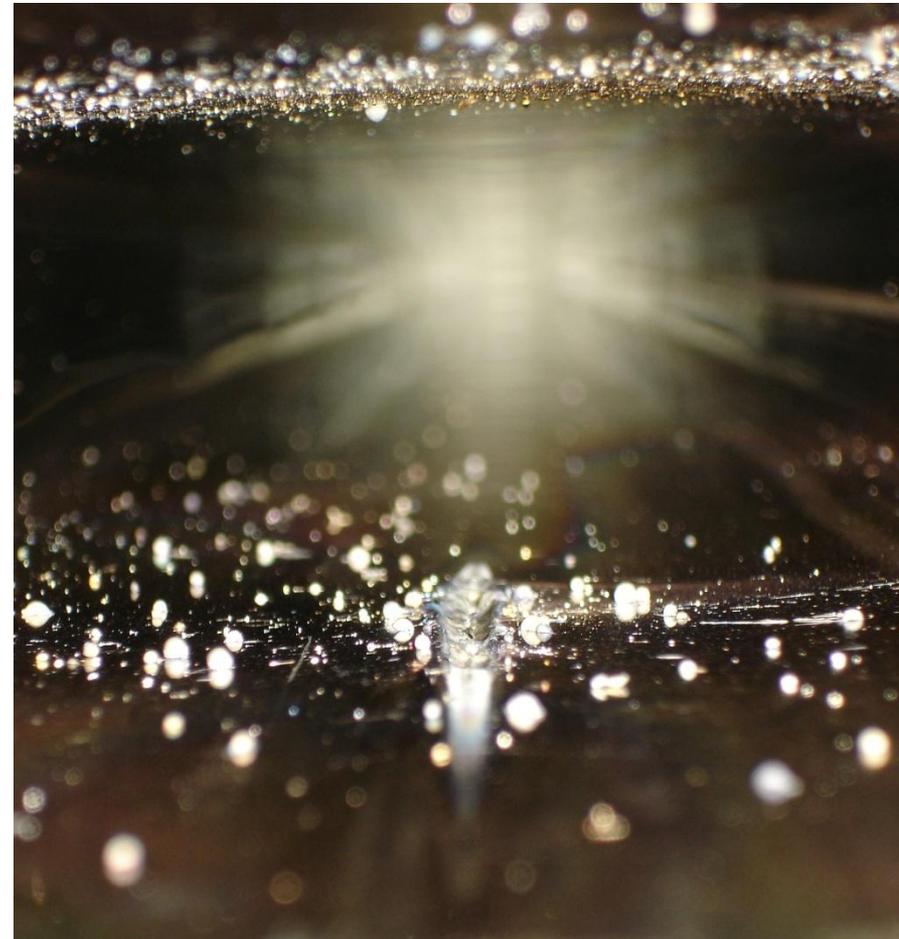
Few cm long groove on an SPS vacuum chamber from the impact of **$\sim 1\%$ of a nominal LHC beam** during an incident:

- vacuum chamber ripped open.
- 3 day repair.

The same incident at the LHC implies a shutdown of > 3 months.

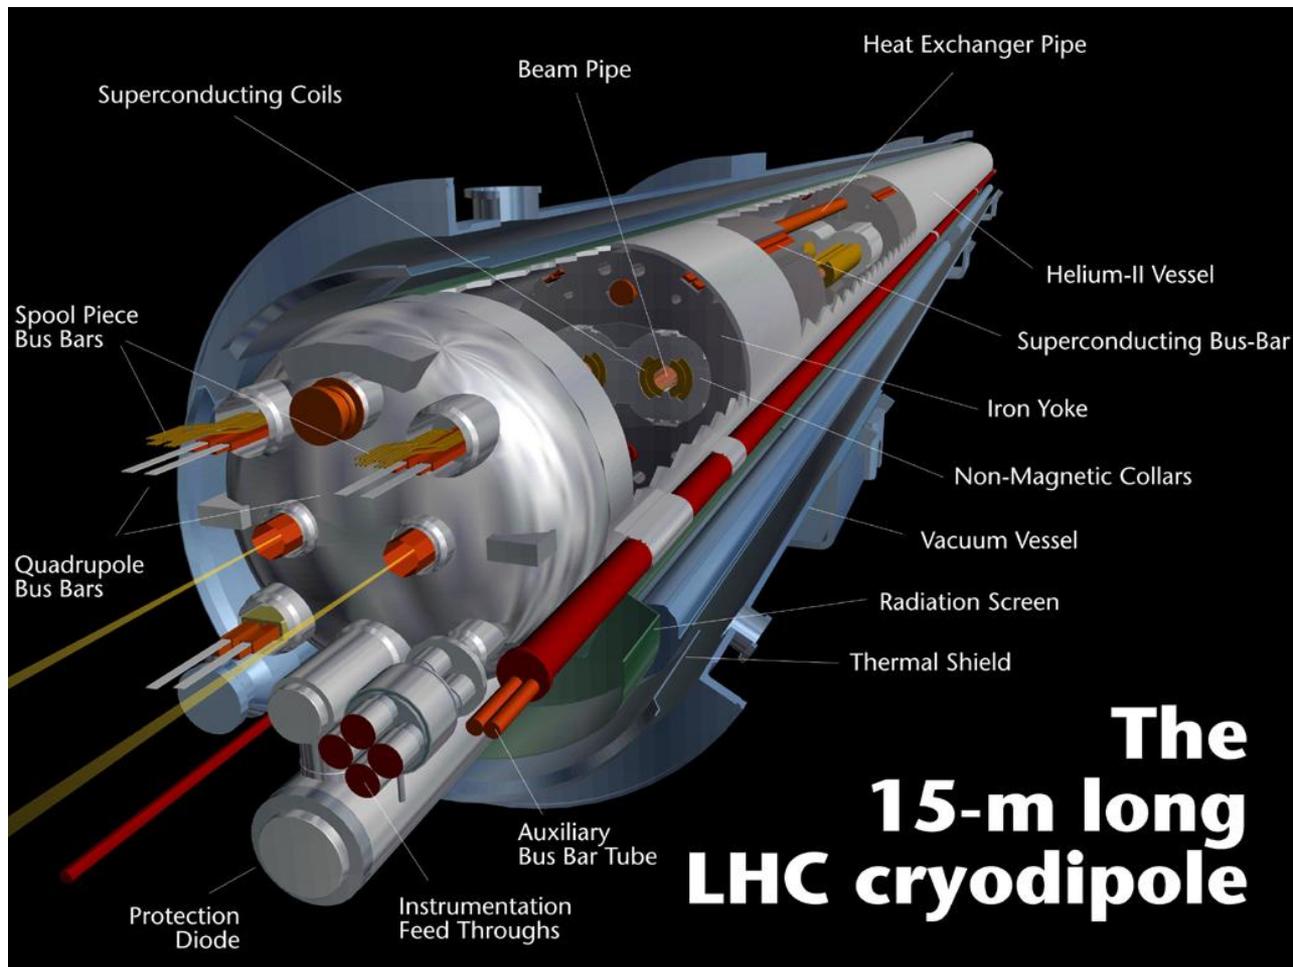
Dipole magnet challenge

- 1232 dipole magnets.
- Magnetic field 8.3 T @ 1.9 K.
- 15 m long.
- 2 magnets-in-one design : two beam tubes with an opening of 56 mm.

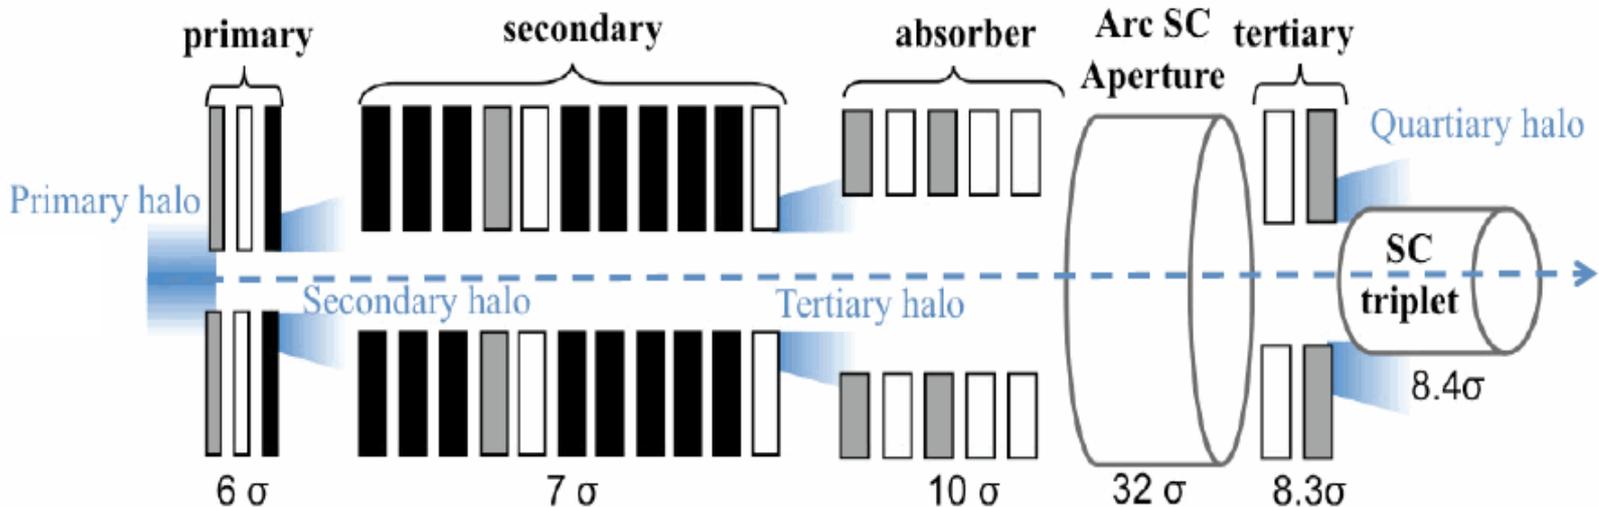
Collimation (1)

A 4-stage halo cleaning (collimation) system is installed to protect the LHC magnets from beam induced quenches.

- A cascade of more than 100 collimators is required to prevent the high energy protons and their debris to reach the superconducting magnet coils.
 - the collimators must reduce the energy load into the magnets due to particle lost from the beam to a level that does not quench the magnets.

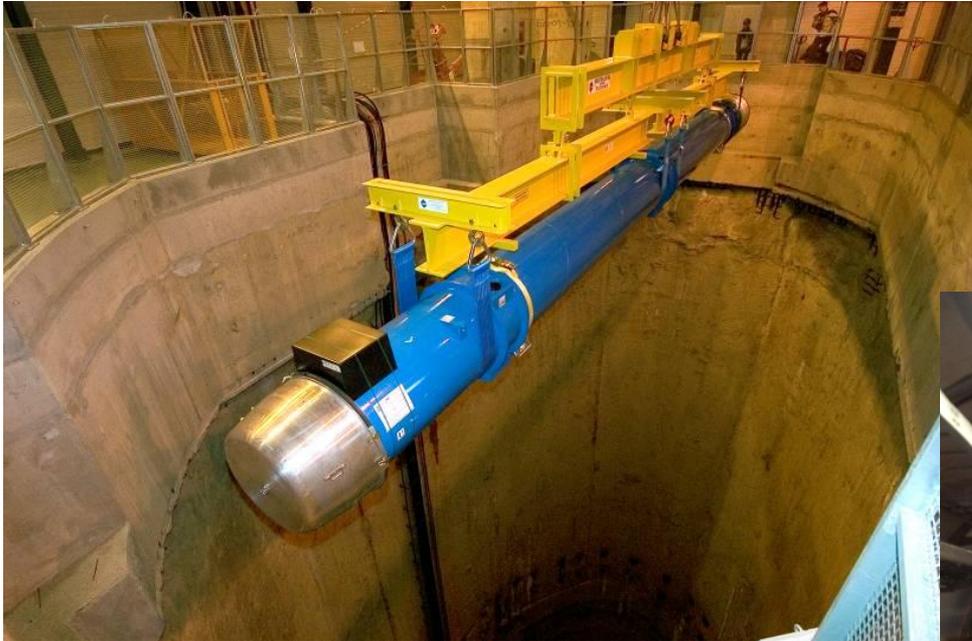
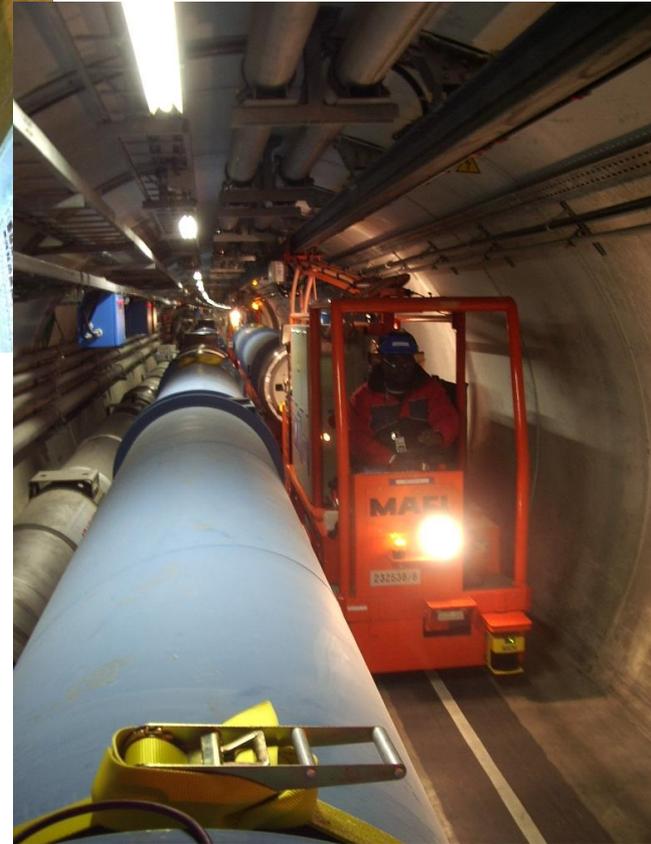
First dipole lowered 7th March 2005

Transport in the tunnel with an
optically guided vehicle

Approx. 1600 magnets to be transported
over up to 20 km at 3 km/hour

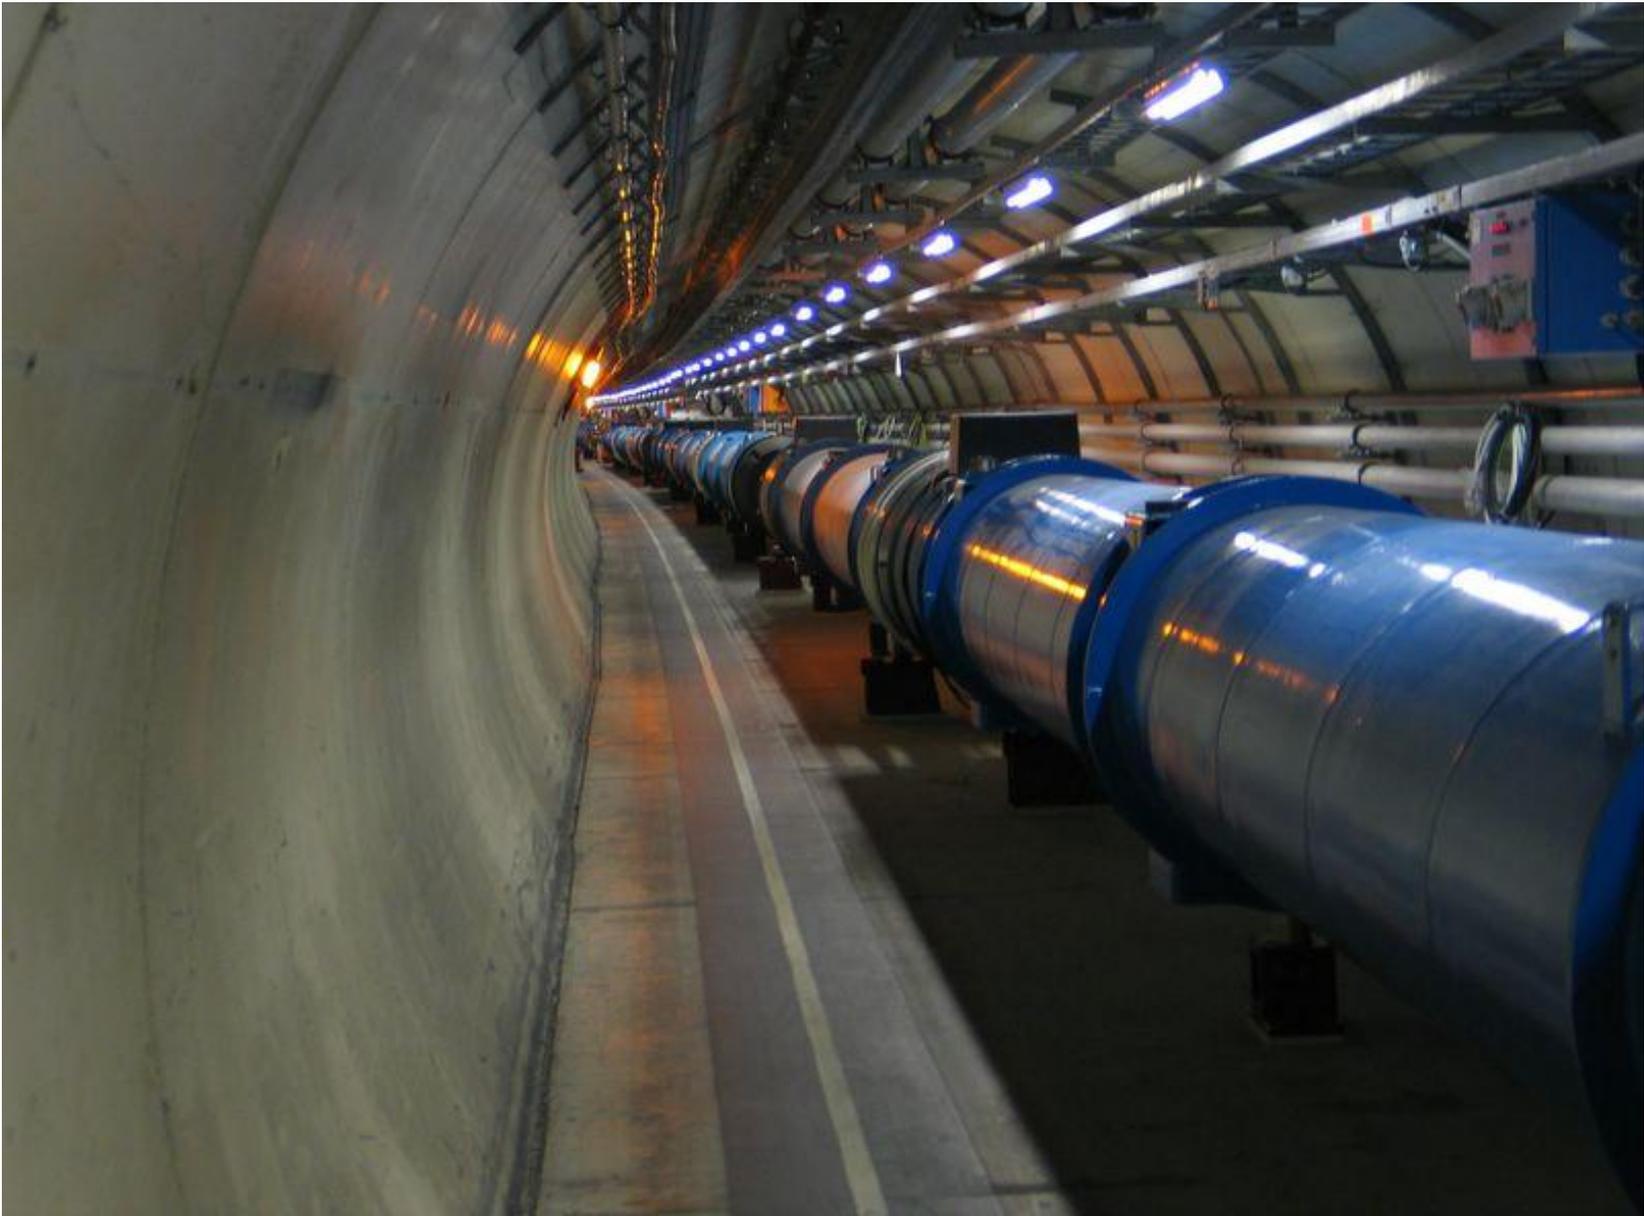
3 km long cryostats

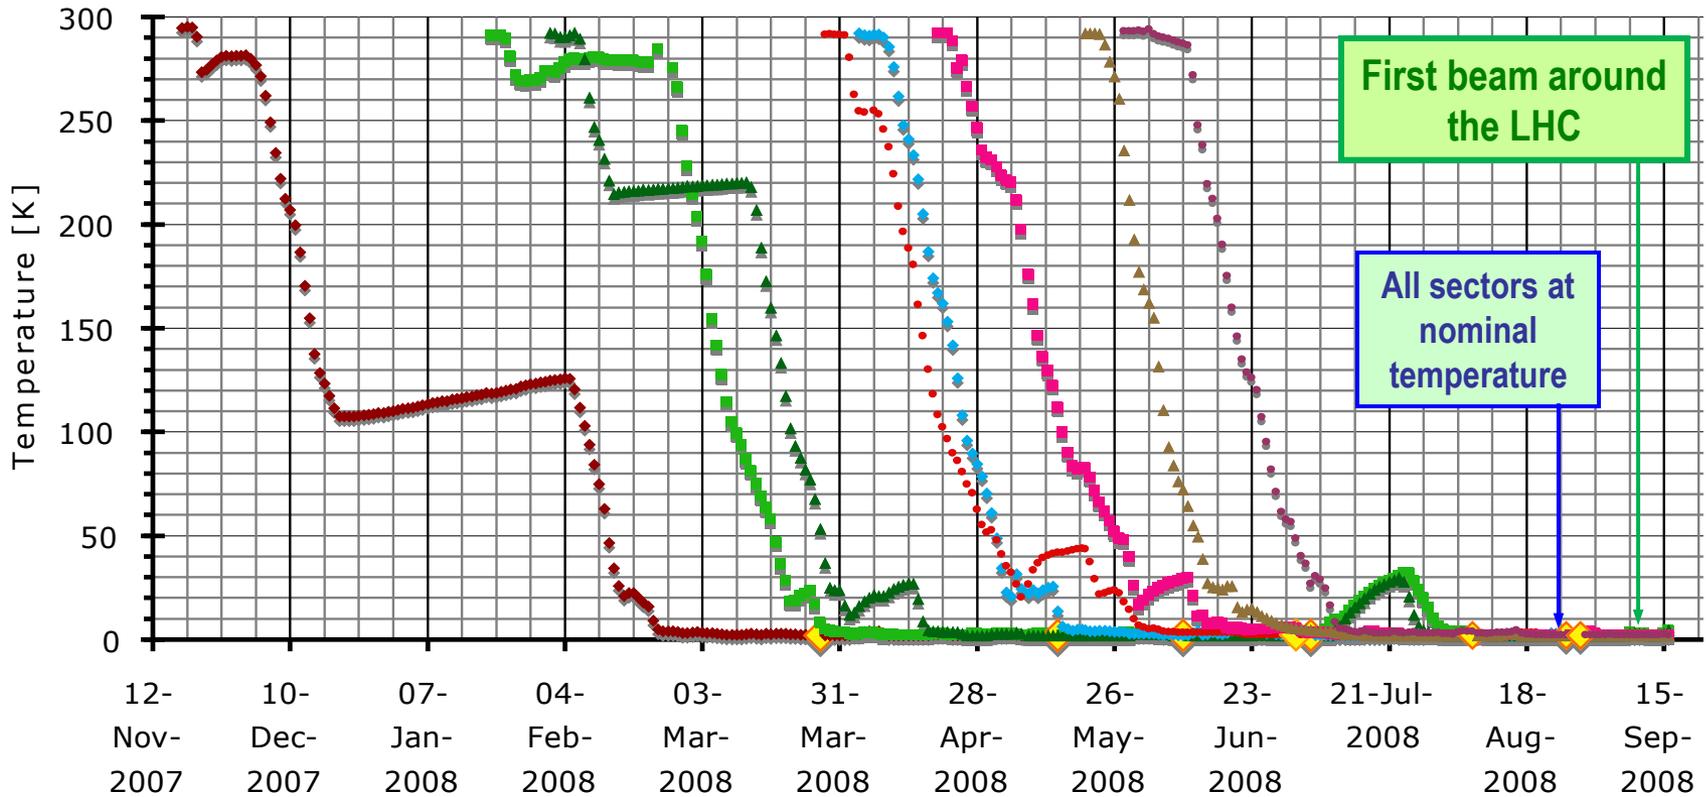
LHC cool-down in 2008

Cool-down time to 1.9 K ~ 4-6 weeks/sector
[sector = 1/8 LHC]

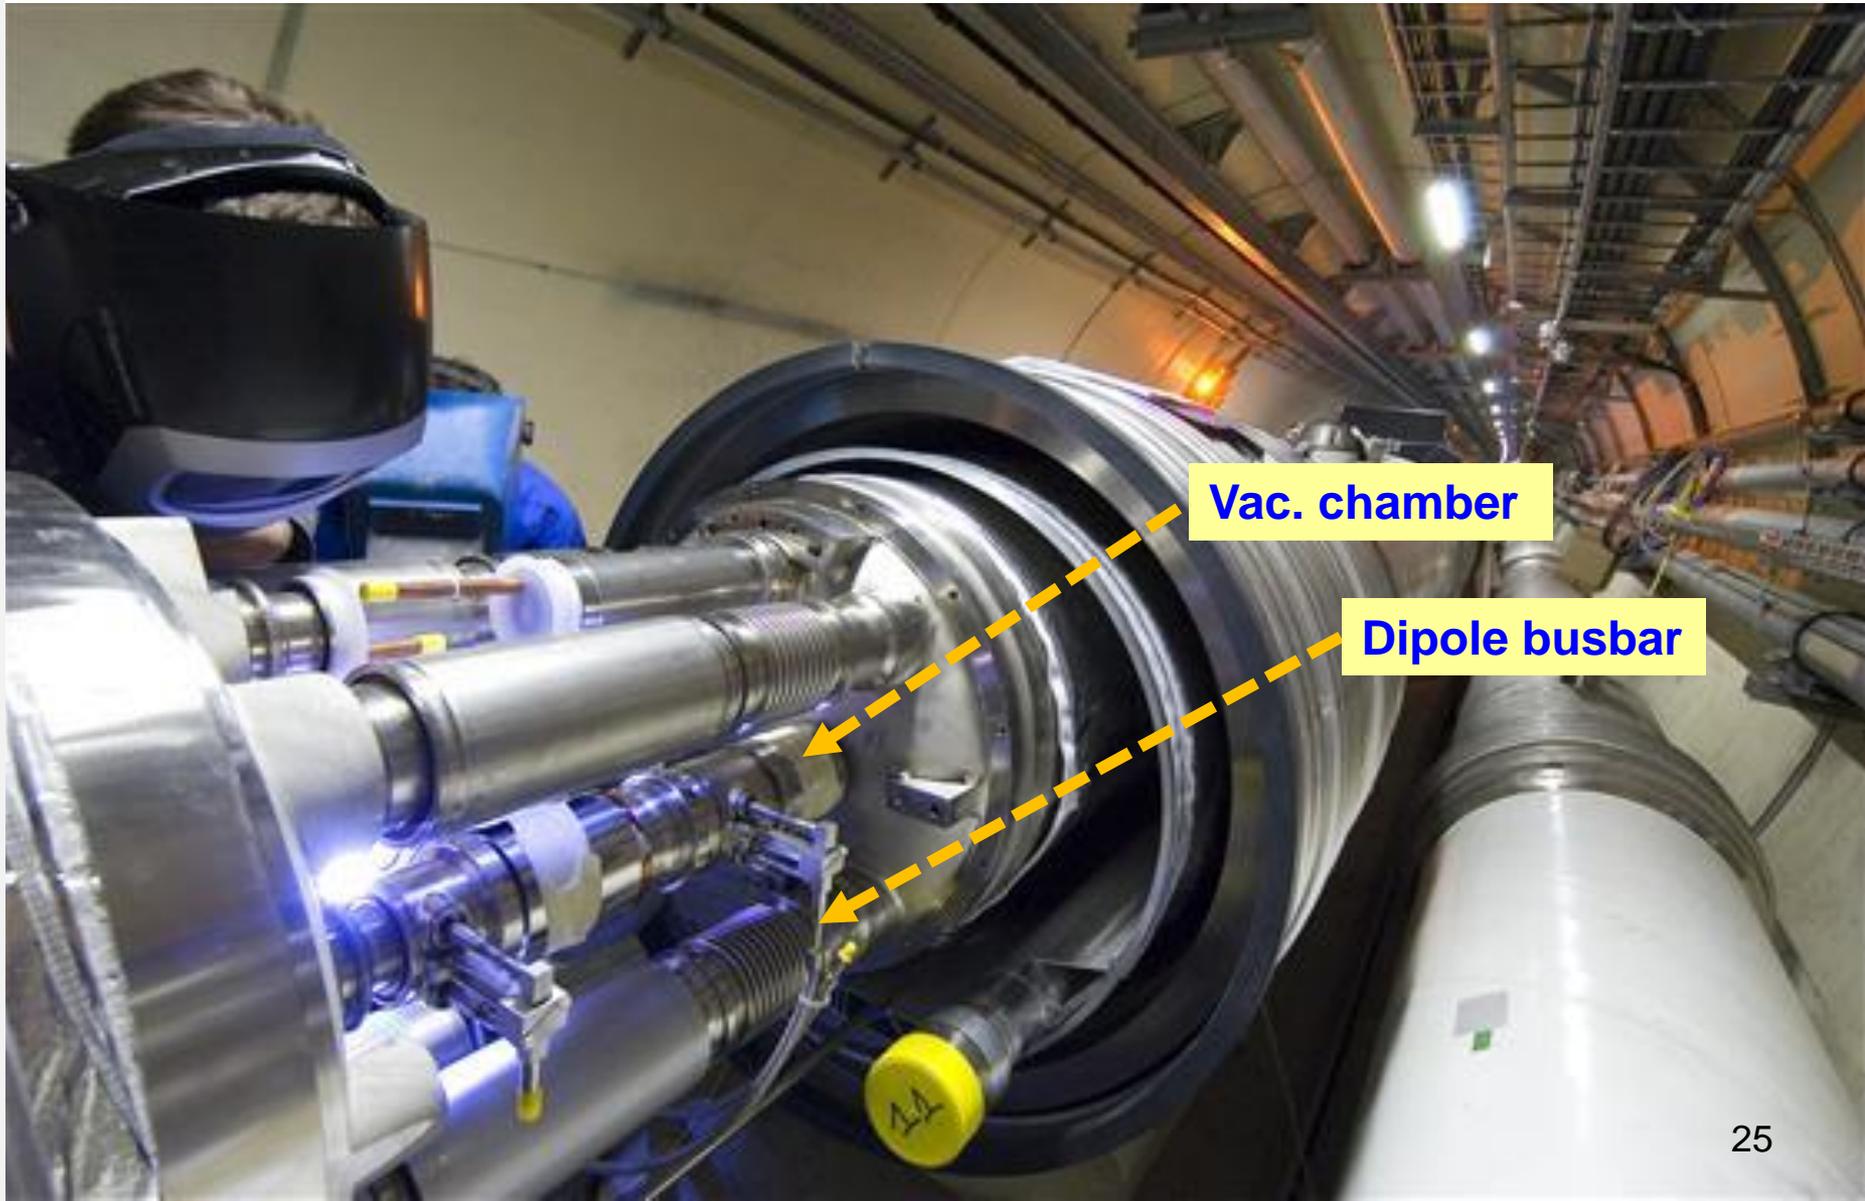
Inter-connection

- ❑ Last commissioning step of the main dipole circuit in sector 34 : [ramp to 9.3kA \(5.5 TeV\)](#).
- ❑ At 8.7kA an electrical fault developed in the **dipole bus bar** (the bus bar is the cable carrying the current that connects all magnet of a circuit).
- ❑ An electrical arc developed which punctured the helium enclosure.
Secondary arcs developed along the arc.
Around 400 MJ were dissipated in the cold-mass and in electrical arcs.
- ❑ Large amounts of Helium were released into the insulating vacuum.
In total 6 tons of He were released.

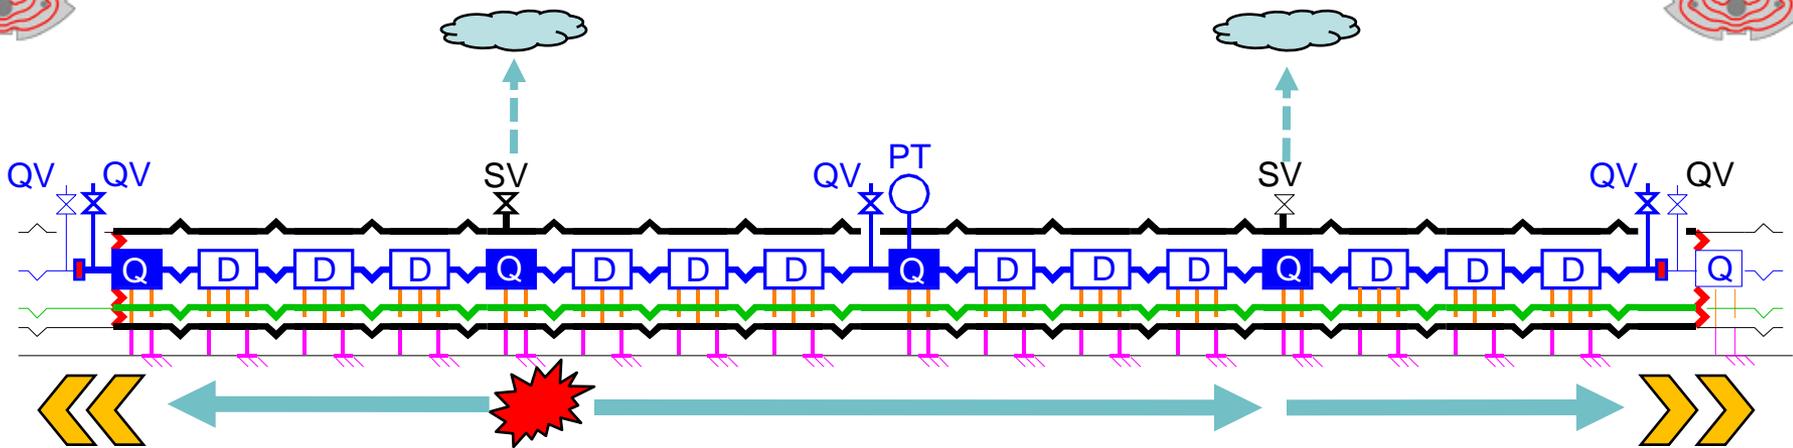
- Cold-mass
- Vacuum vessel
- Line E
- Cold support post
- Warm Jack
- Compensator/Bellows
- Vacuum barrier

- Pressure wave propagates in both directions along the magnets inside the insulating vacuum enclosure.
- Rapid pressure rise :
 - Self actuating relief valves could not handle the pressure.
designed for 2 kg He/s, incident ~ 20 kg/s.
 - Large forces exerted on the vacuum barriers (every 2 cells).
designed for a pressure of 1.5 bar, incident ~ 10 bar.
 - Several quadrupoles displaced by up to ~50 cm.
 - Connections to the cryogenic line damaged in some places.
 - Beam vacuum to atmospheric pressure.

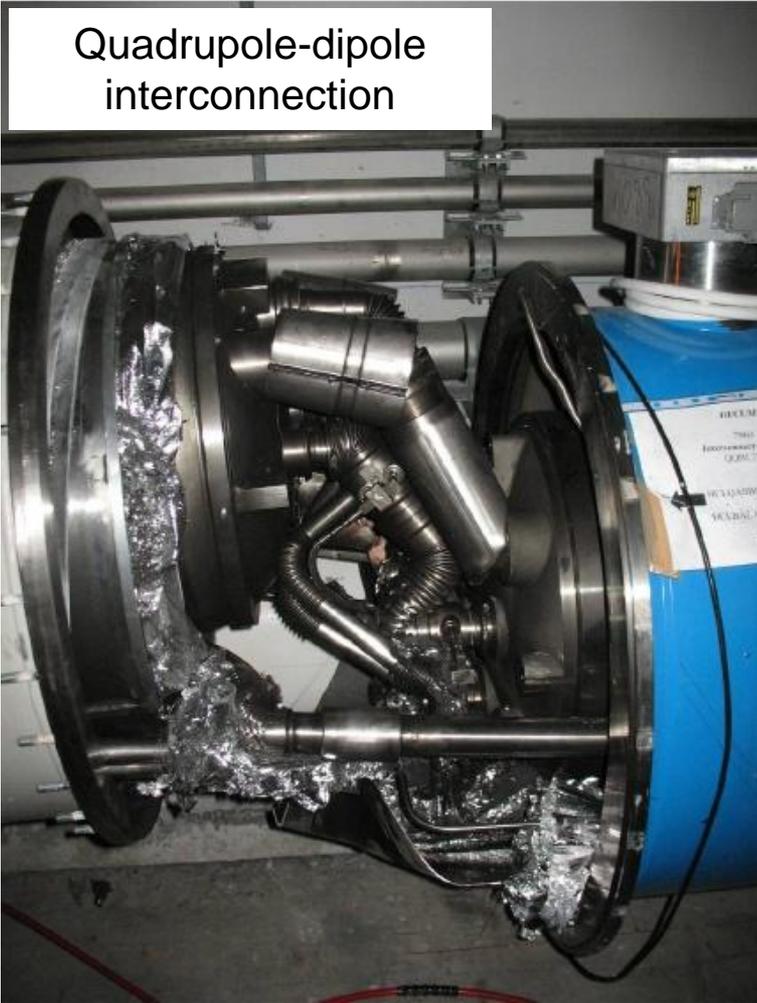
Quadrupole-dipole
interconnection

Collateral damage : displacements

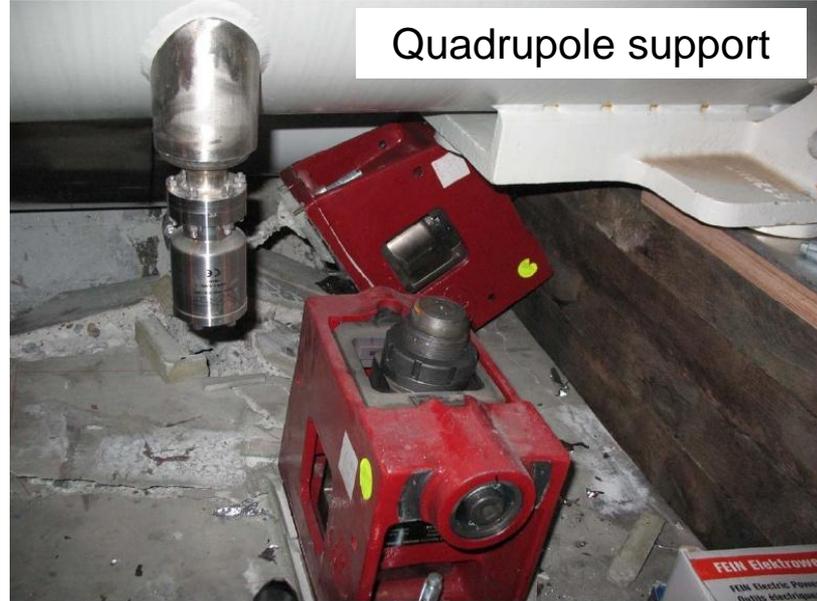
Quadrupole support

Main damage area ~ 700 metres.

- **39** out of 154 **dipoles**,
- **14** out of 47 **quadrupole** short straight sections (SSS)

from the sector had to be moved to the surface for repair (16) or replacement (37).

- Reinforcement of the quadrupole supports.

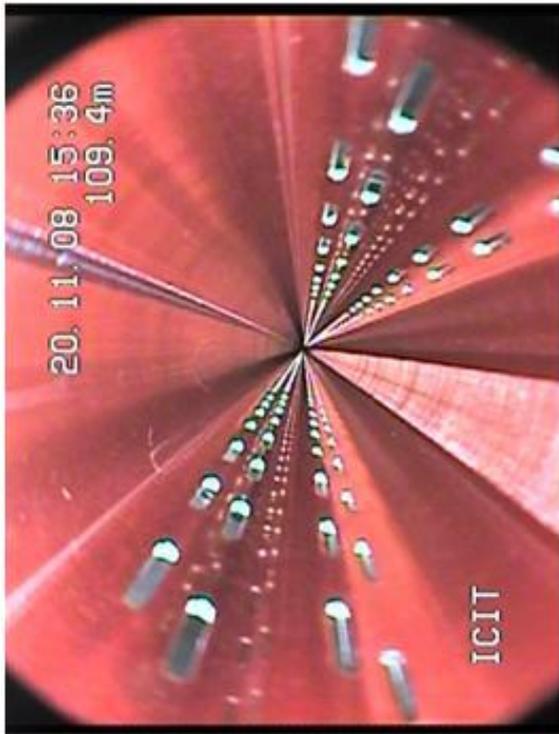
Clean Copper surface.

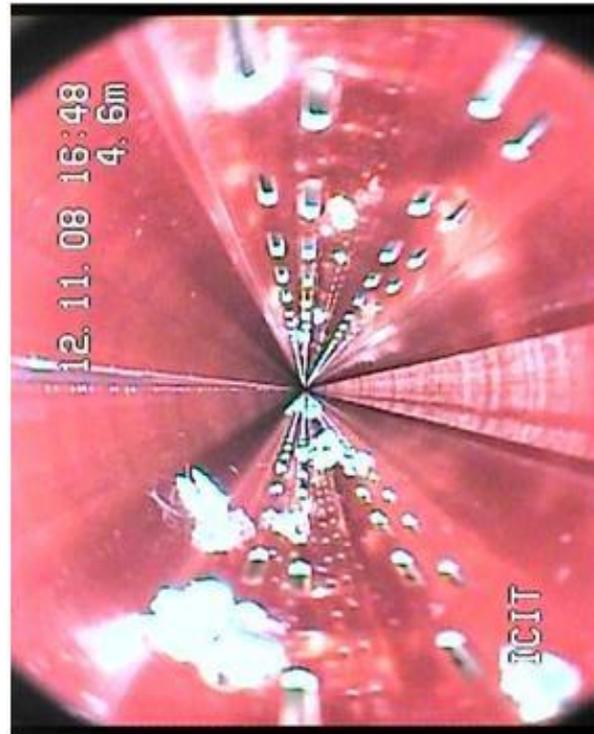
Contamination with multi-layer magnet insulation debris.

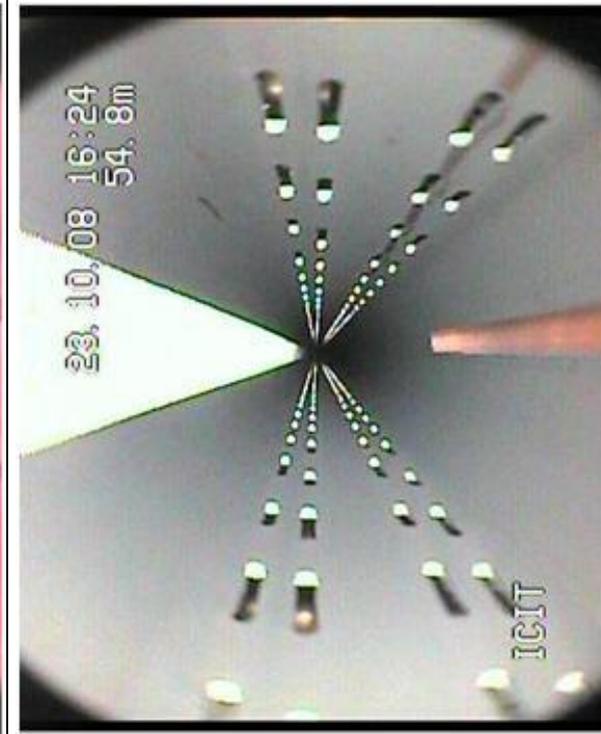
Contamination with sooth.

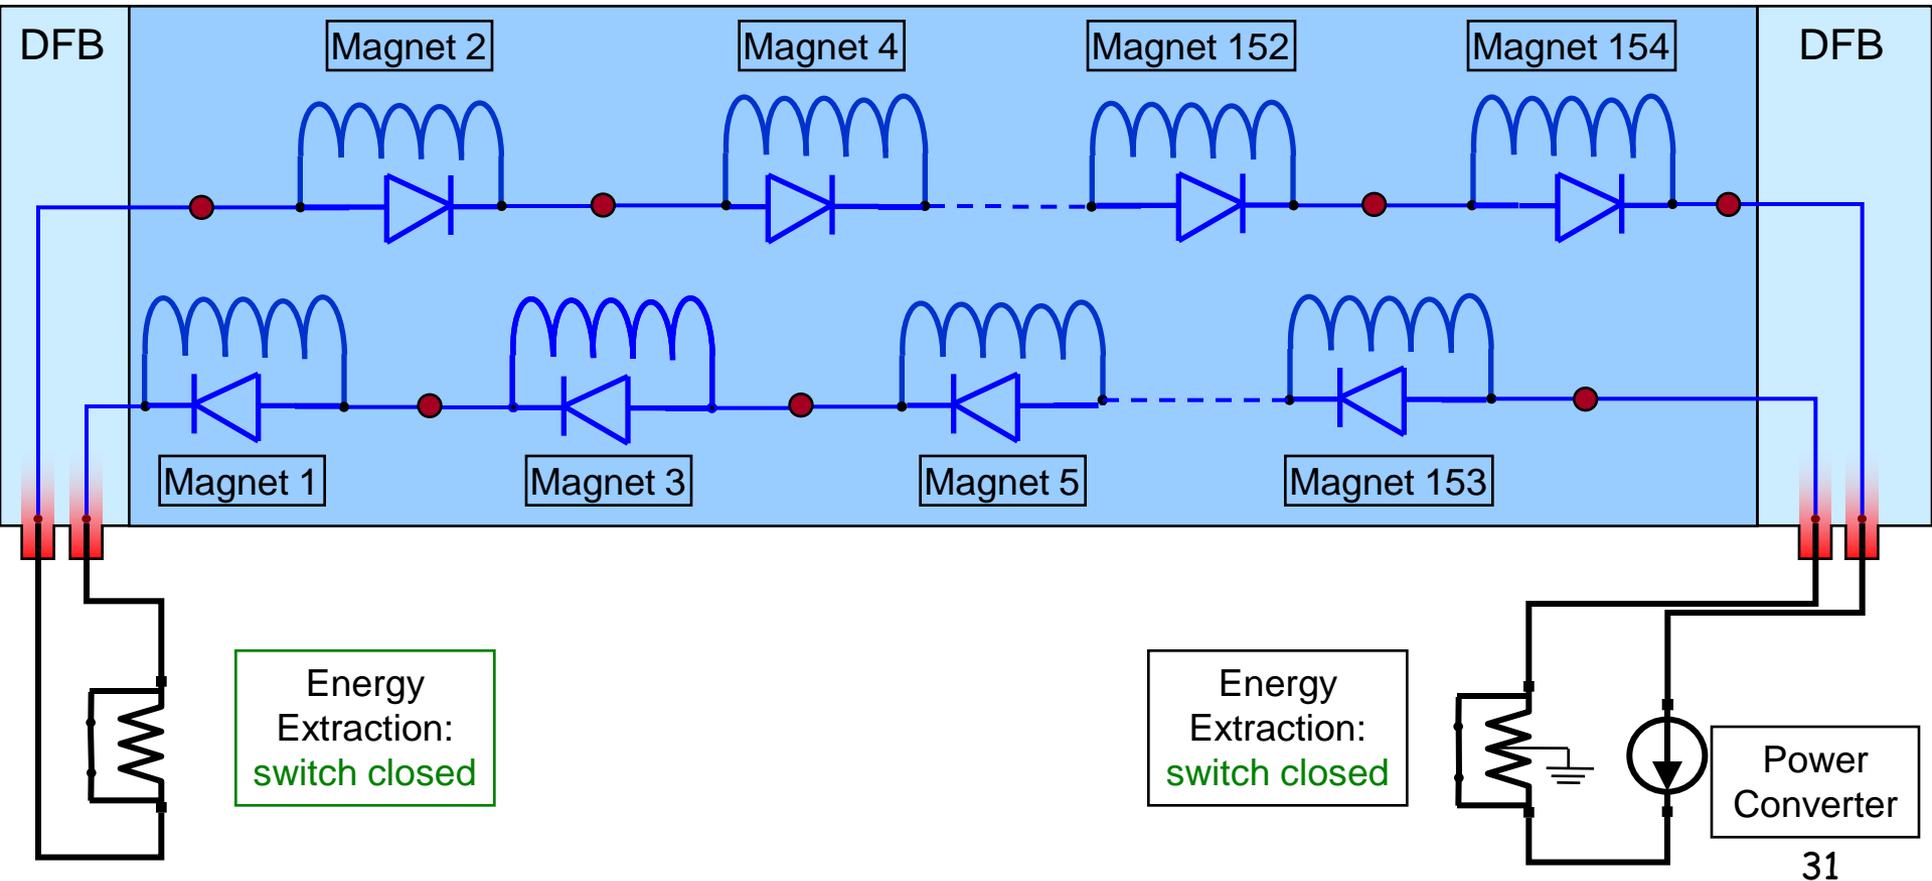
Dipole magnets in arc cryostat

- 154 dipole magnets are connected together as one circuit to the power converter.
- Time for the energy/field **ramp** is about **20-30 min** (energy from the grid)
- Time for regular discharge (ramp down) is about **the same** (energy to the grid)

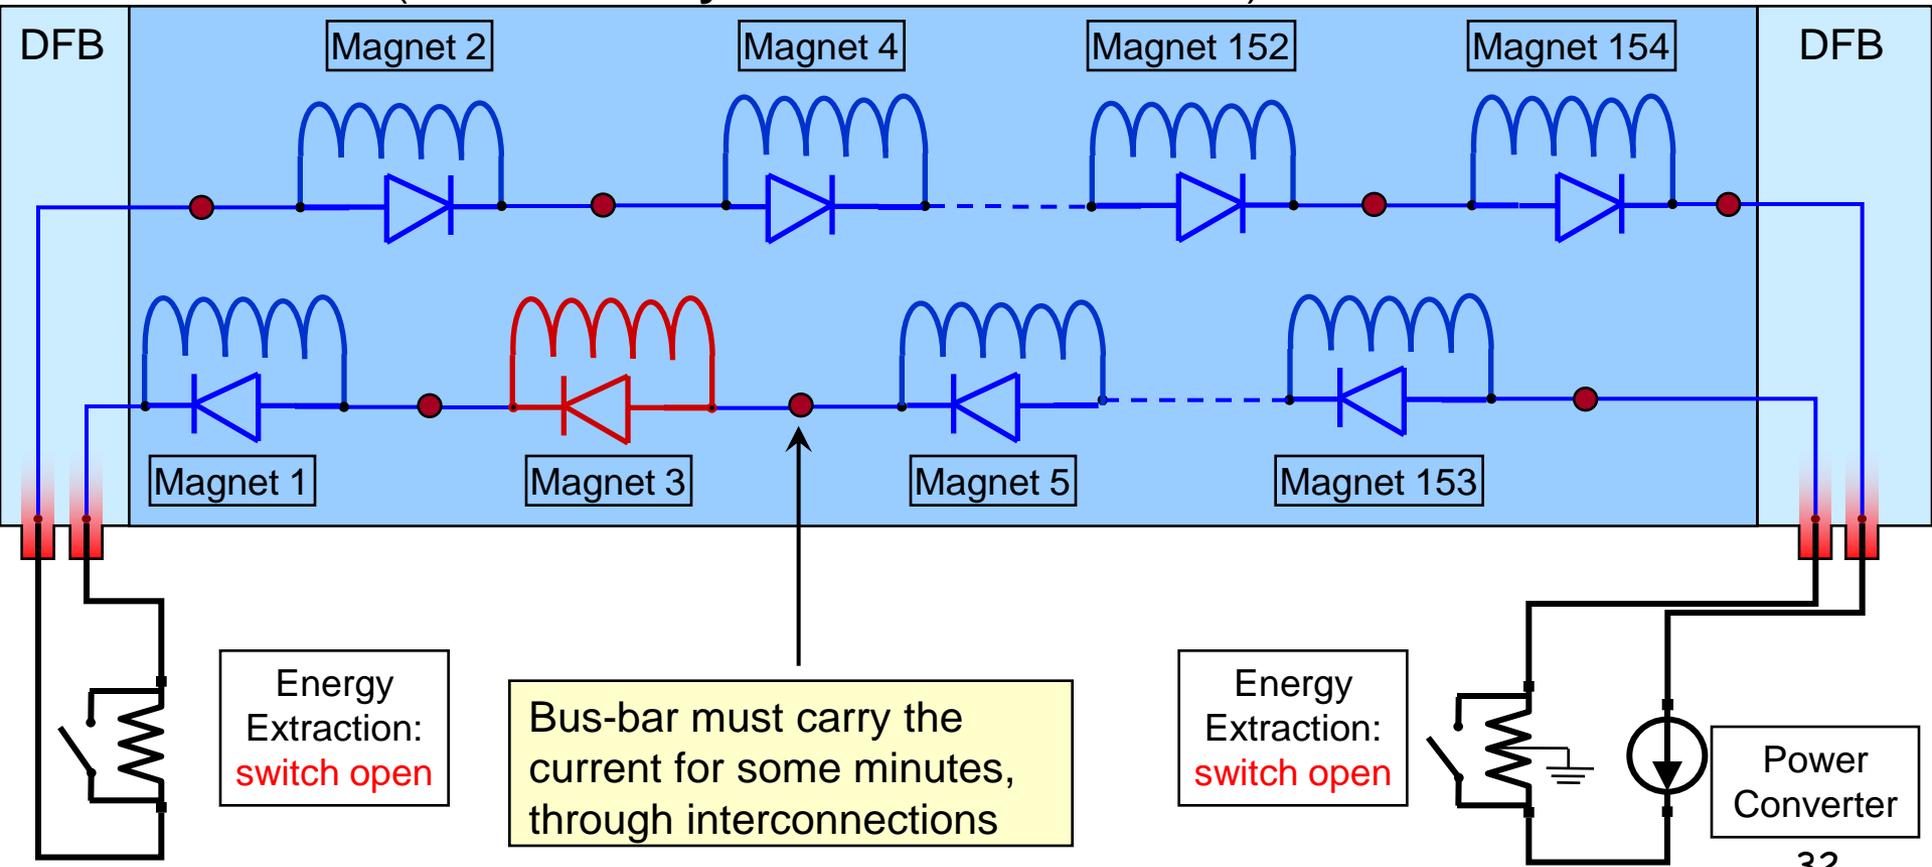
Dipole magnet protection

- ❑ **Quench detected:** energy stored in magnet dissipated inside the magnet (time constant of 200 ms).
- ❑ **Parallel diode becomes conducting:** current of other magnets through diode.
- ❑ **Resistances are switched into the circuit:** up to 1 GJ of energy is dissipated in the resistances (**current decay time constant of 100 s**).

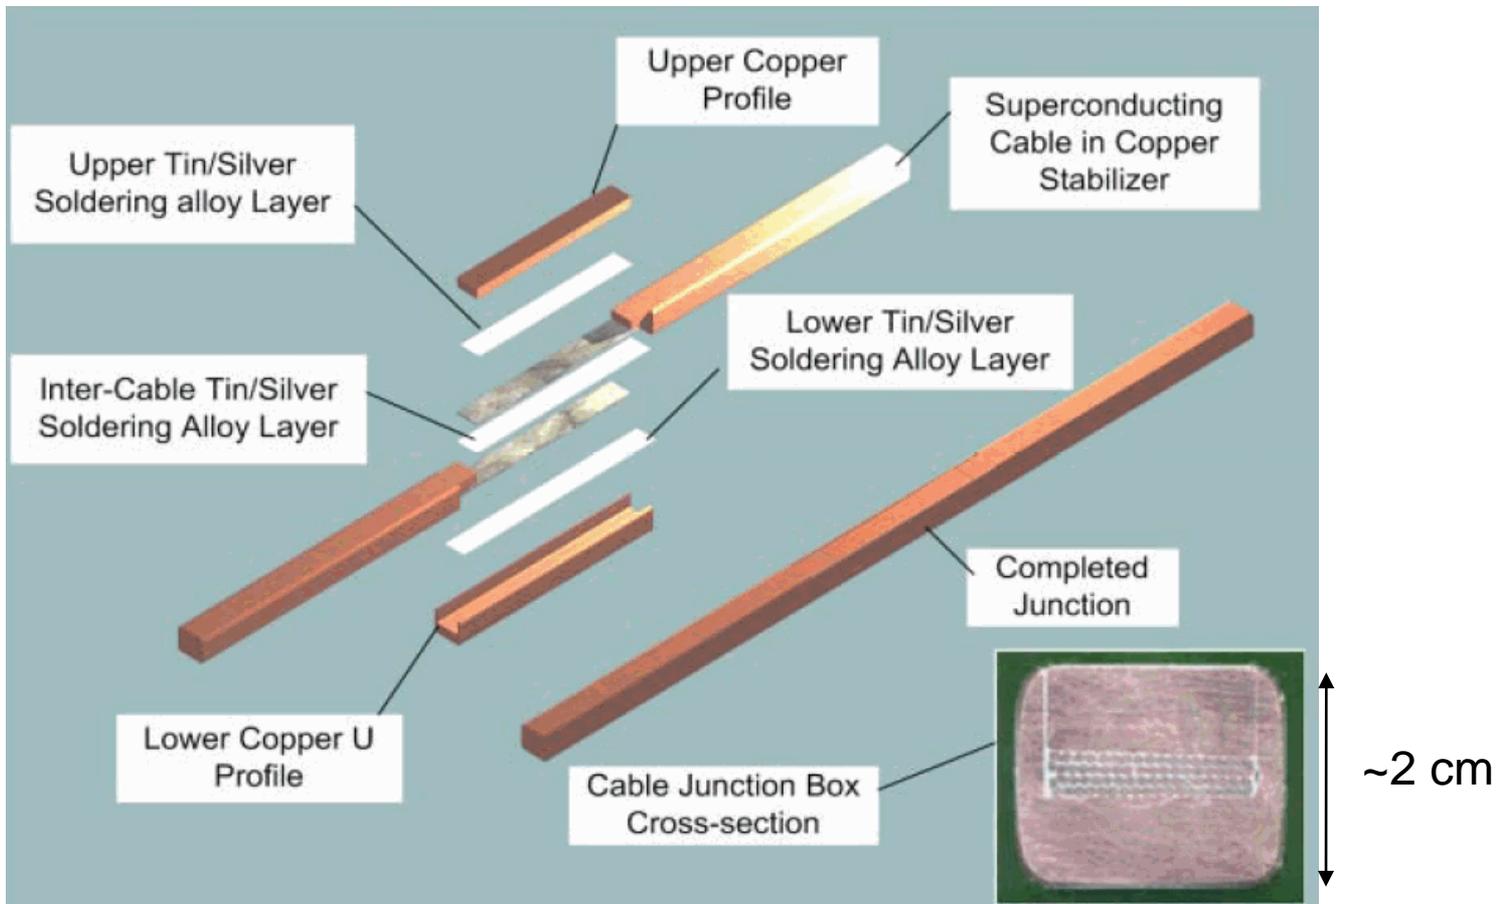
Bus-bar joint (1)

- ❑ Superconducting cable embedded in Copper stabilizer.
- ❑ Bus bar joint is soldered (not clamped).
- ❑ Joint resistance $\sim 0.35 \text{ n}\Omega$ (@ 1.9 K).
- ❑ Protection of the joint during quench relies on *good joint quality*.

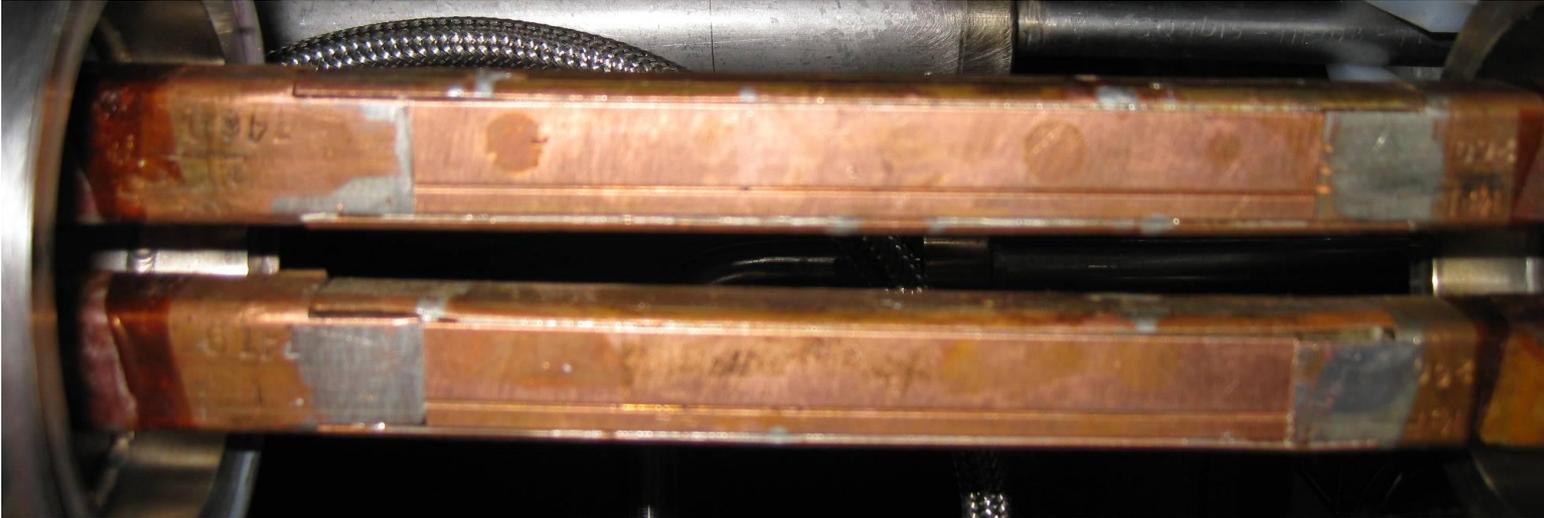
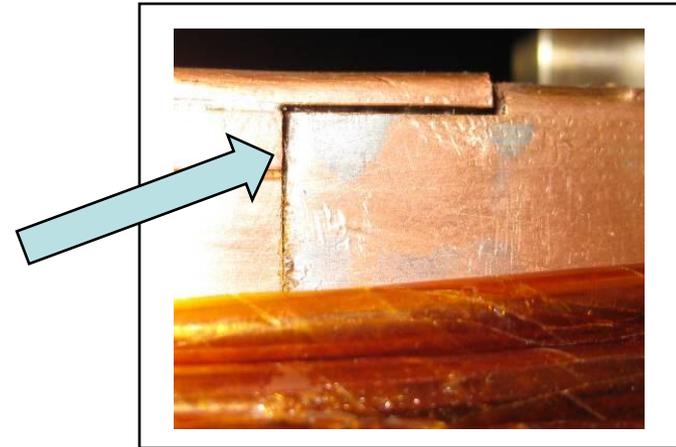
Bus-bar joint (2)

- ❑ A post-mortem analysis of the data from the sector with the incident revealed the presence of a **200 nΩ non-conform resistance** in the cell of the primary electrical arc. This acted as a heat source that quenched the superconducting cable.
- >> Unfortunately the evidence is destroyed...
- ❑ A careful inspection of many other joints revealed non-conformities like bad soldering and/or reduced electrical contact as in the example to the right.

- A method to localize a bad quality joints by measuring the resistance of the copper cable (+joint) has revealed to be very powerful.
 - *Ongoing race to identify and repair faulty joints.*
 - *Unfortunately poor quality joints are localized in many places – likely to slow down progress with the machine re-commissioning.*
 - *½ LHC is still cold (≤ 80 K)...*
- The vacuum chambers are cleaned in situ.
