Status of the LHC Machine

J. Wenninger

CERN Beams Department

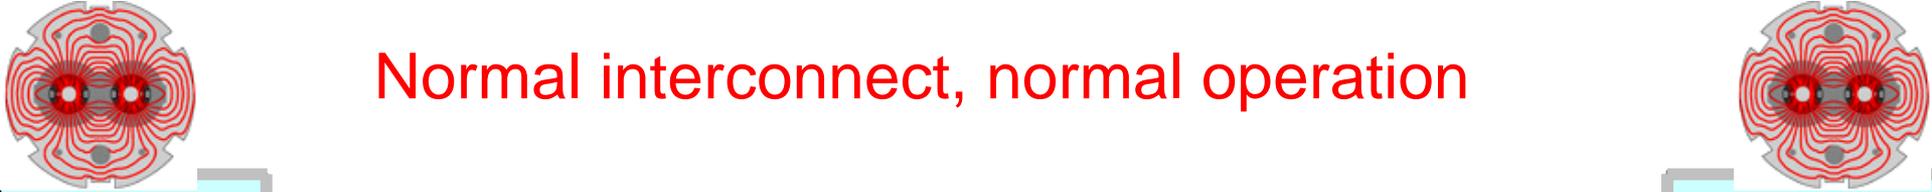
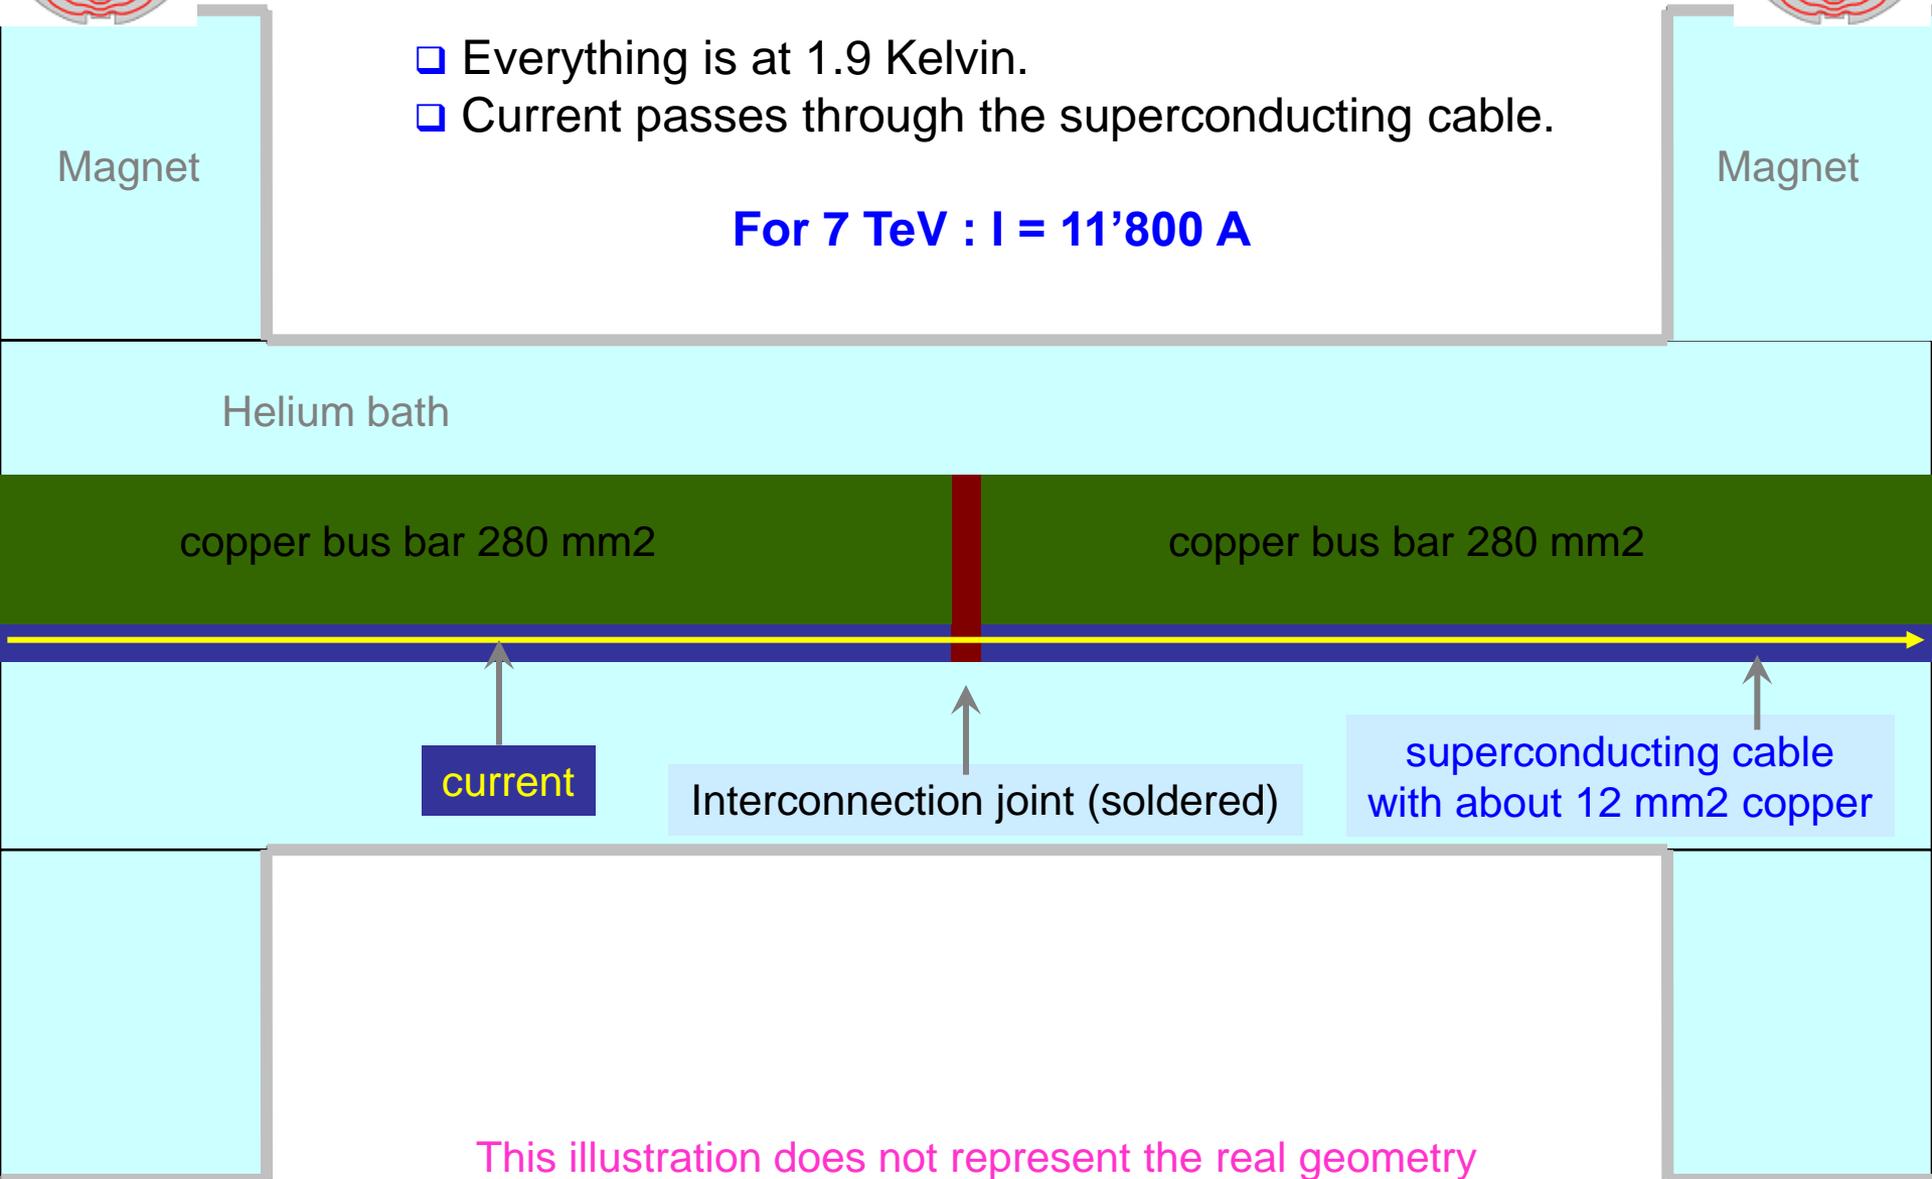
Normal interconnect, normal operation

- Everything is at 1.9 Kelvin.
- Current passes through the superconducting cable.

For 7 TeV : $I = 11'800 \text{ A}$

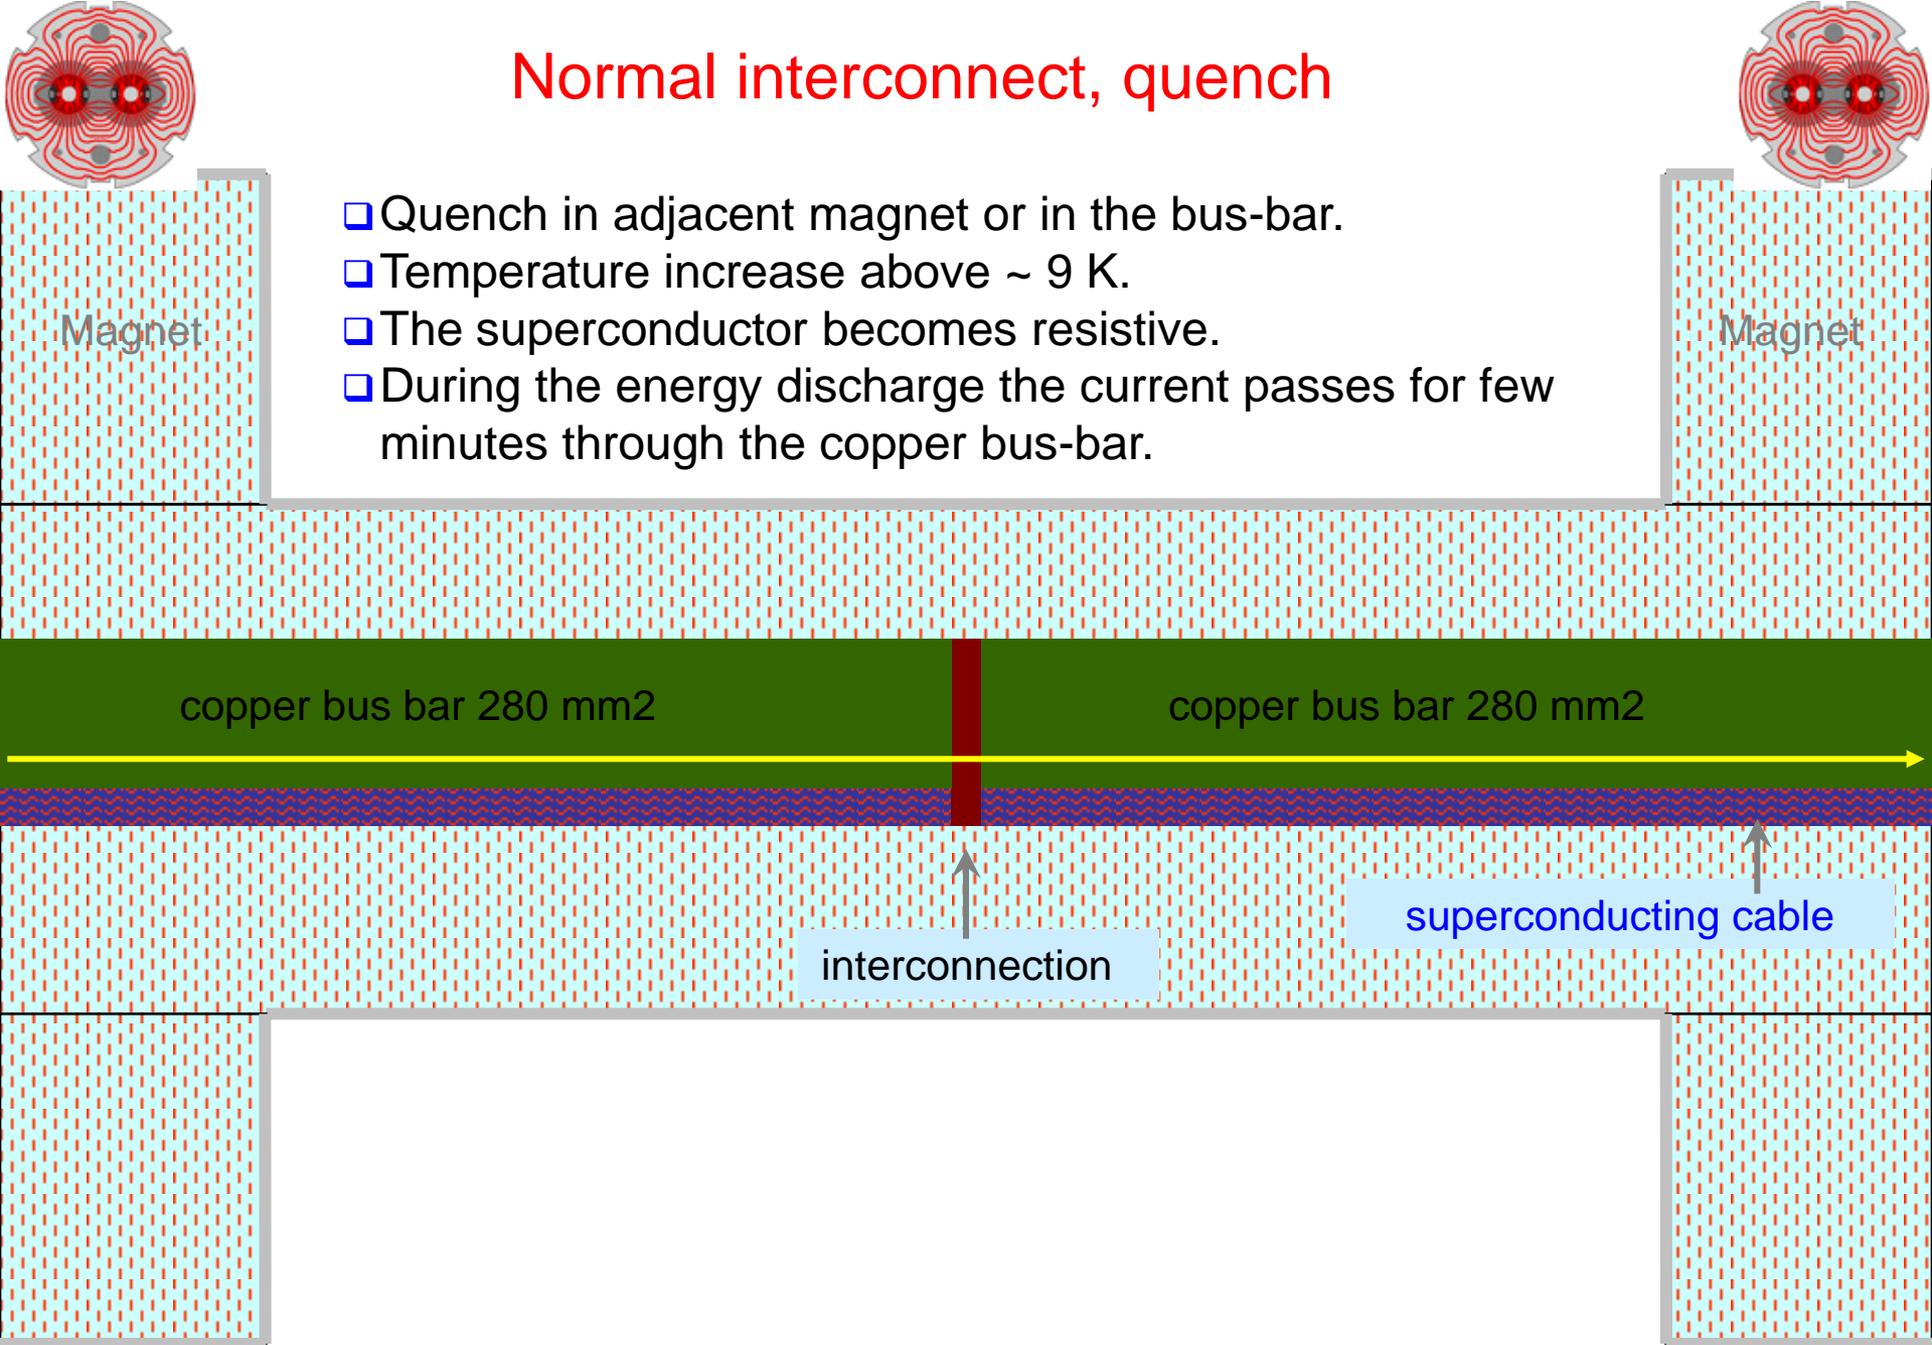
Normal interconnect, quench

- ❑ Quench in adjacent magnet or in the bus-bar.
- ❑ Temperature increase above ~ 9 K.
- ❑ The superconductor becomes resistive.
- ❑ During the energy discharge the current passes for few minutes through the copper bus-bar.

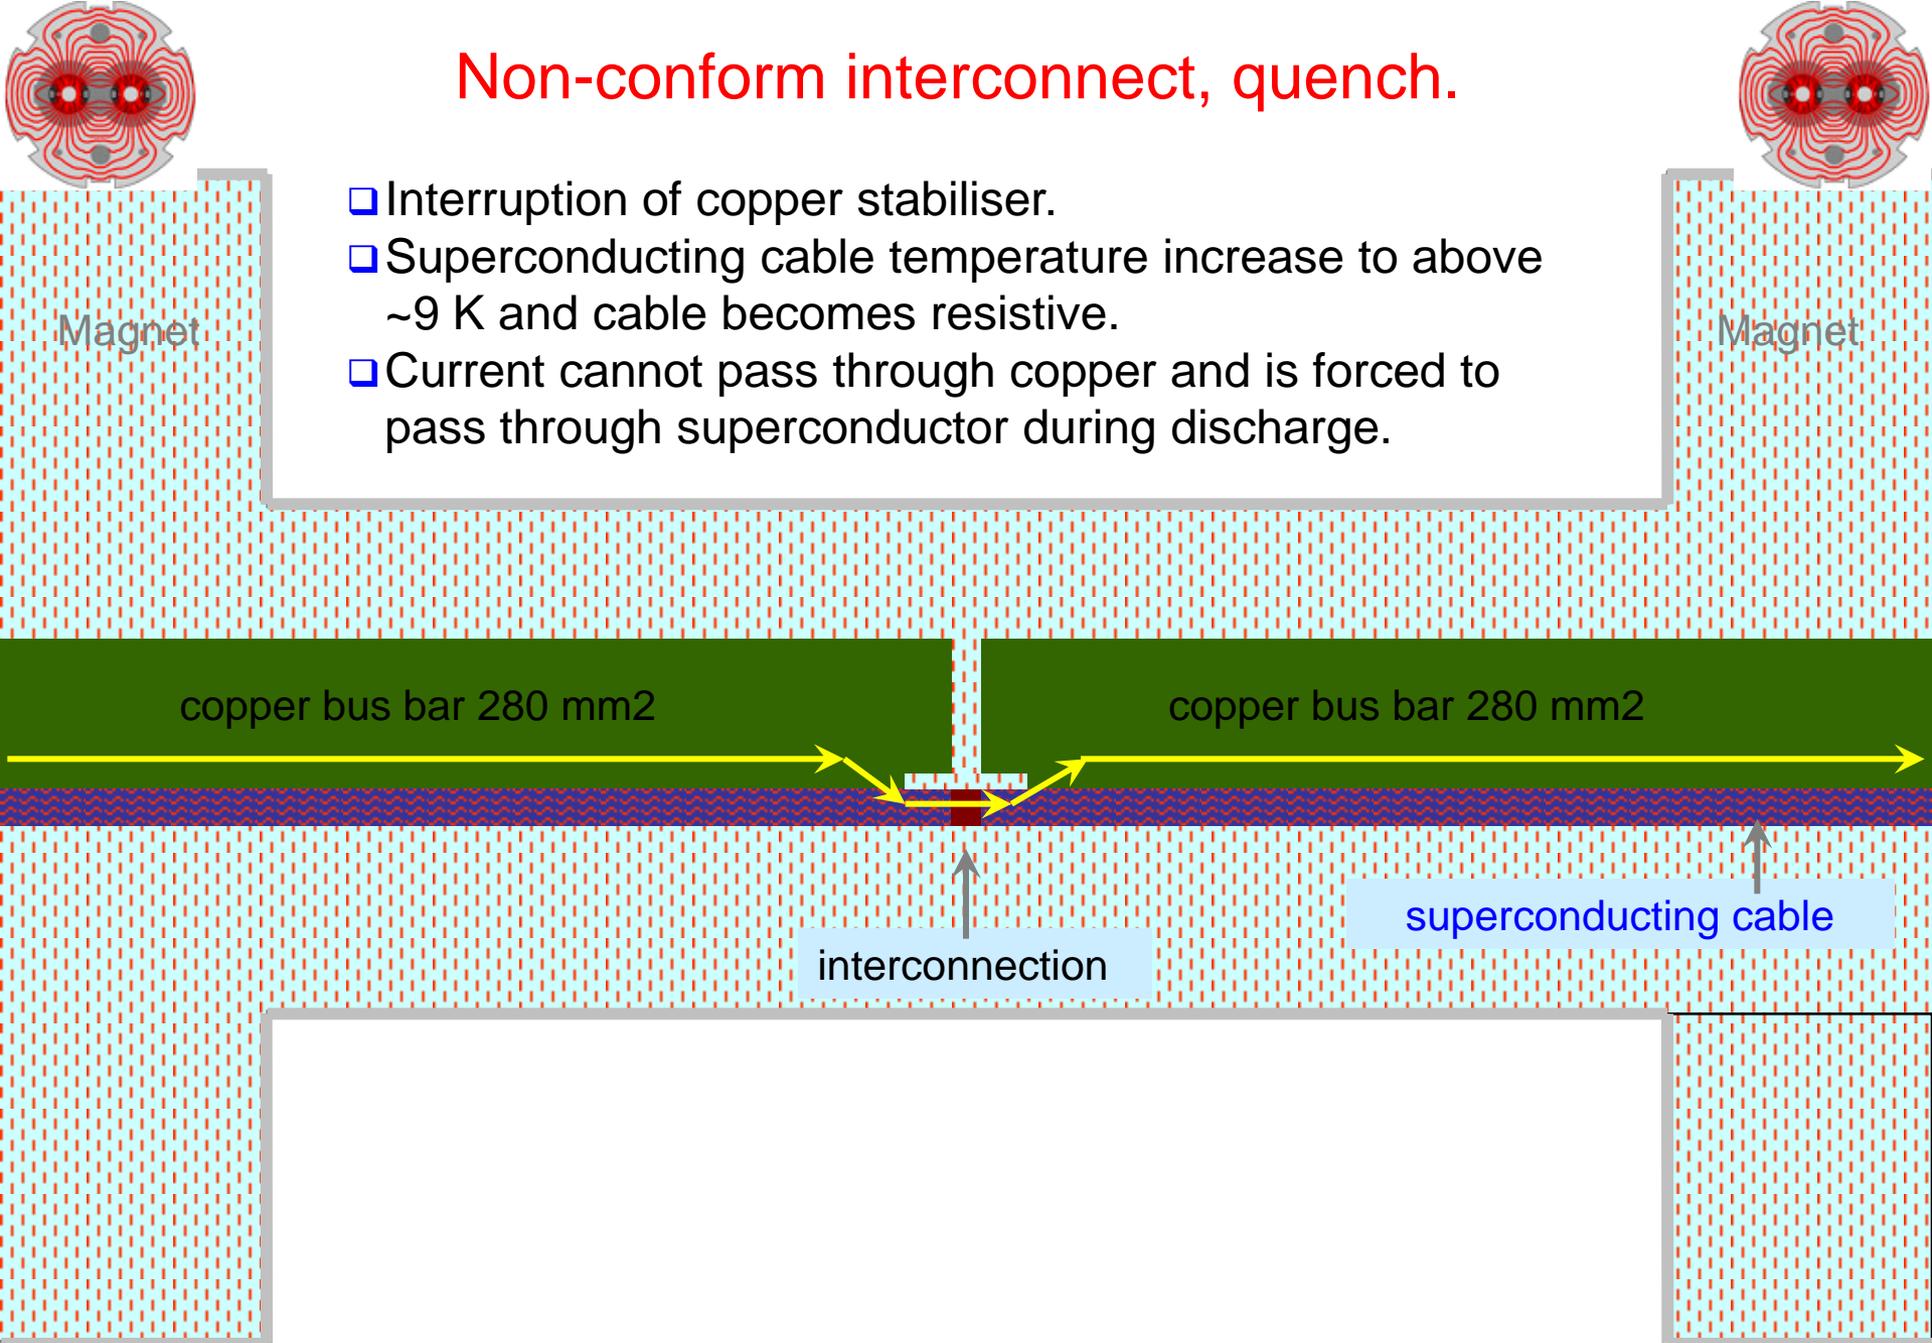
Non-conform interconnect, quench.

- ❑ Interruption of copper stabiliser.
- ❑ Superconducting cable temperature increase to above ~9 K and cable becomes resistive.
- ❑ Current cannot pass through copper and is forced to pass through superconductor during discharge.

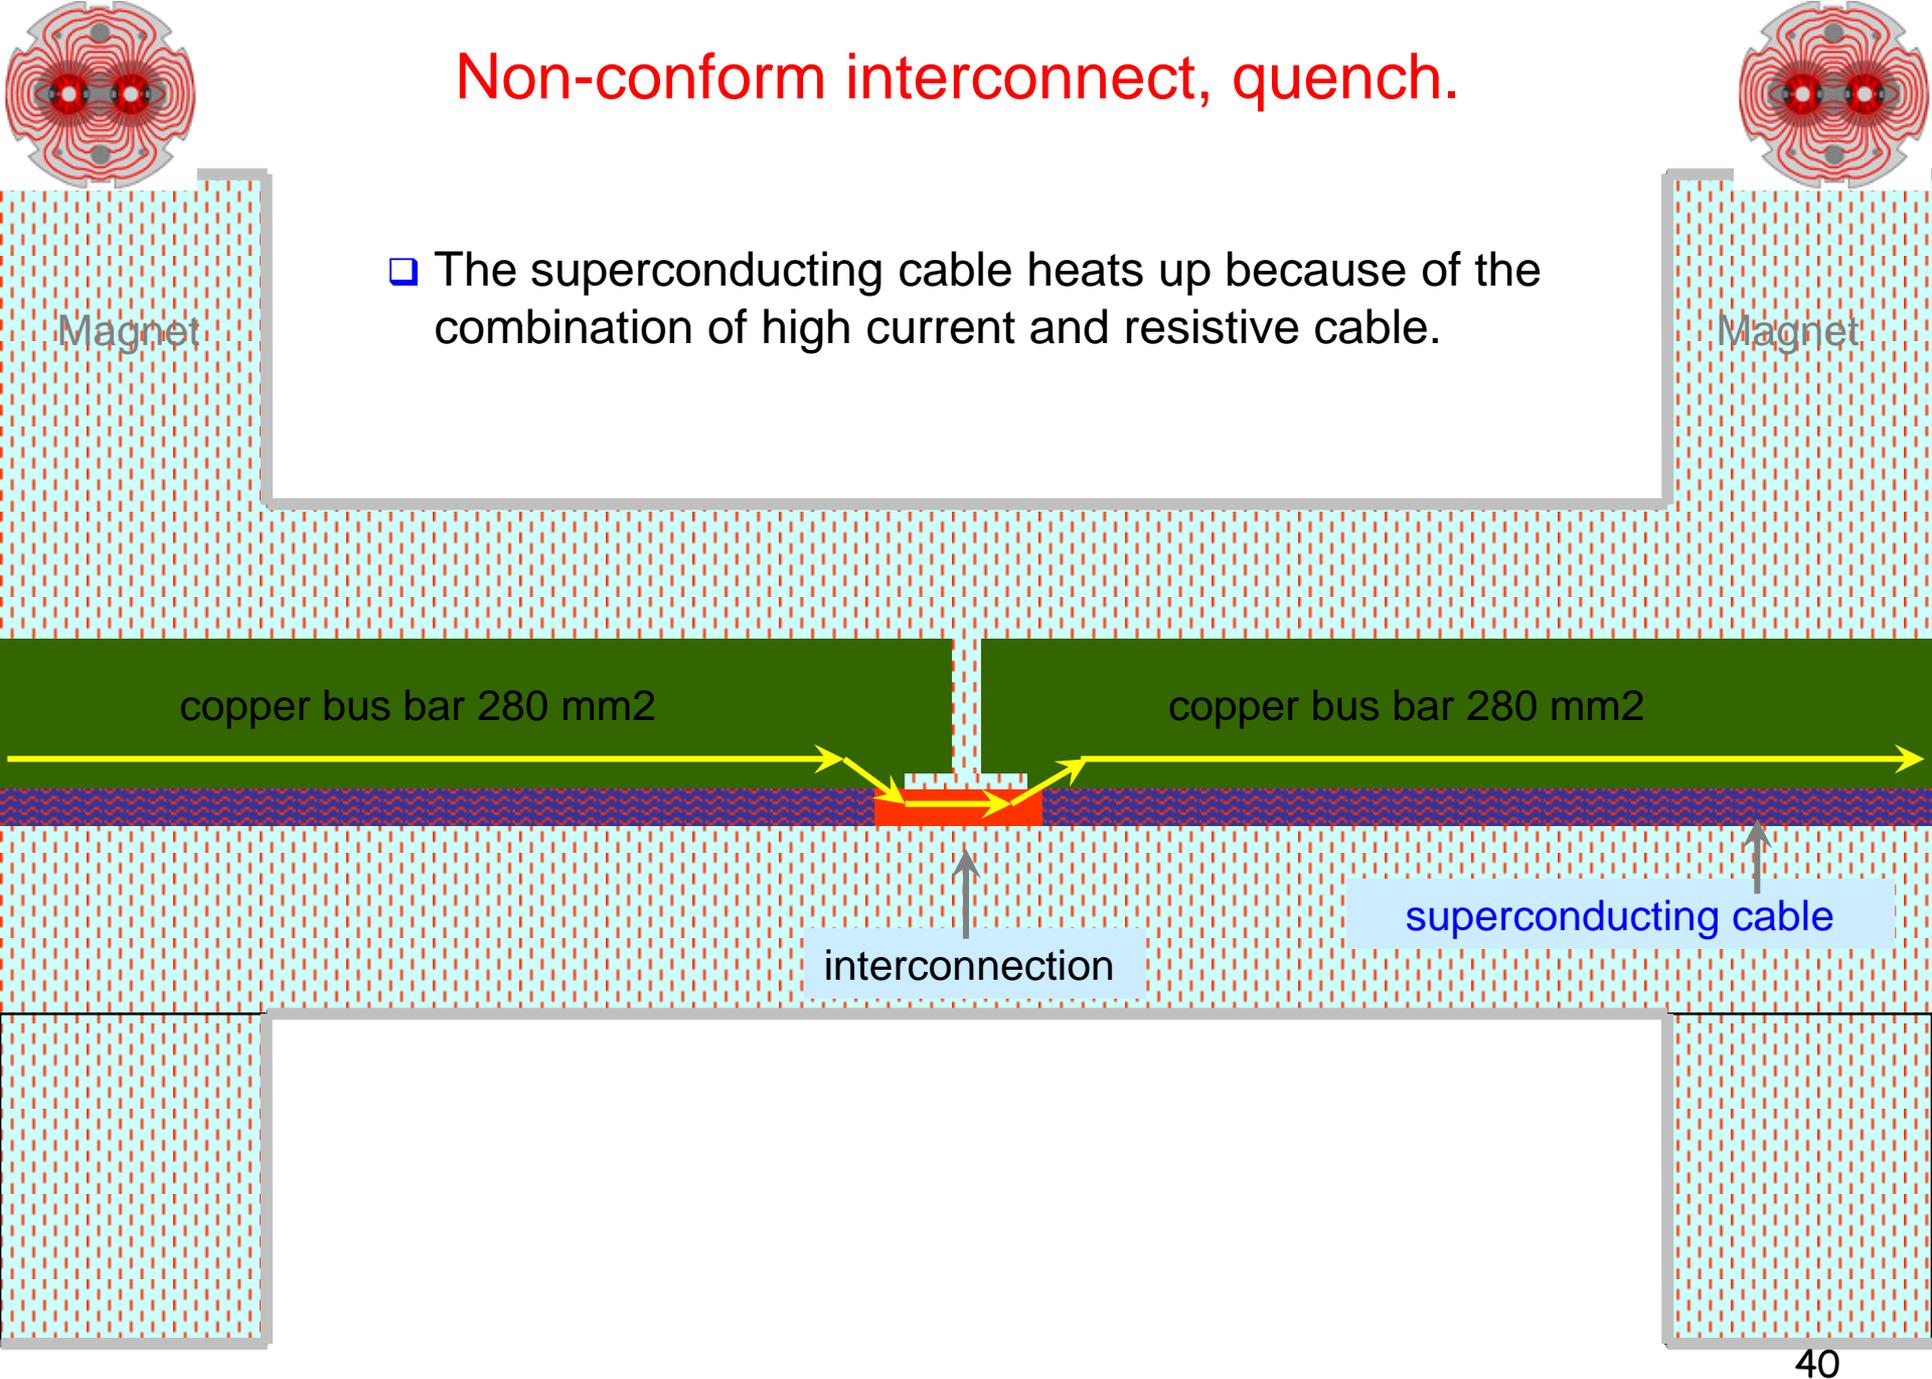
Non-conform interconnect, quench.

- The superconducting cable heats up because of the combination of high current and resistive cable.

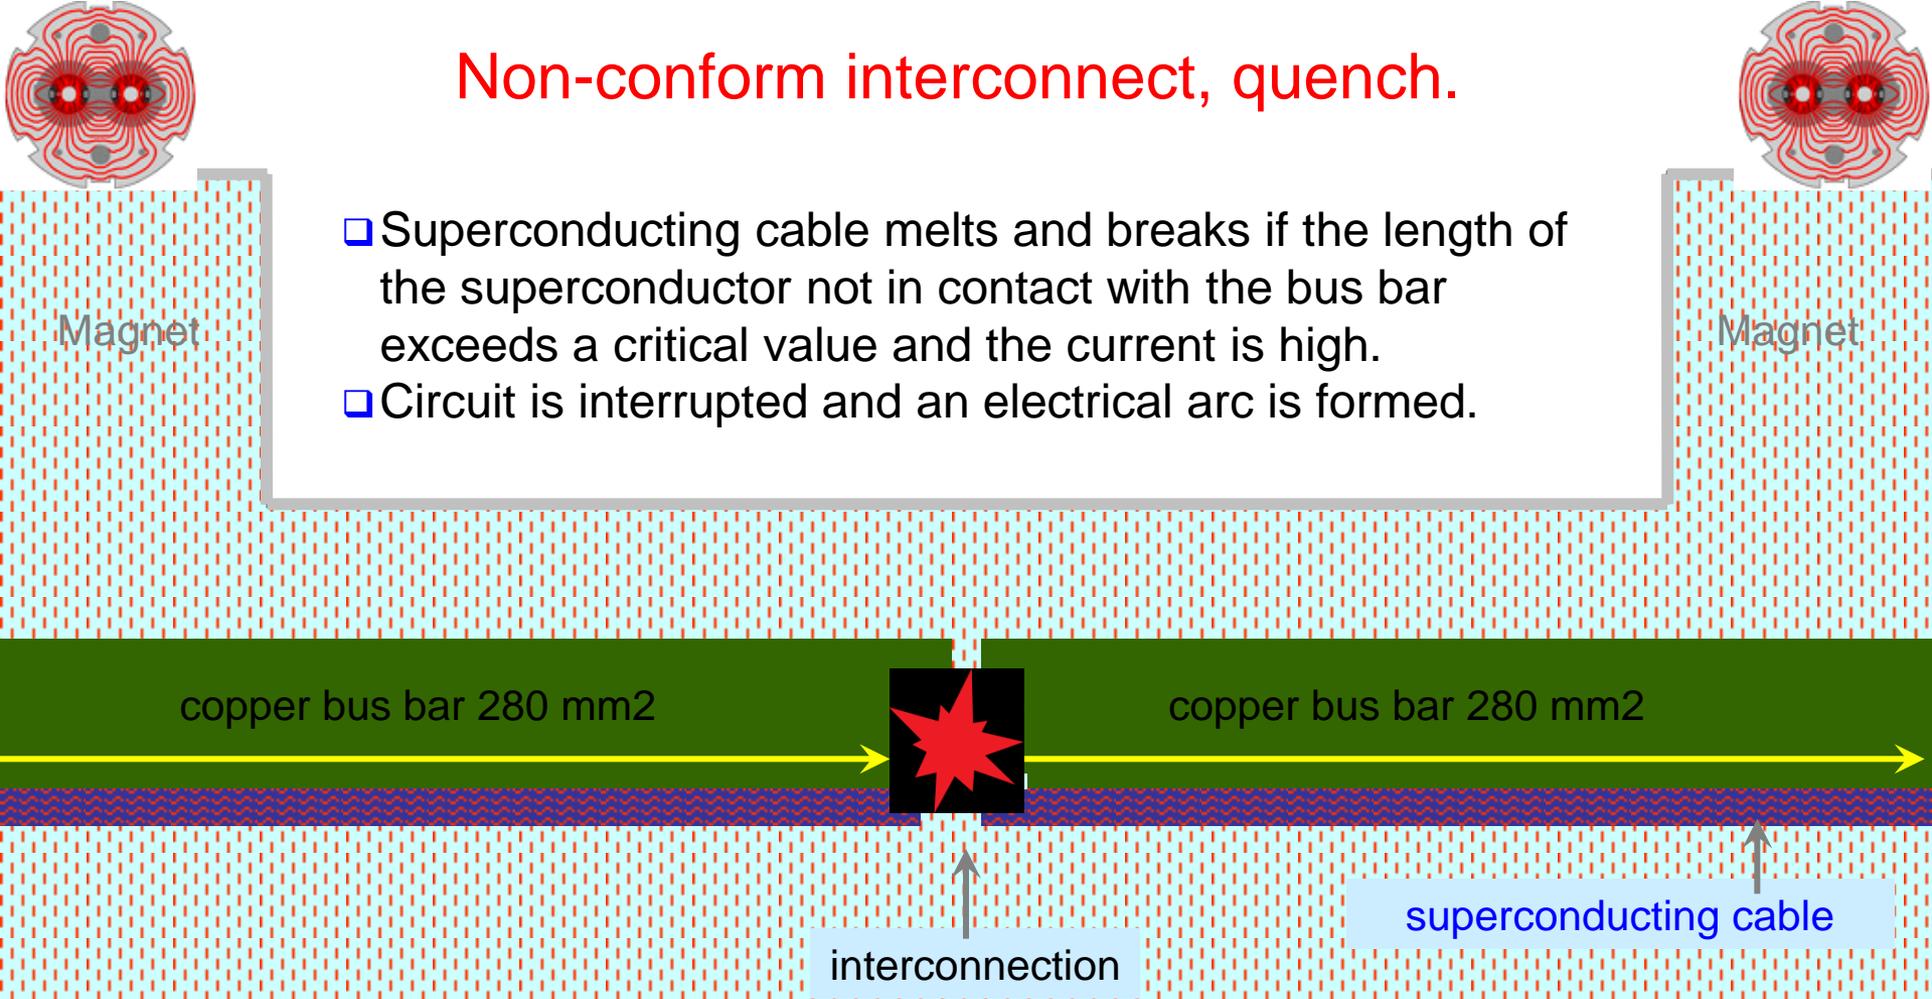
Non-conform interconnect, quench.

- ❑ Superconducting cable melts and breaks if the length of the superconductor not in contact with the bus bar exceeds a critical value and the current is high.
- ❑ Circuit is interrupted and an electrical arc is formed.

- Depending on 'type' of non-conformity, problems appear :
- at different current levels.
 - under different conditions (magnet or bus bar quench..).

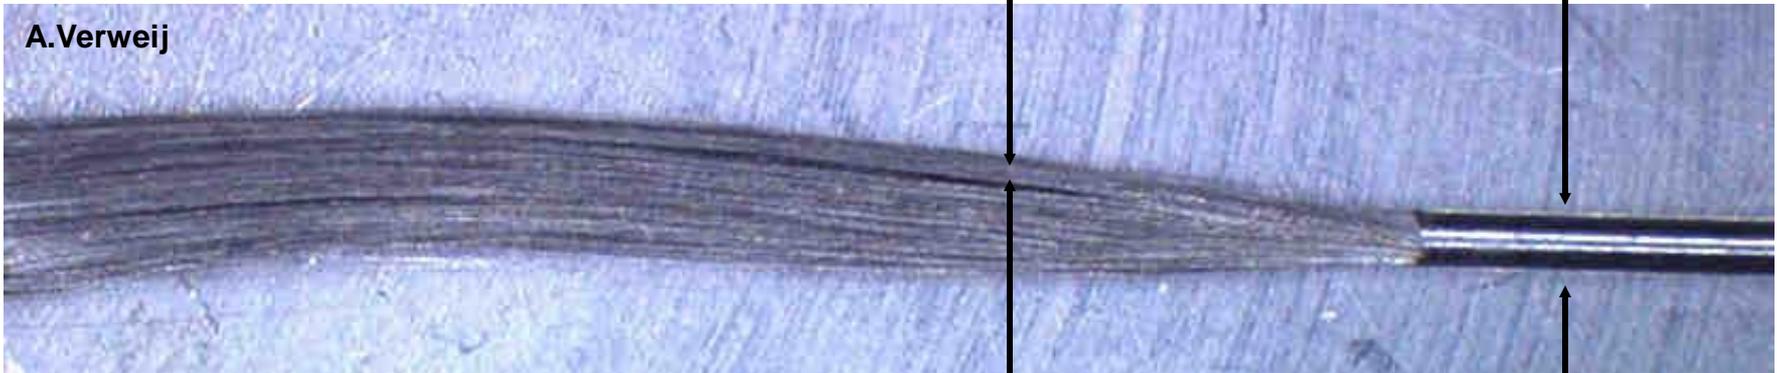
Superconducting cable

NbTi filaments embedded in a
Copper matrix

$\varnothing 6 \mu\text{m}$

$\varnothing 1 \text{ mm}$

Typical value for operation at 8T and 1.9 K: 800 A

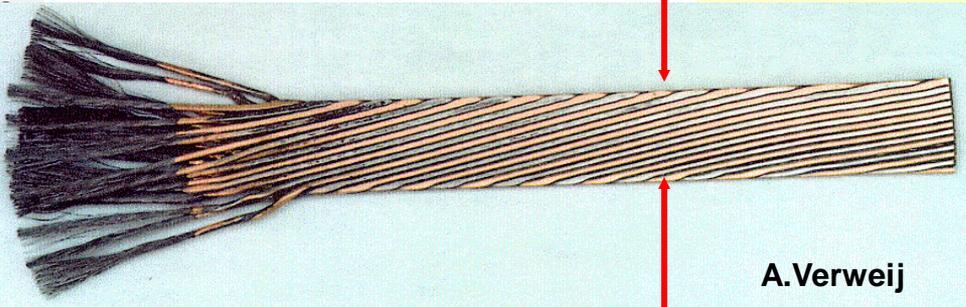
Rutherford cable

width 15 mm

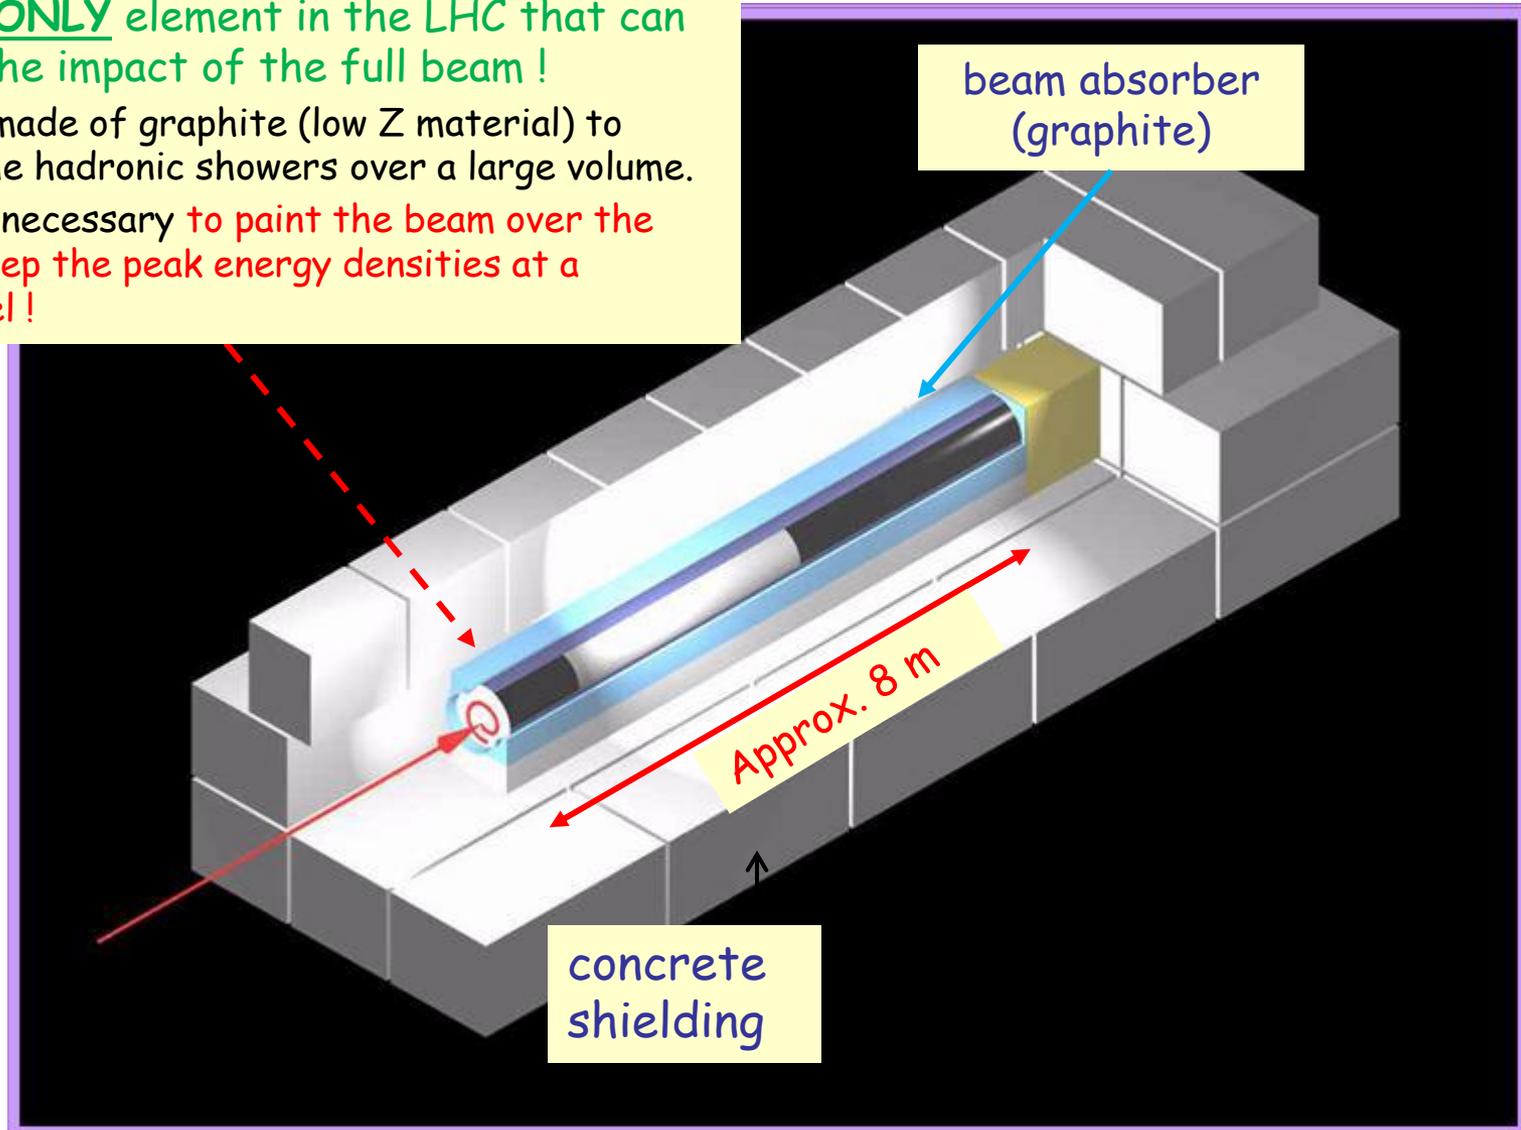
LHC dump block

- This is the **ONLY** element in the LHC that can withstand the impact of the full beam !
- The block is made of graphite (low Z material) to spread out the hadronic showers over a large volume.
- It is actually necessary to paint the beam over the surface to keep the peak energy densities at a tolerable level !
