Fukushima
11-30 marzo 2011

diario ed effetti

Gli effetti immediati del terremoto e dello tsunami

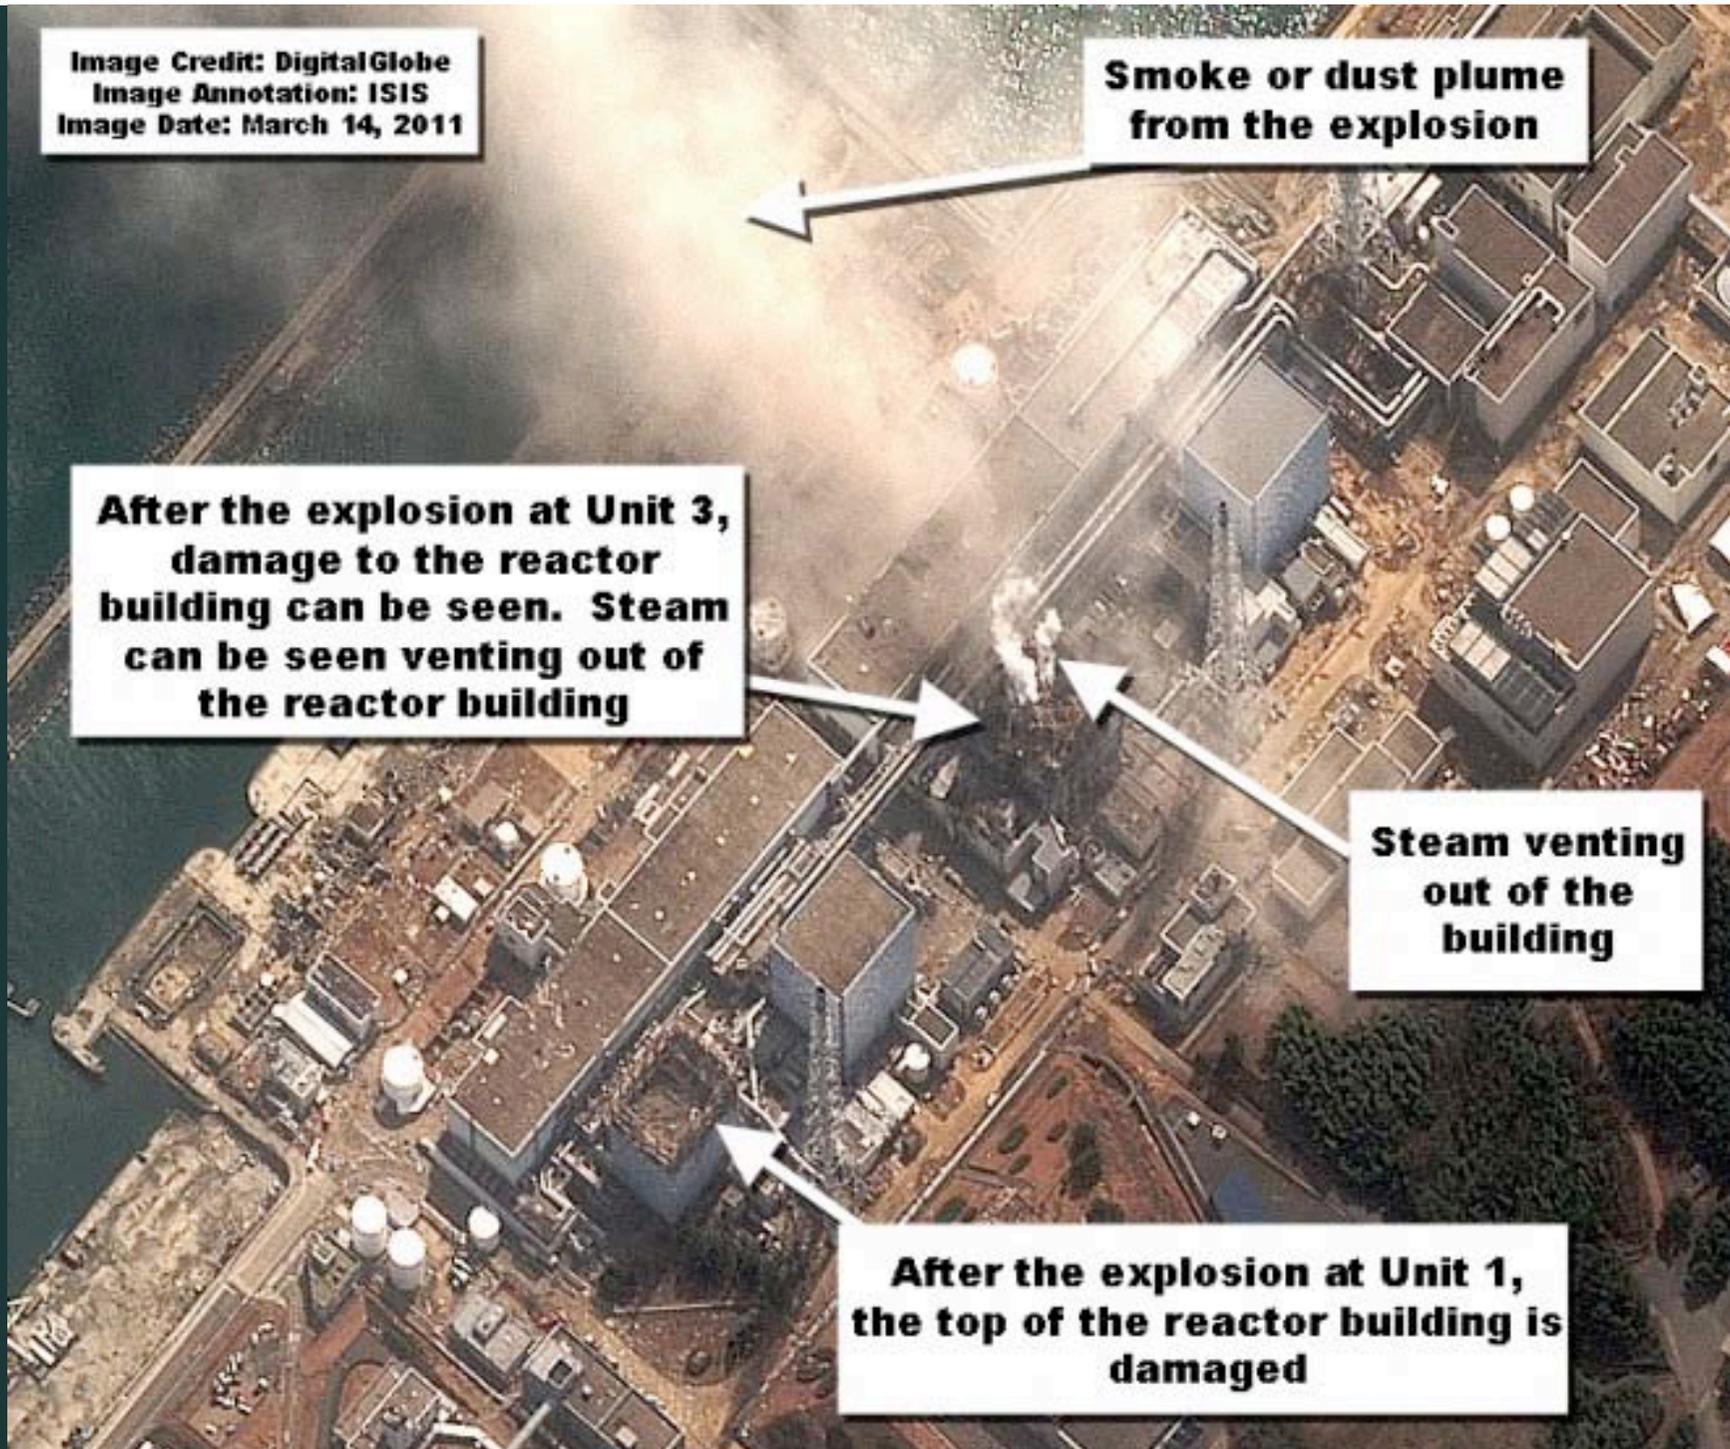
Image Credit: DigitalGlobe
Image Annotation: ISIS
Image Date: March 14, 2011

Smoke or dust plume from the explosion

After the explosion at Unit 3, damage to the reactor building can be seen. Steam can be seen venting out of the reactor building

Steam venting out of the building

After the explosion at Unit 1, the top of the reactor building is damaged

- esplosione di idrogeno nell'edificio del reattore 3 con danni alla copertura della parte superiore e ferimento di 11 lavoratori
- si sospetta che il livello dell'acqua nei 3 reattori non copra completamente il combustibile, con possibili danni alle barre
- le strutture di confinamento del reattore 3 rimangono intatte ma viene danneggiato il sistema di raffreddamento dell'unità 2
- si pompa acqua di mare anche nel reattore 2

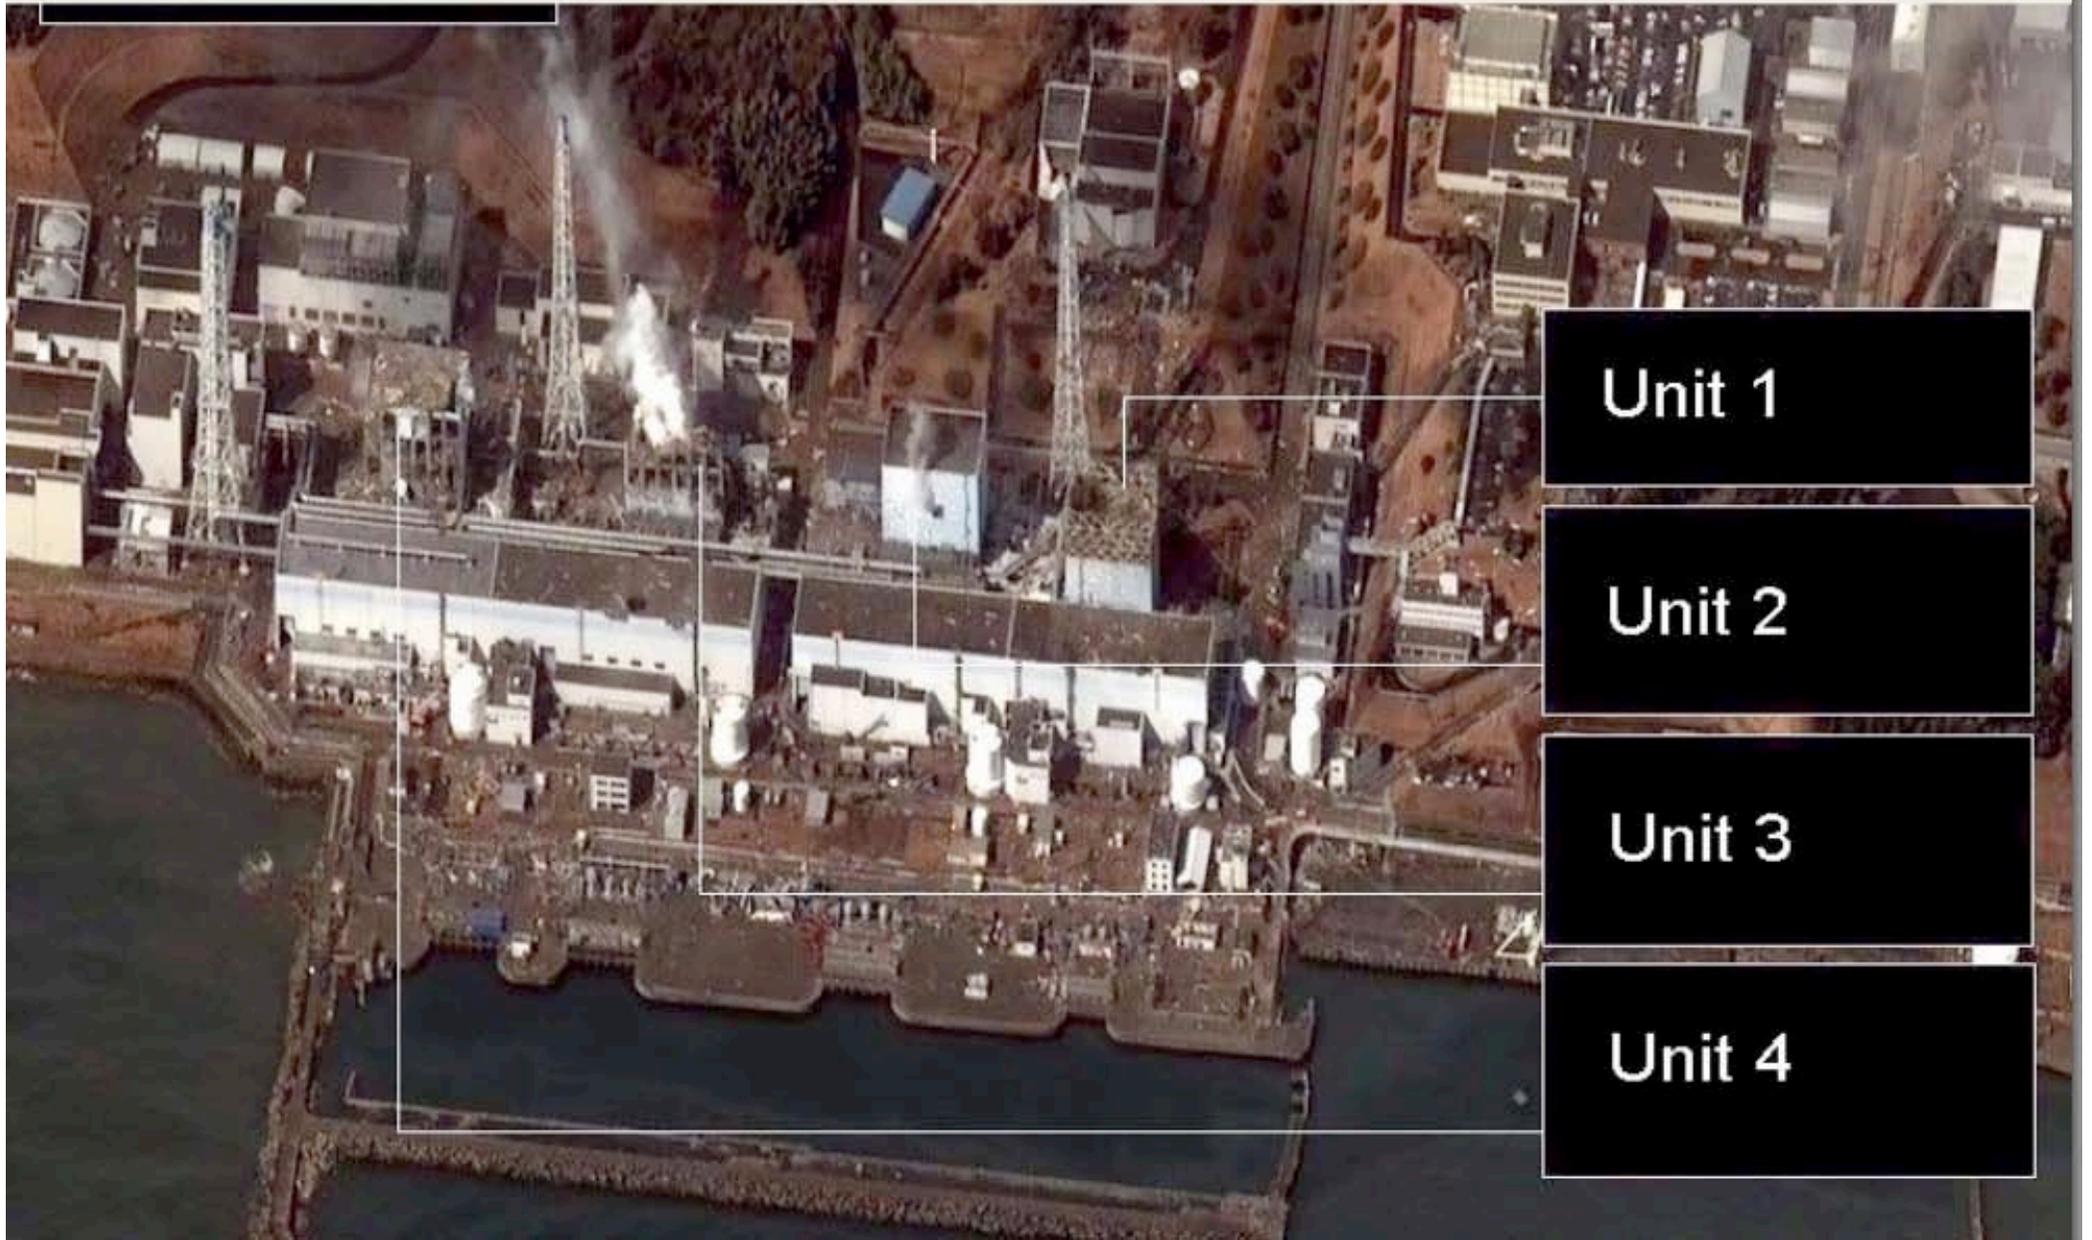
Fukushima Dai-ichi Nuclear Power Plant

Steam likely still venting from side of Unit 2 reactor building

Reactor building for Unit 1; top portion of building damaged from explosion

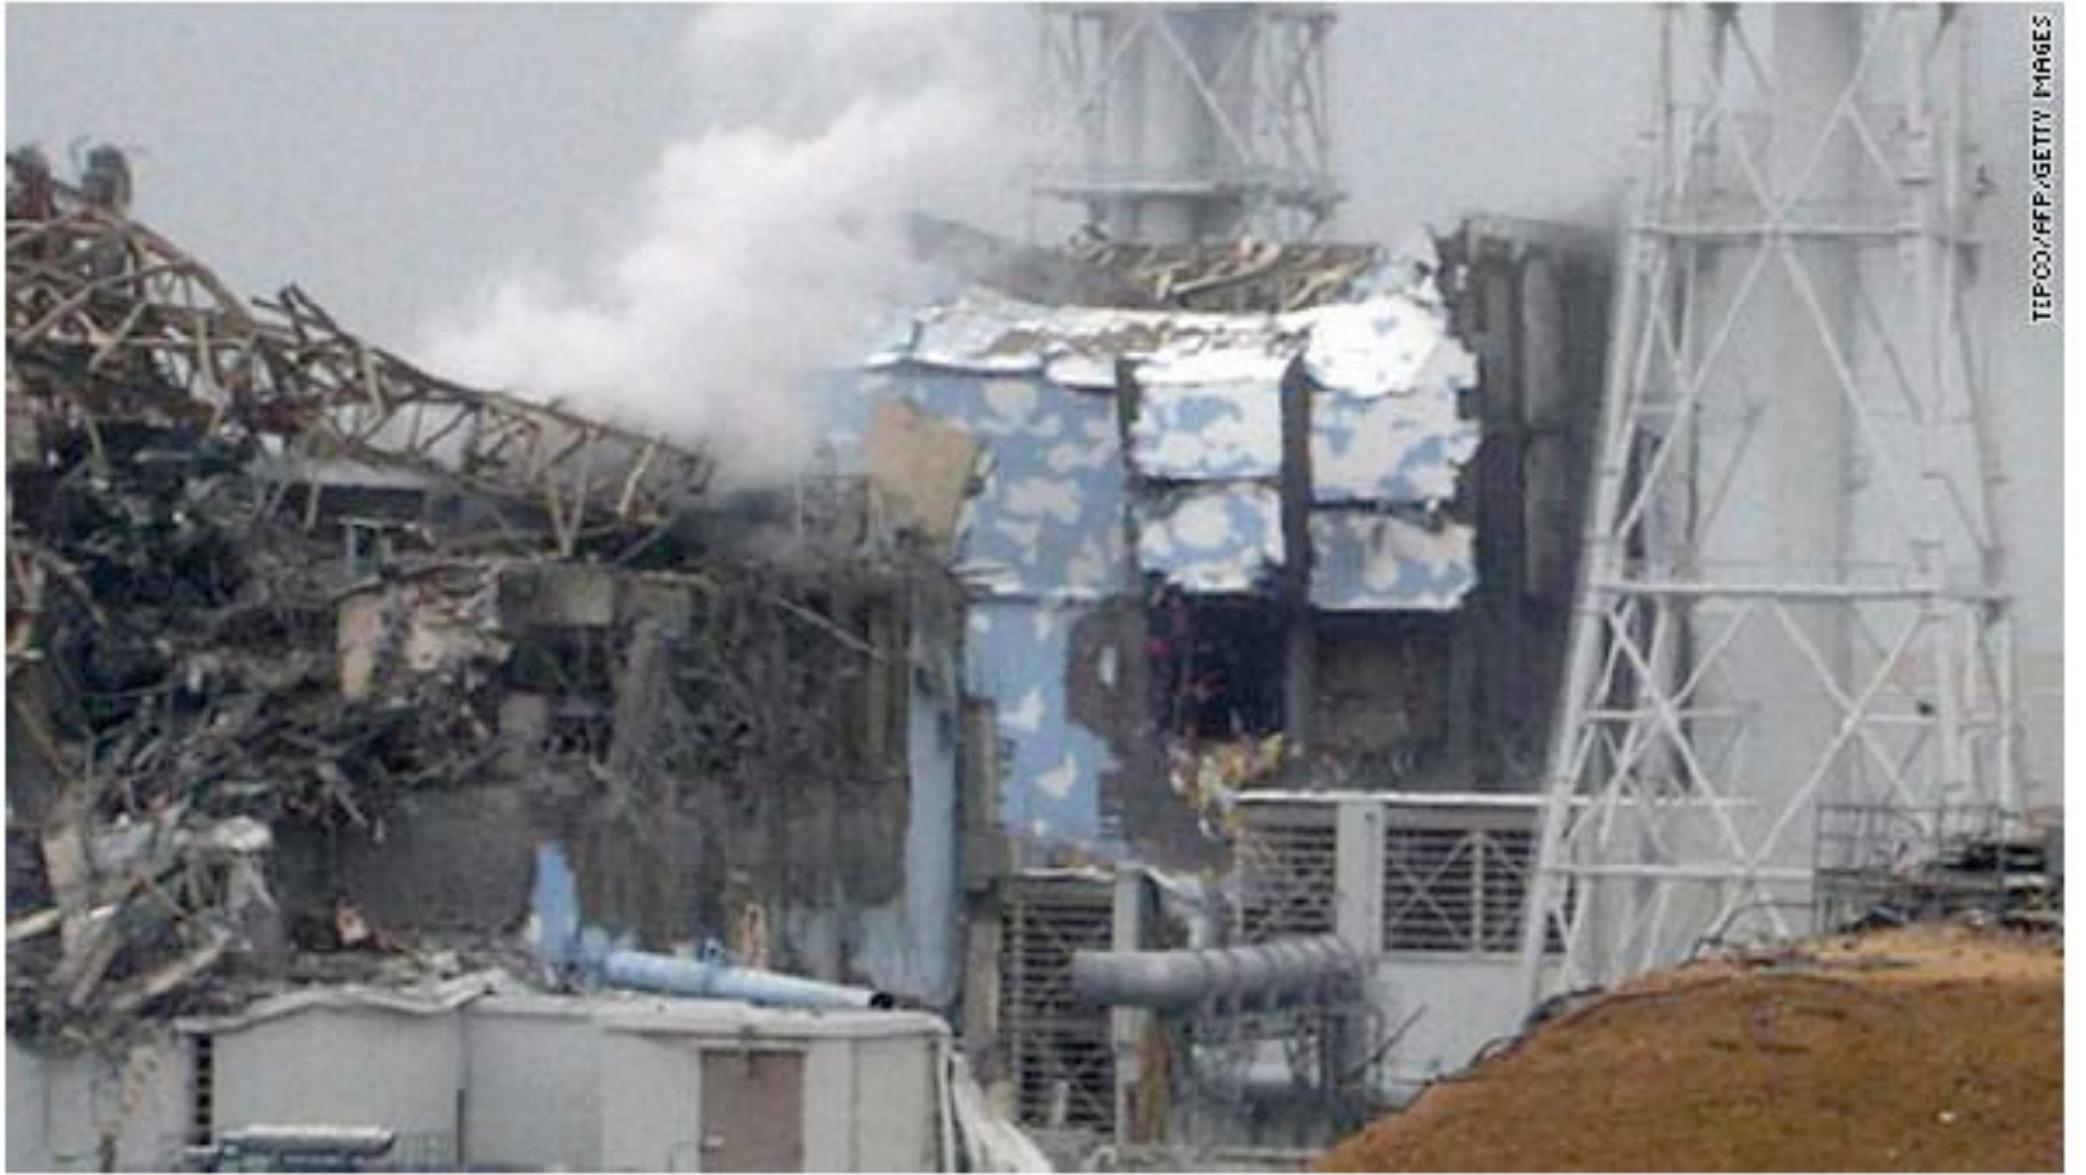
AP Photo/TEPCO
Annotation: ISIS

**Reactor building
for unit 4**

**Smoke or
steam plume**

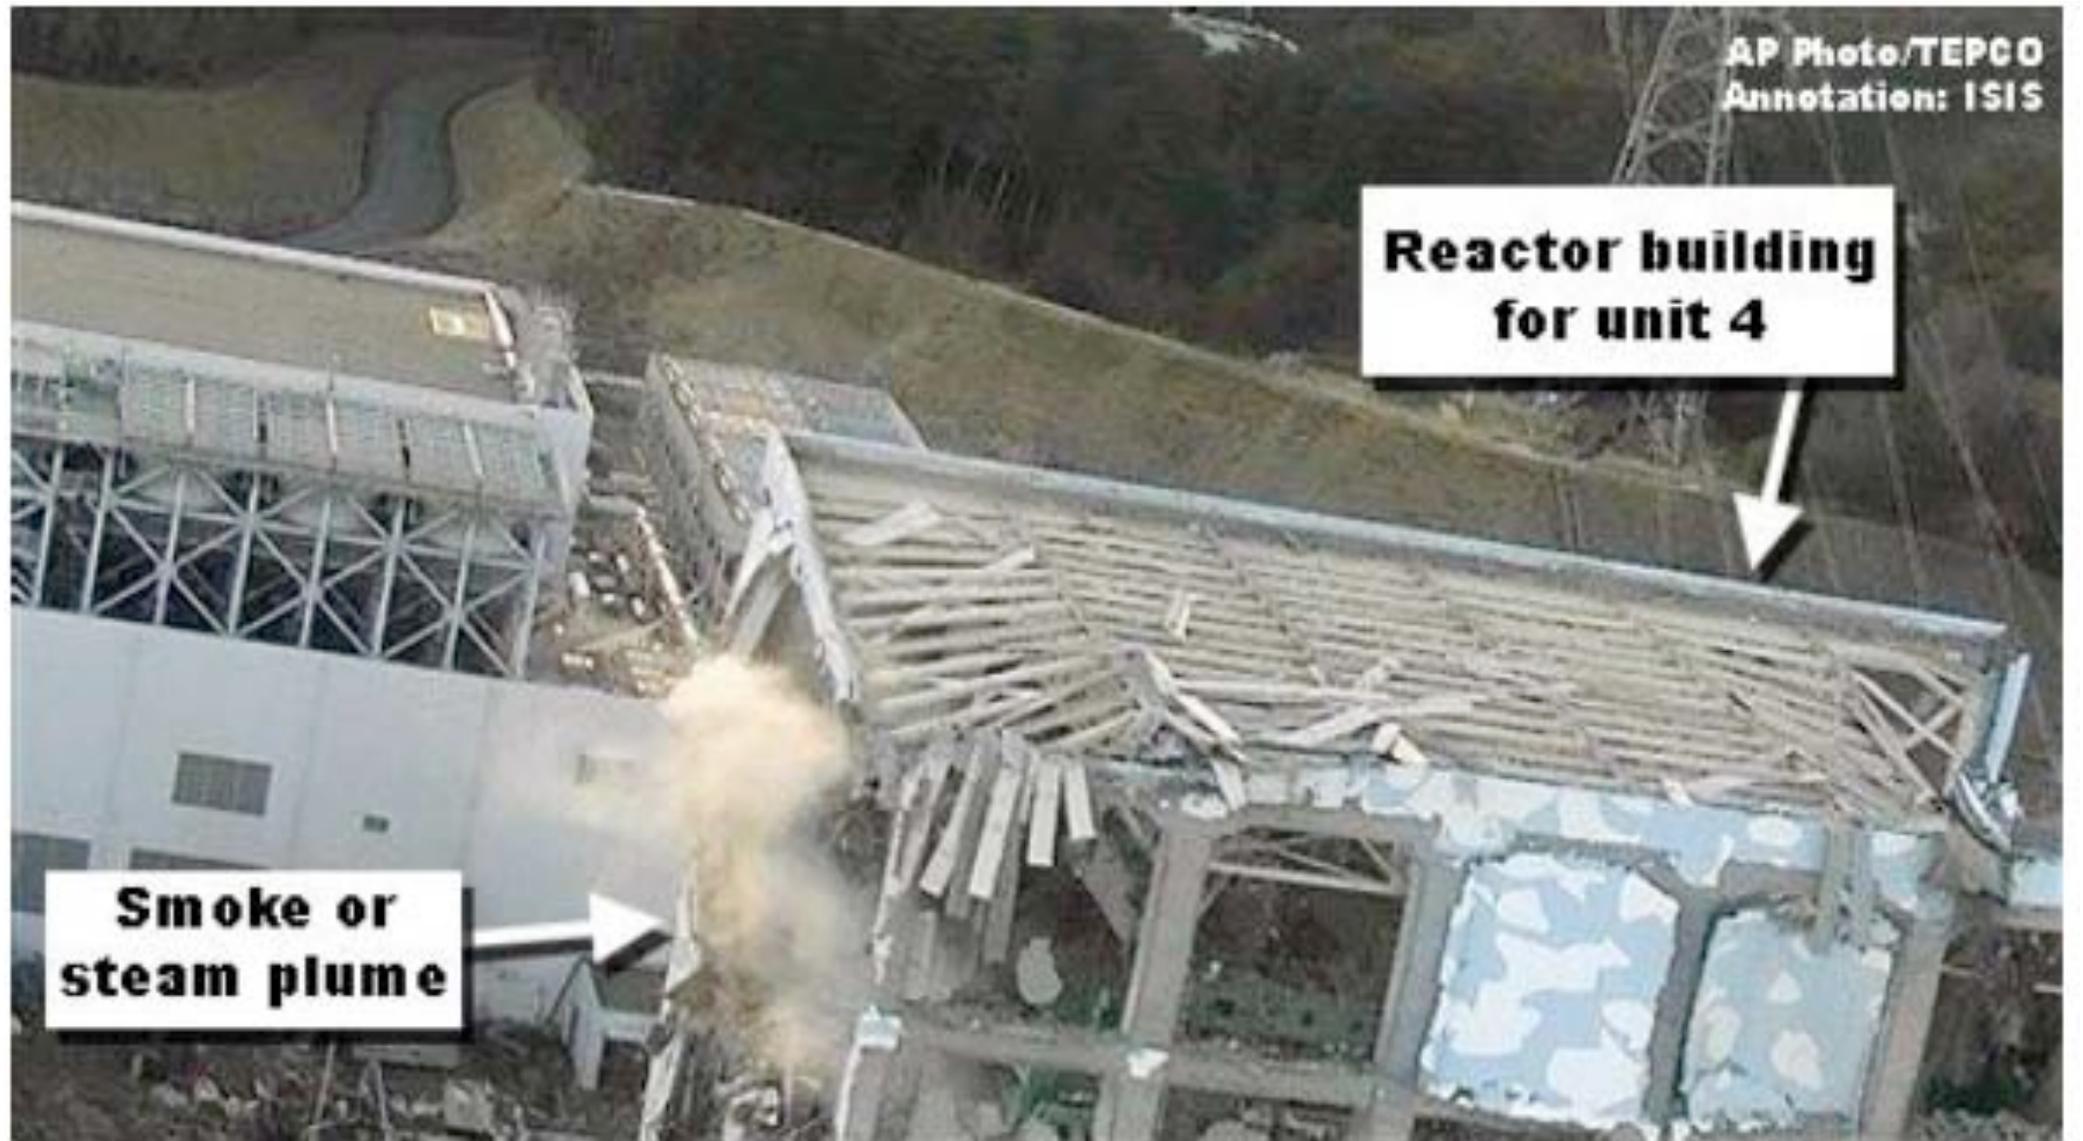
Image Credit: DigitalGlobe - ISIS
Image Date: March 17, 2011

Roof of reactor building for Unit 4 appears different than in the March 16, 2011 image

Steam still venting from the top of Unit 3 reactor building

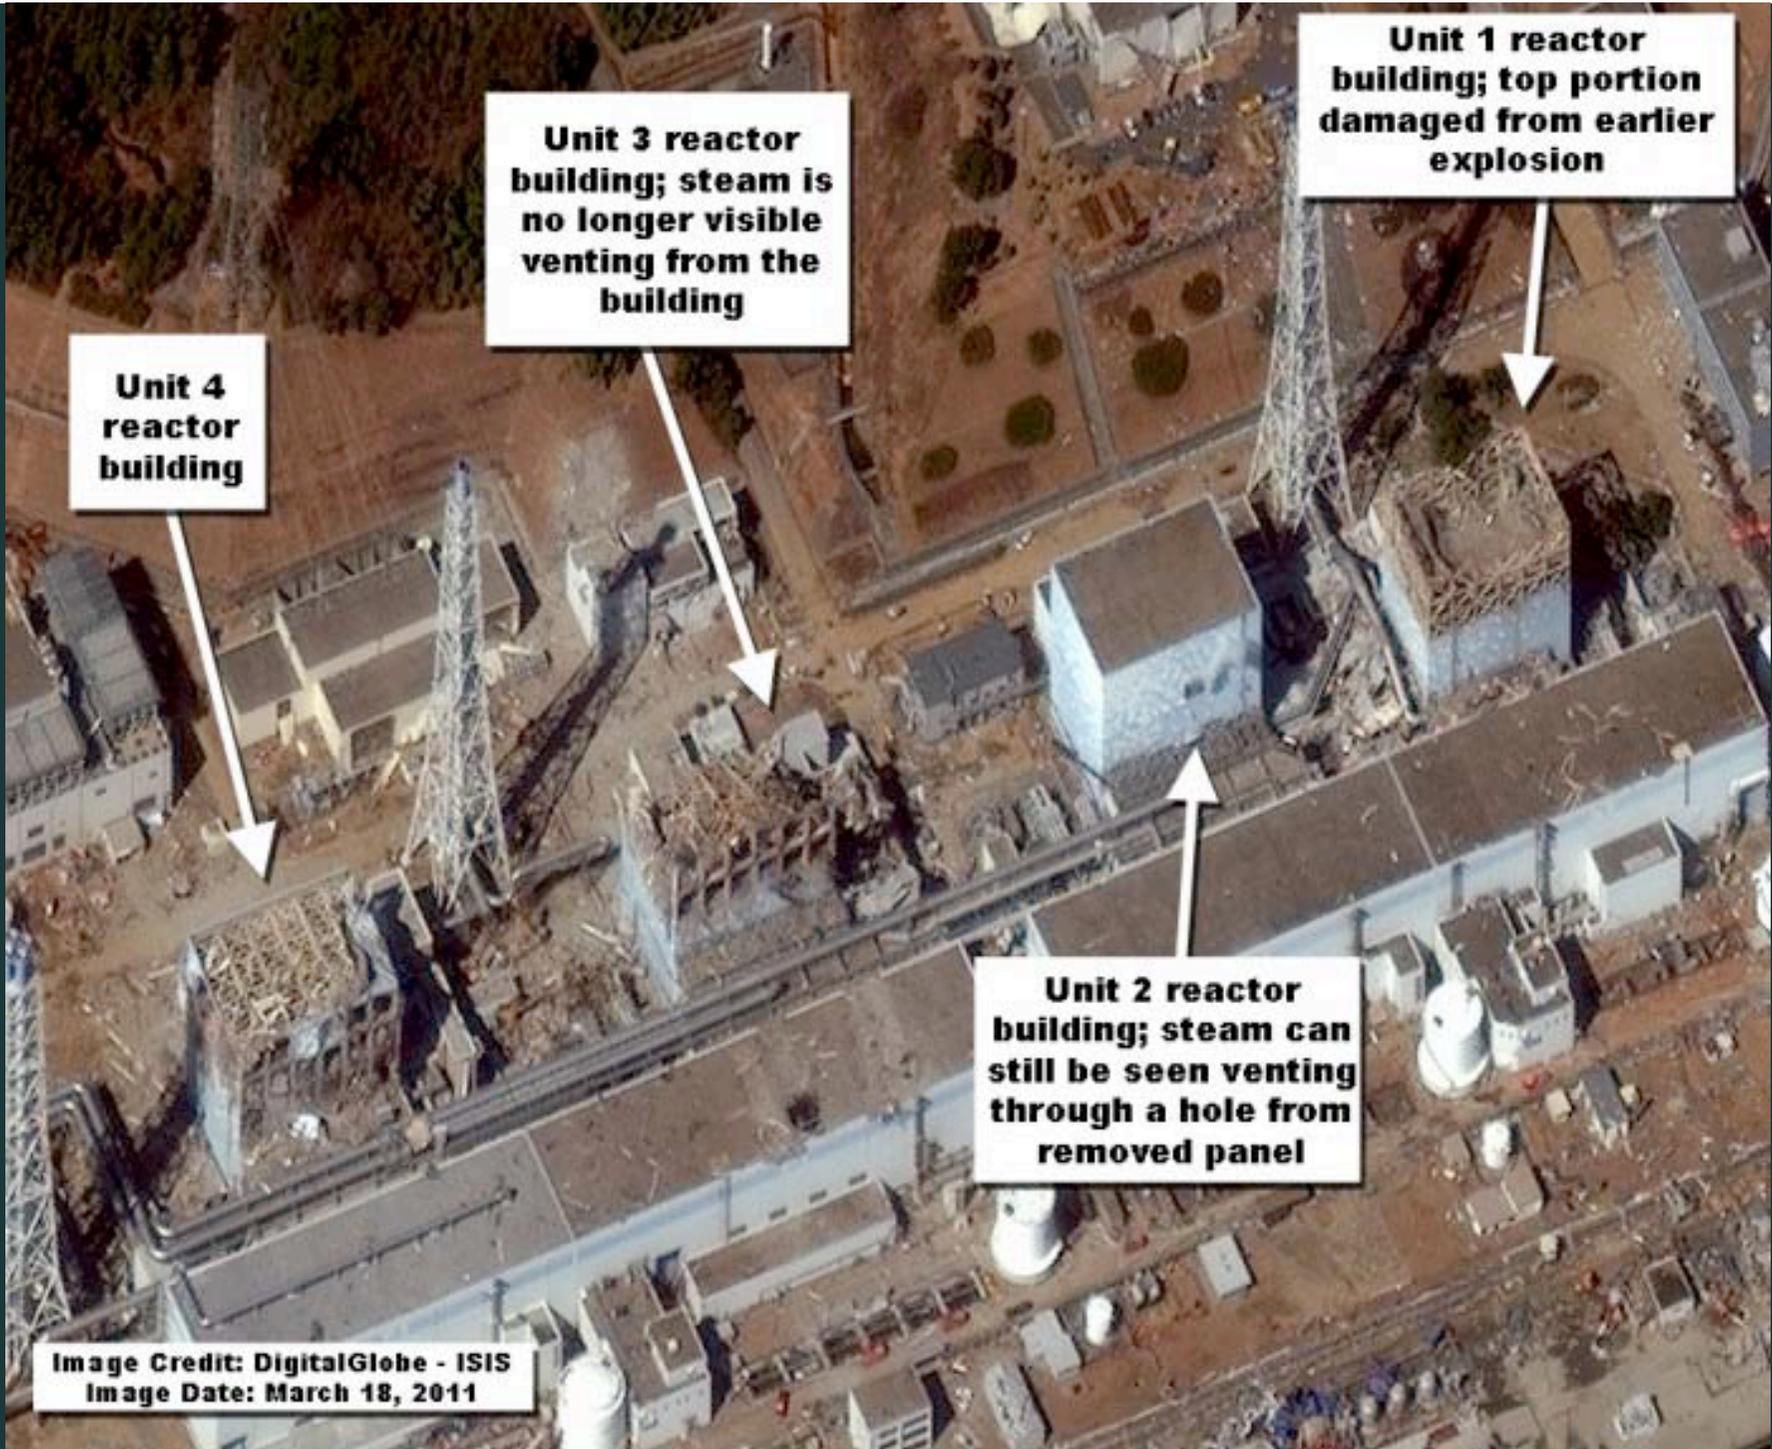
**Image Credit: DigitalGlobe - ISIS
Image Date: March 18, 2011**

Unit 1 reactor building; top portion damaged from earlier explosion

Unit 3 reactor building; steam is no longer visible venting from the building

Unit 4 reactor building

Unit 2 reactor building; steam can still be seen venting through a hole from removed panel

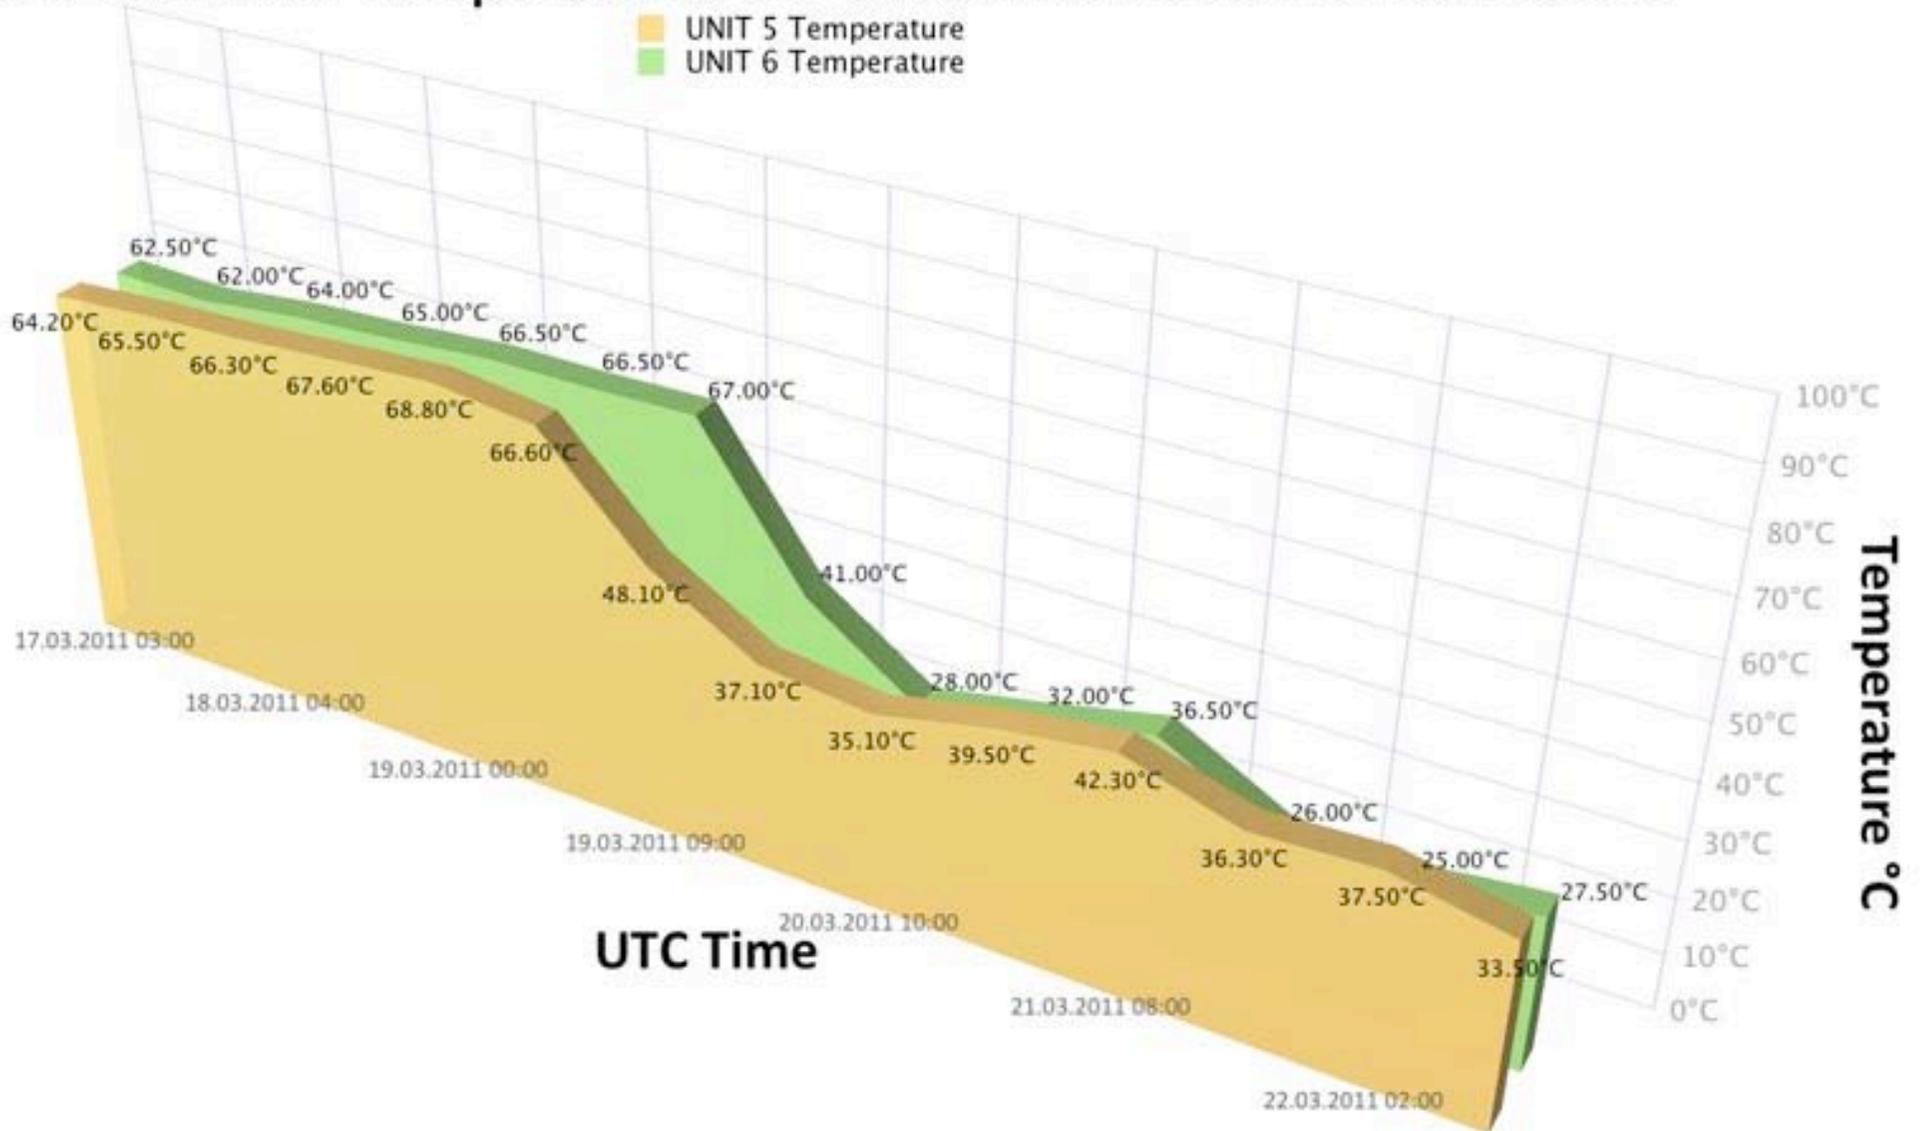
Spent Fuel Pool Temperatures at Fukushima Daiichi Units 5 and 6

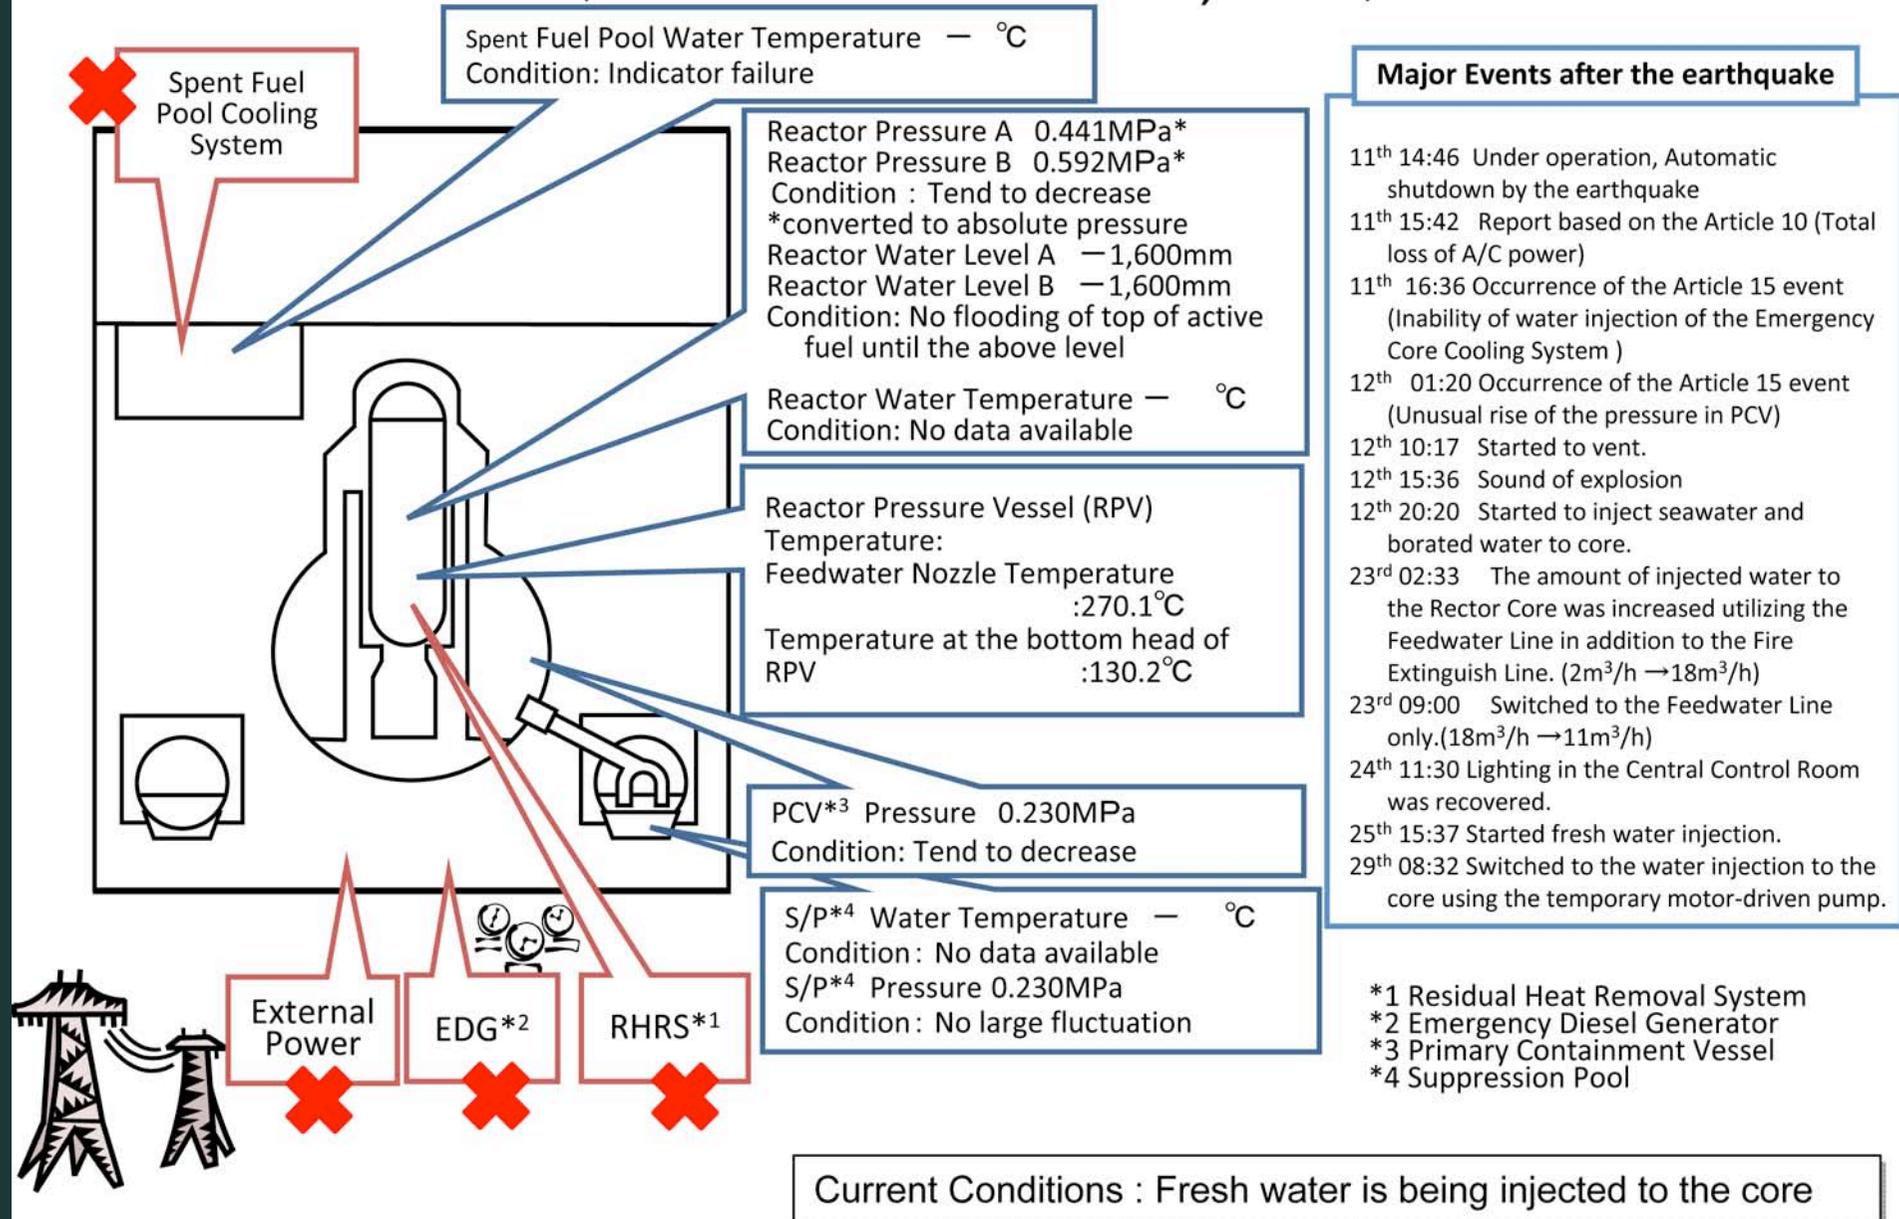
Conditions of Fukushima Dai-ichi Nuclear Power Station Unit 1 (As of 14:00 March 30th, 2011)

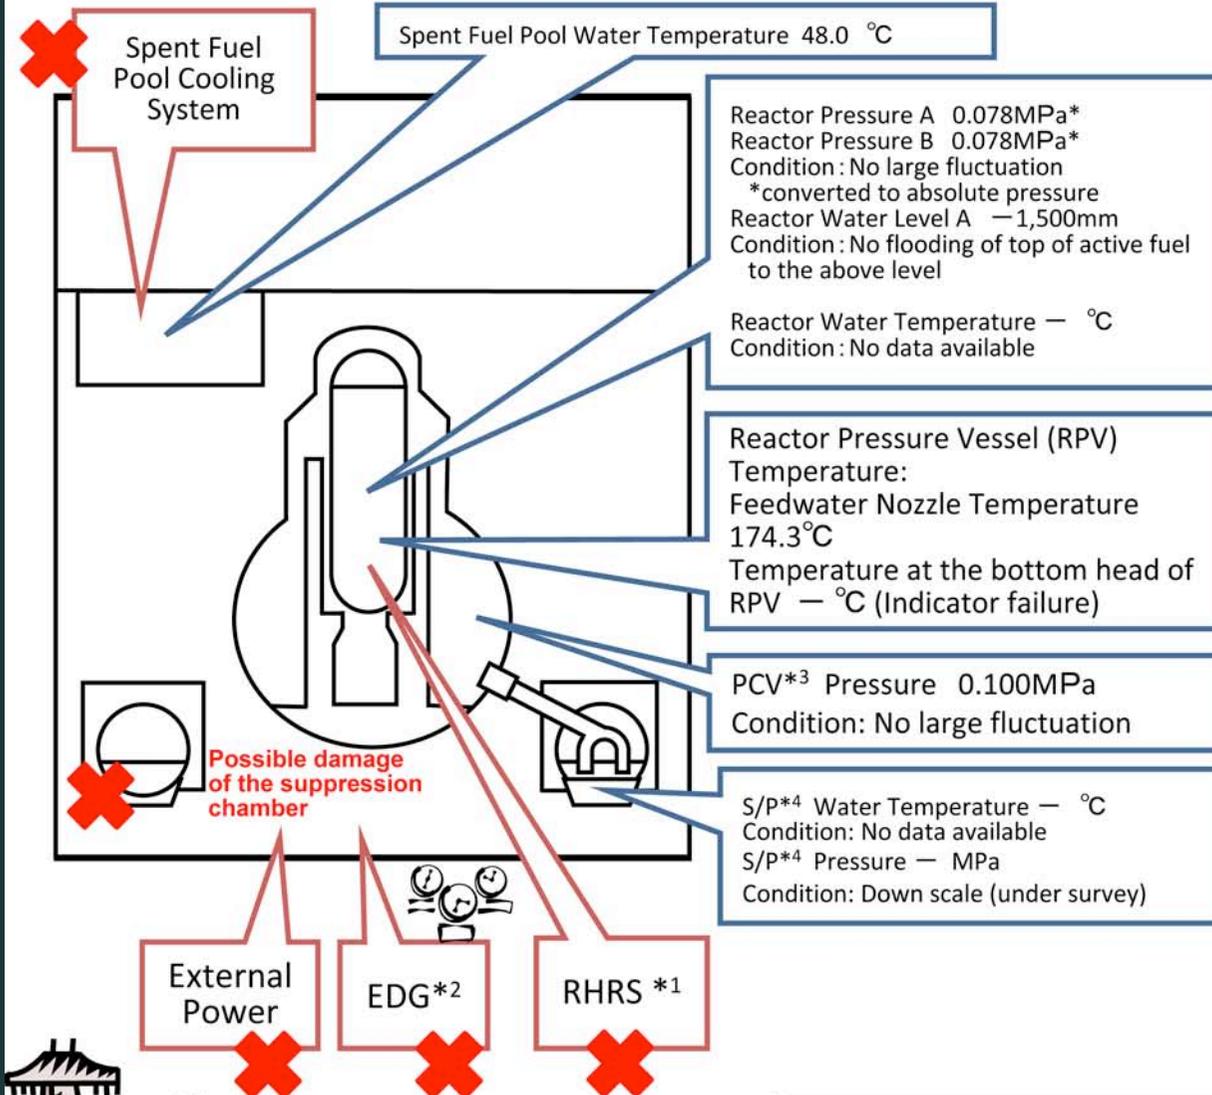
Conditions of Fukushima Dai-ichi Nuclear Power Station Unit 2 (As of 14:00 March 30th, 2011)

- 11th 14:46 Under operation, Automatic shutdown by the earthquake
- 11th 15:42 Report based on the Article 10 (Total loss of A/C power)
- 11th 16:36 Occurrence of the Article 15 event (Inability of water injection of the Emergency Core Cooling System)

- 13th 11:00 Started to vent.
- 14th 13:25 Occurrence of the Article 15 event (Loss of reactor cooling functions)
- 14th 16:34 Started to inject water to the Reactor Core.

- 14th 22:50 Occurrence of the Article 15 event (Unusual rise of the pressure in PCV)
- 15th 00:02 Started to vent.
- 15th 06:10 Sound of explosion
- 15th around 06:20 Possible damage of the suppression chamber

Current Conditions: Sea water is being injected to the Spent Fuel Pool and fresh water is being injected to the core

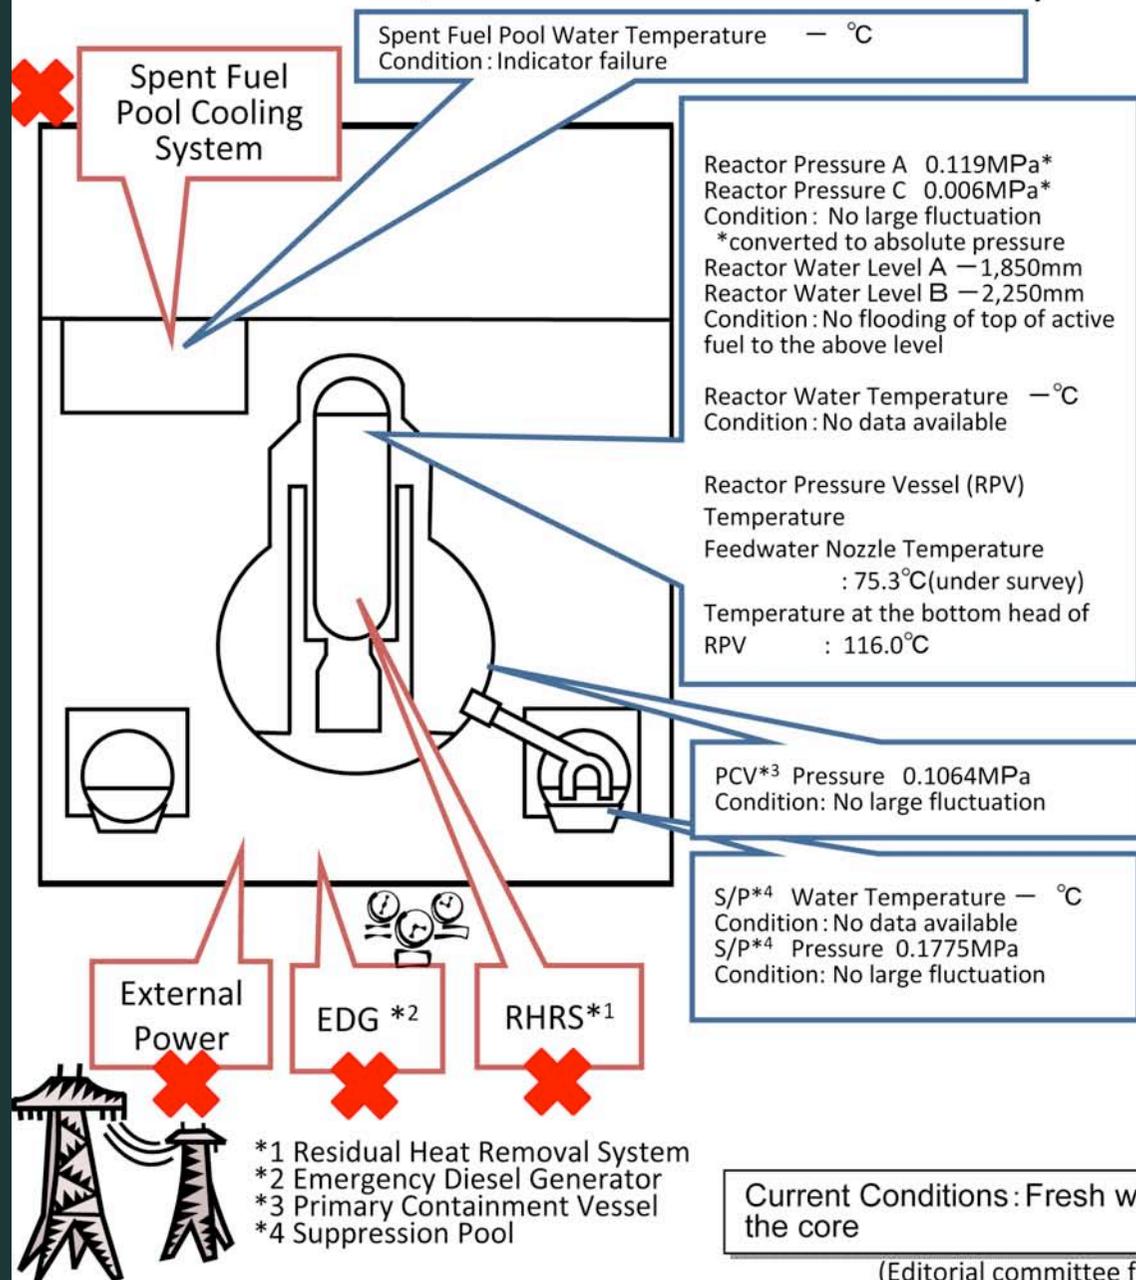
Conditions of Fukushima Dai-ichi Nuclear Power Station Unit 3

- 11th 14:46 Under operation, Automatic shutdown by the earthquake
- 11th 15:42 Report based on the Article 10 (Total loss of A/C power)
- 13th 05:10 Occurrence of the Article 15 event (Inability of water injection of the Emergency Core Cooling System)

- 13th 08:41 Started to vent.
- 13th 13:12 Started to inject seawater and borated water to core.
- 14th 05:20 Started to vent.
- 14th 07:44 Occurrence of the Article 15 event (Unusual rise of the pressure in PCV)

Current Conditions: Fresh water is being injected to the Spent Fuel Pool and the core

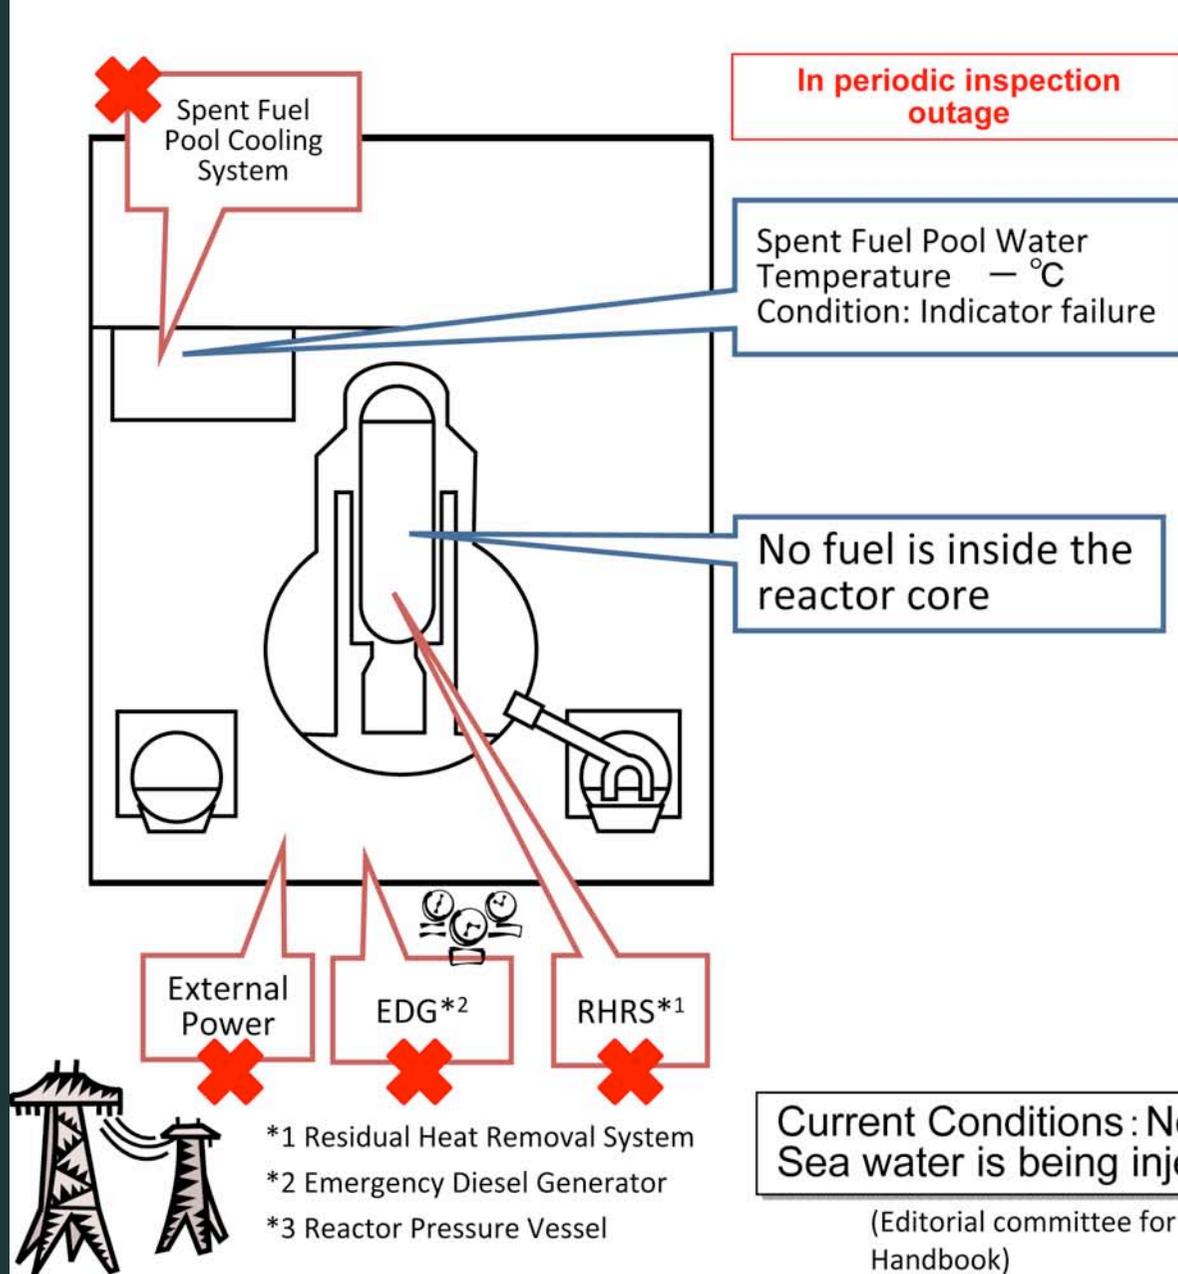
Conditions of Fukushima Dai-ichi Nuclear Power Station Unit 4 (As of 14:00 March 30th, 2011)

- In periodic inspection outage when the earthquake occurred
- 14th 04:08 Water temperature in the Spent Fuel Pool (SFP), 84°C
- 15th 06:14 Confirmed the partial damage of wall in the 4th floor.

**Current Conditions: No fuel is in RPV*3.
Sea water is being injected to the Spent Fuel Pool.**
