Fukushima
11-30 marzo 2011

diario ed effetti

Gli effetti immediati del terremoto e dello tsunami

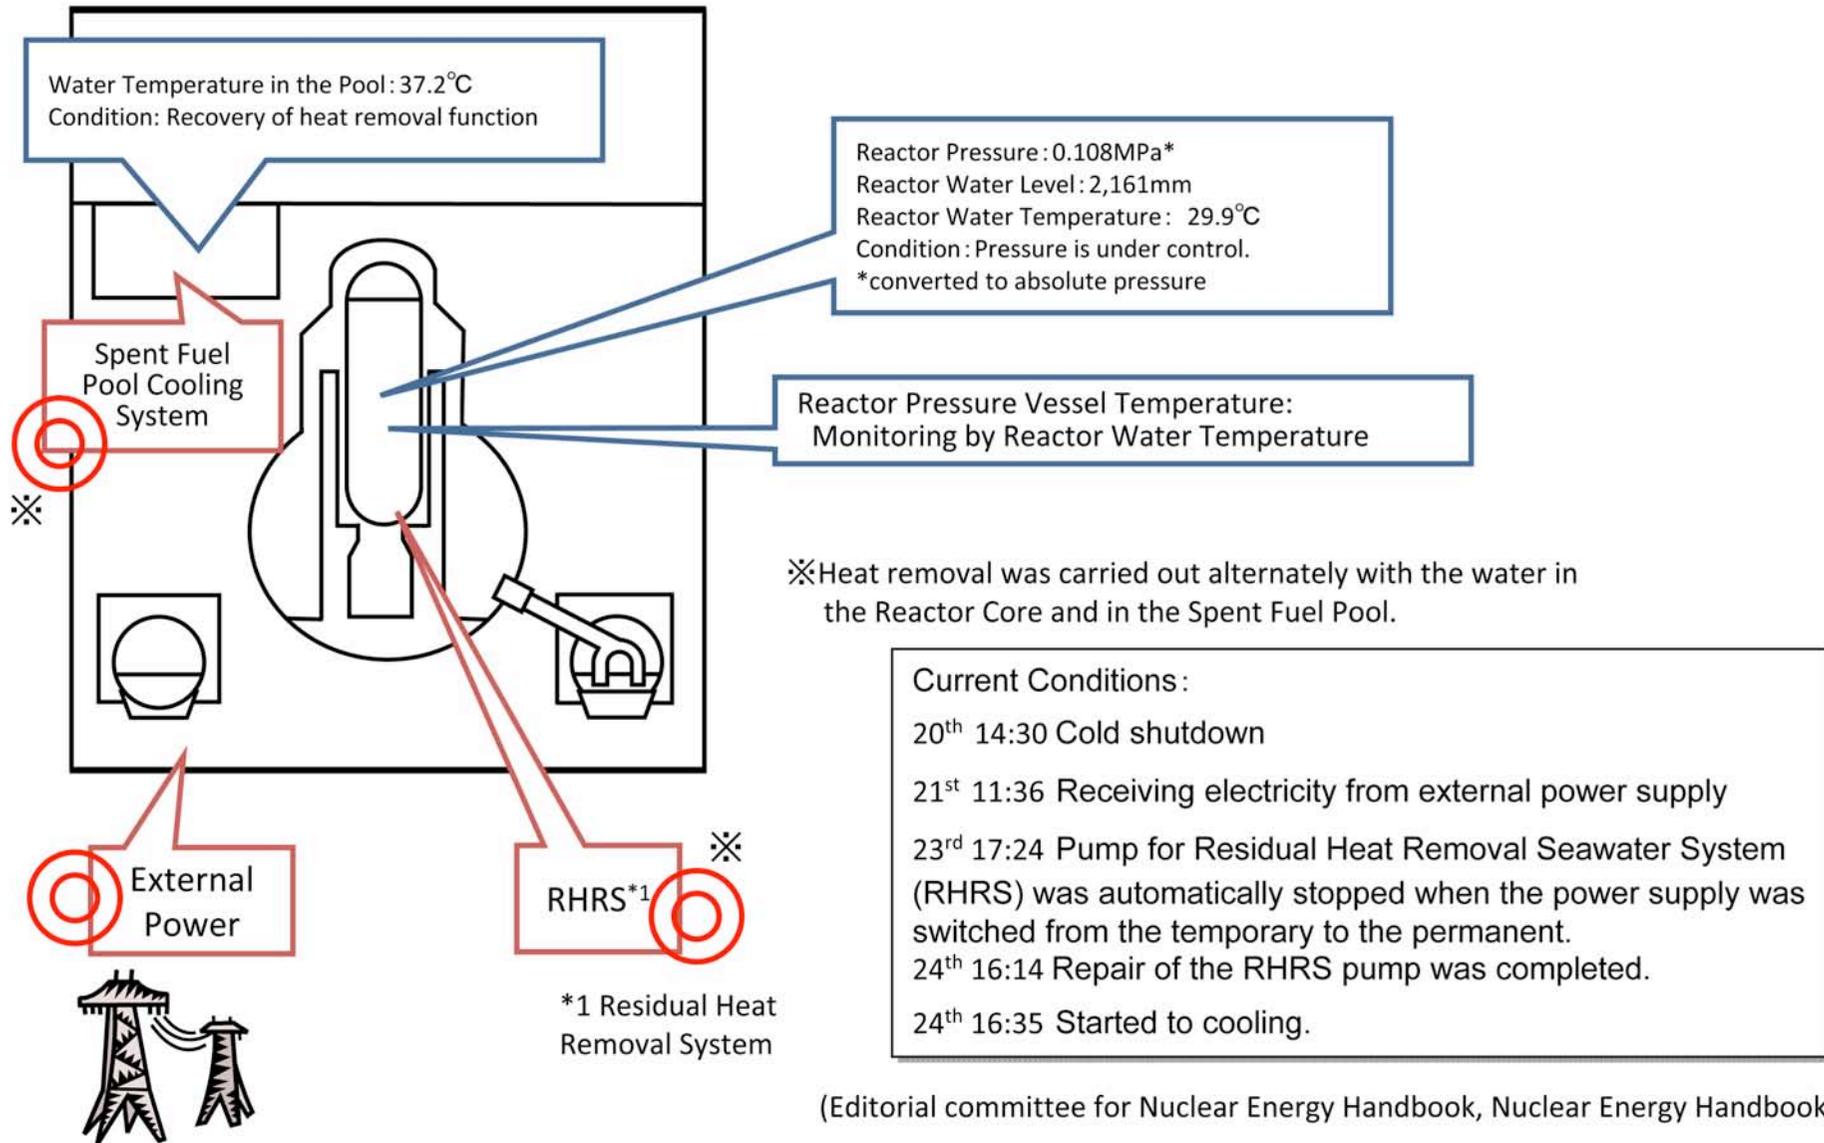
Conditions of Fukushima Dai-ichi Nuclear Power Station Unit 5 (As of 14:00 March 30th, 2011)

In periodic inspection outage

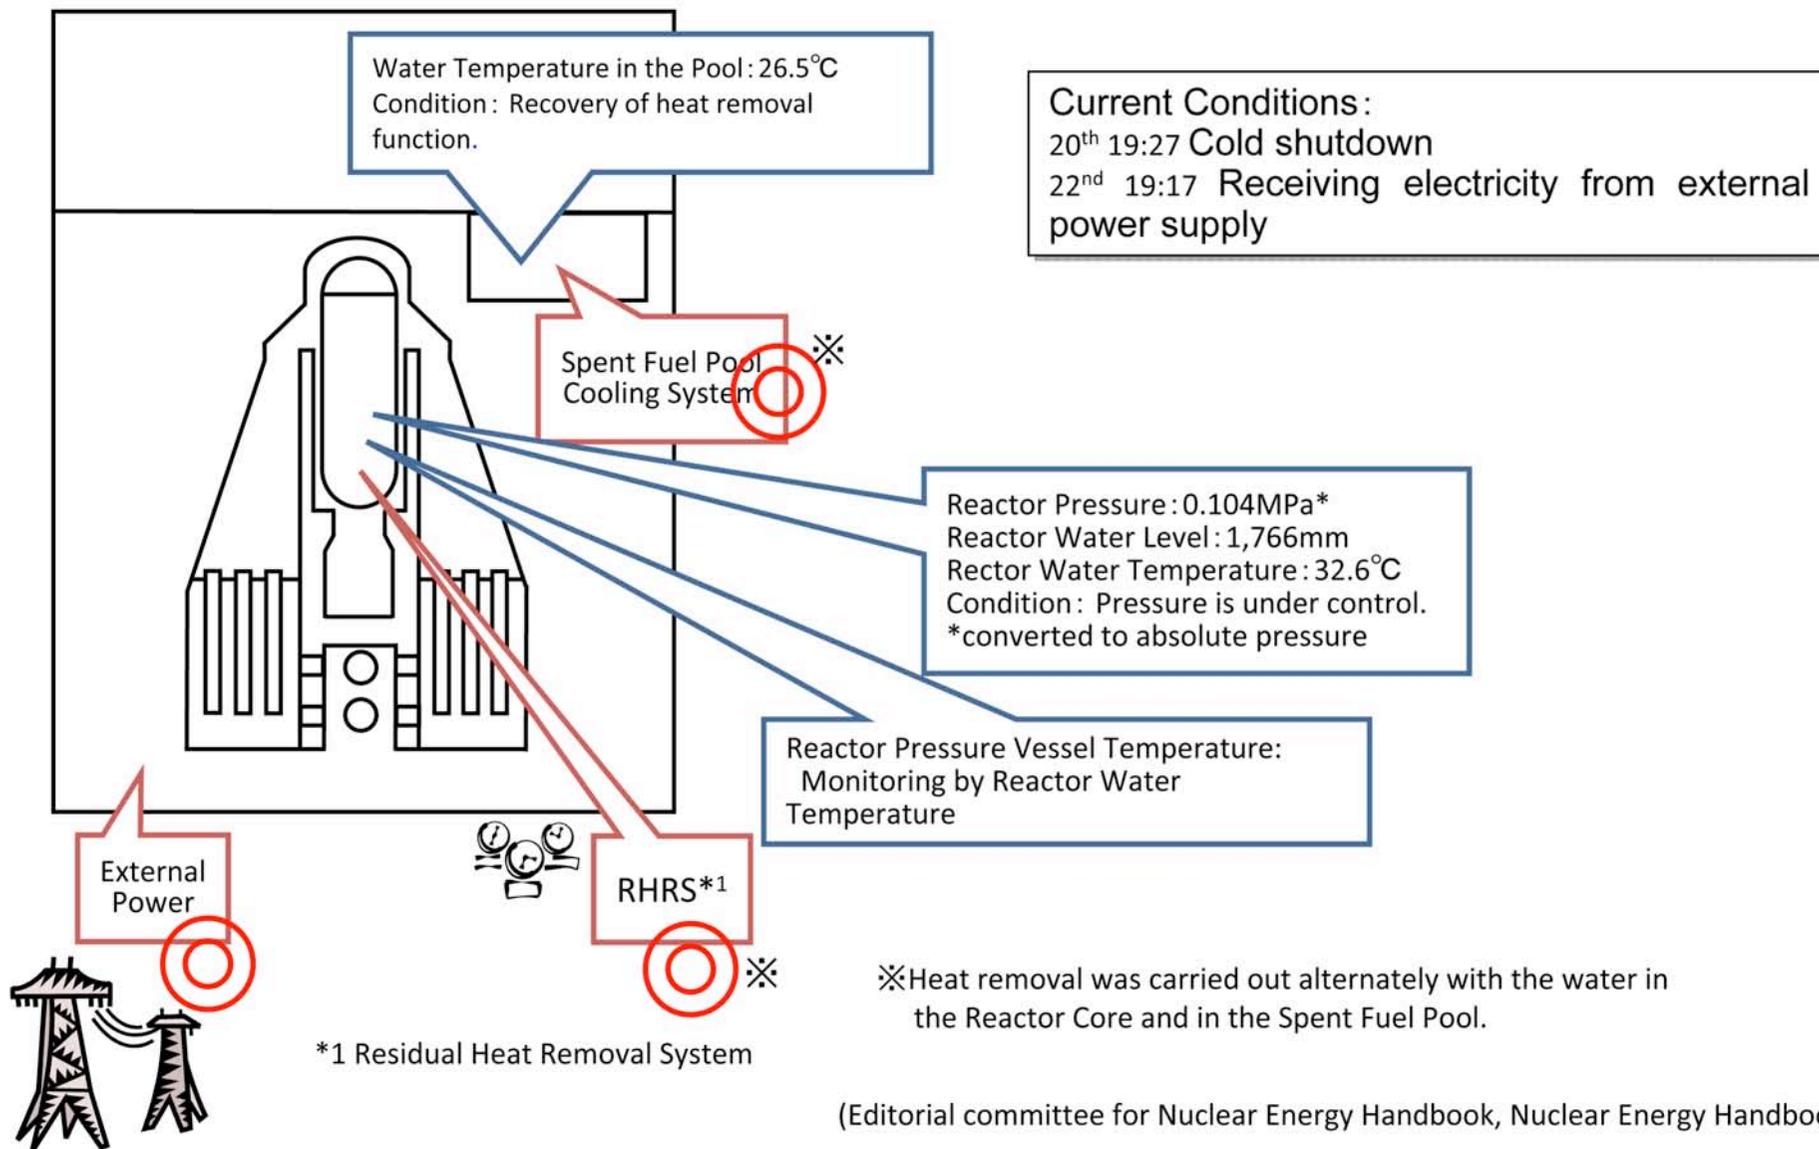
Conditions of Fukushima Dai-ichi Nuclear Power Station Unit 6 (As of 14:00 March 30th, 2011)

In periodic inspection outage

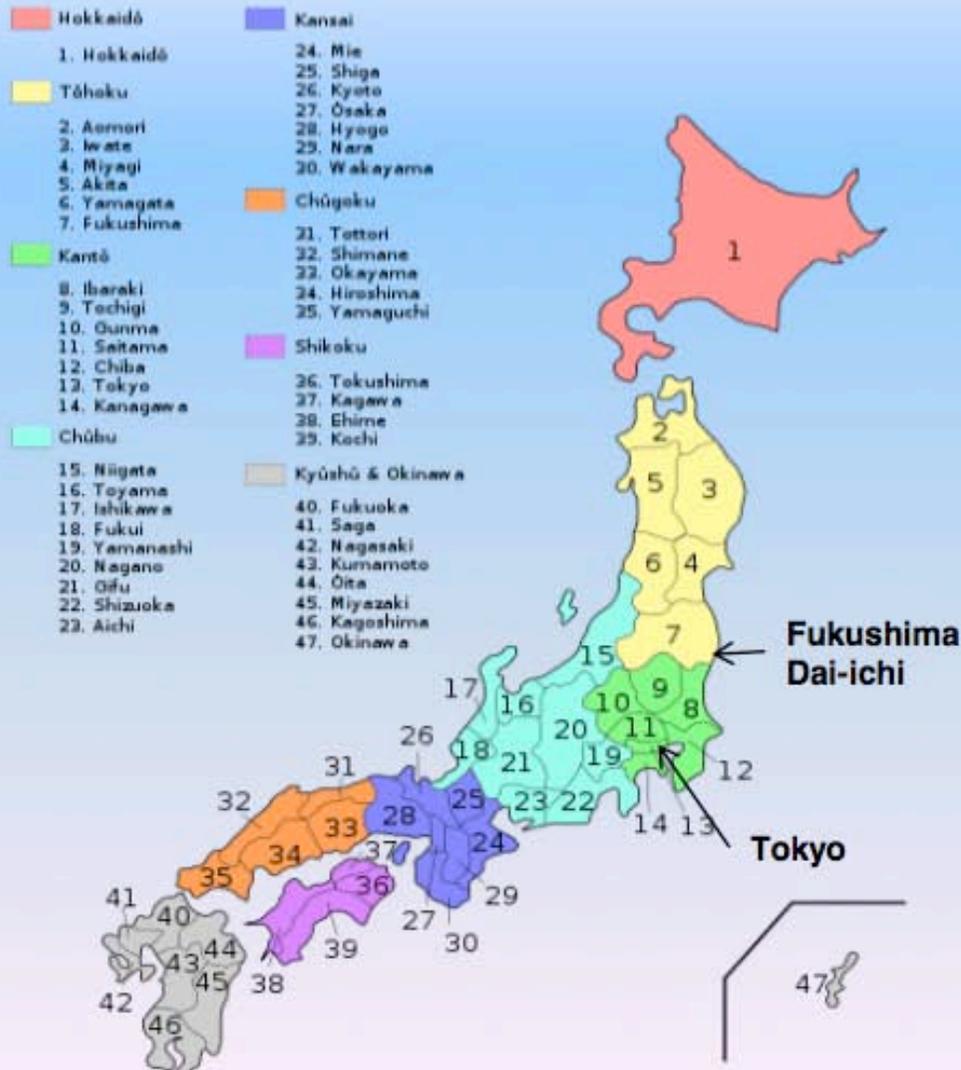
Dose Rates in Prefectures Near Fukushima plant as of 17 March at 18:00

Prefecture	Dose Rate 17 March At 18:00 ($\mu\text{Sv/h}$)	Normal Natural Radiation Dose Rate ($\mu\text{Sv/h}$)	Map Reference
Ibaraki	0.244	0.036 – 0.056	8
Tochigi	0.213	0.030 – 0.067	9
Gunma	0.109	0.017 – 0.045	10
Saitama	0.068	0.031 – 0.060	11
Chiba	0.041	0.022 – 0.044	12
Tokyo	0.053	0.028 – 0.079	13
Kanagawa	0.056	0.035 – 0.069	14
Niigata	0.048	0.031 – 0.153	15

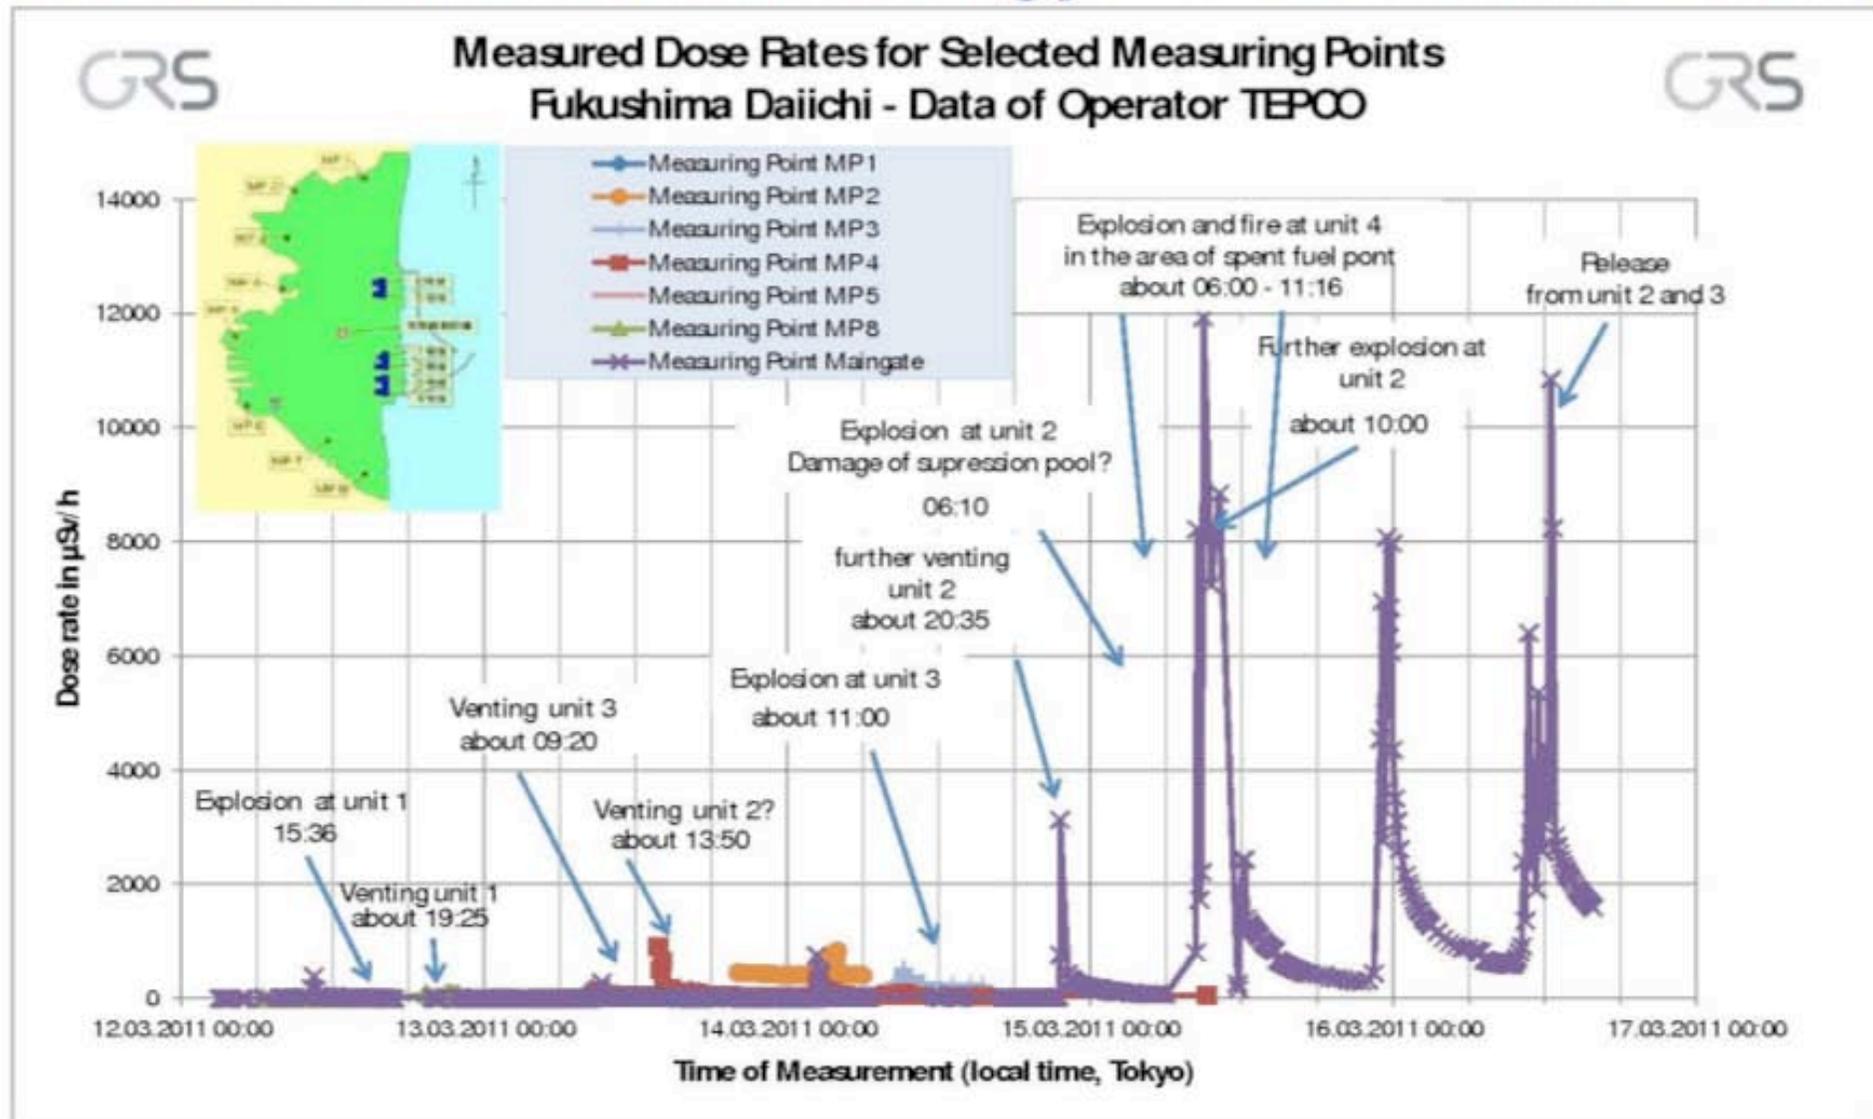
Radiation release chronology – Fukushima Dai-ichi

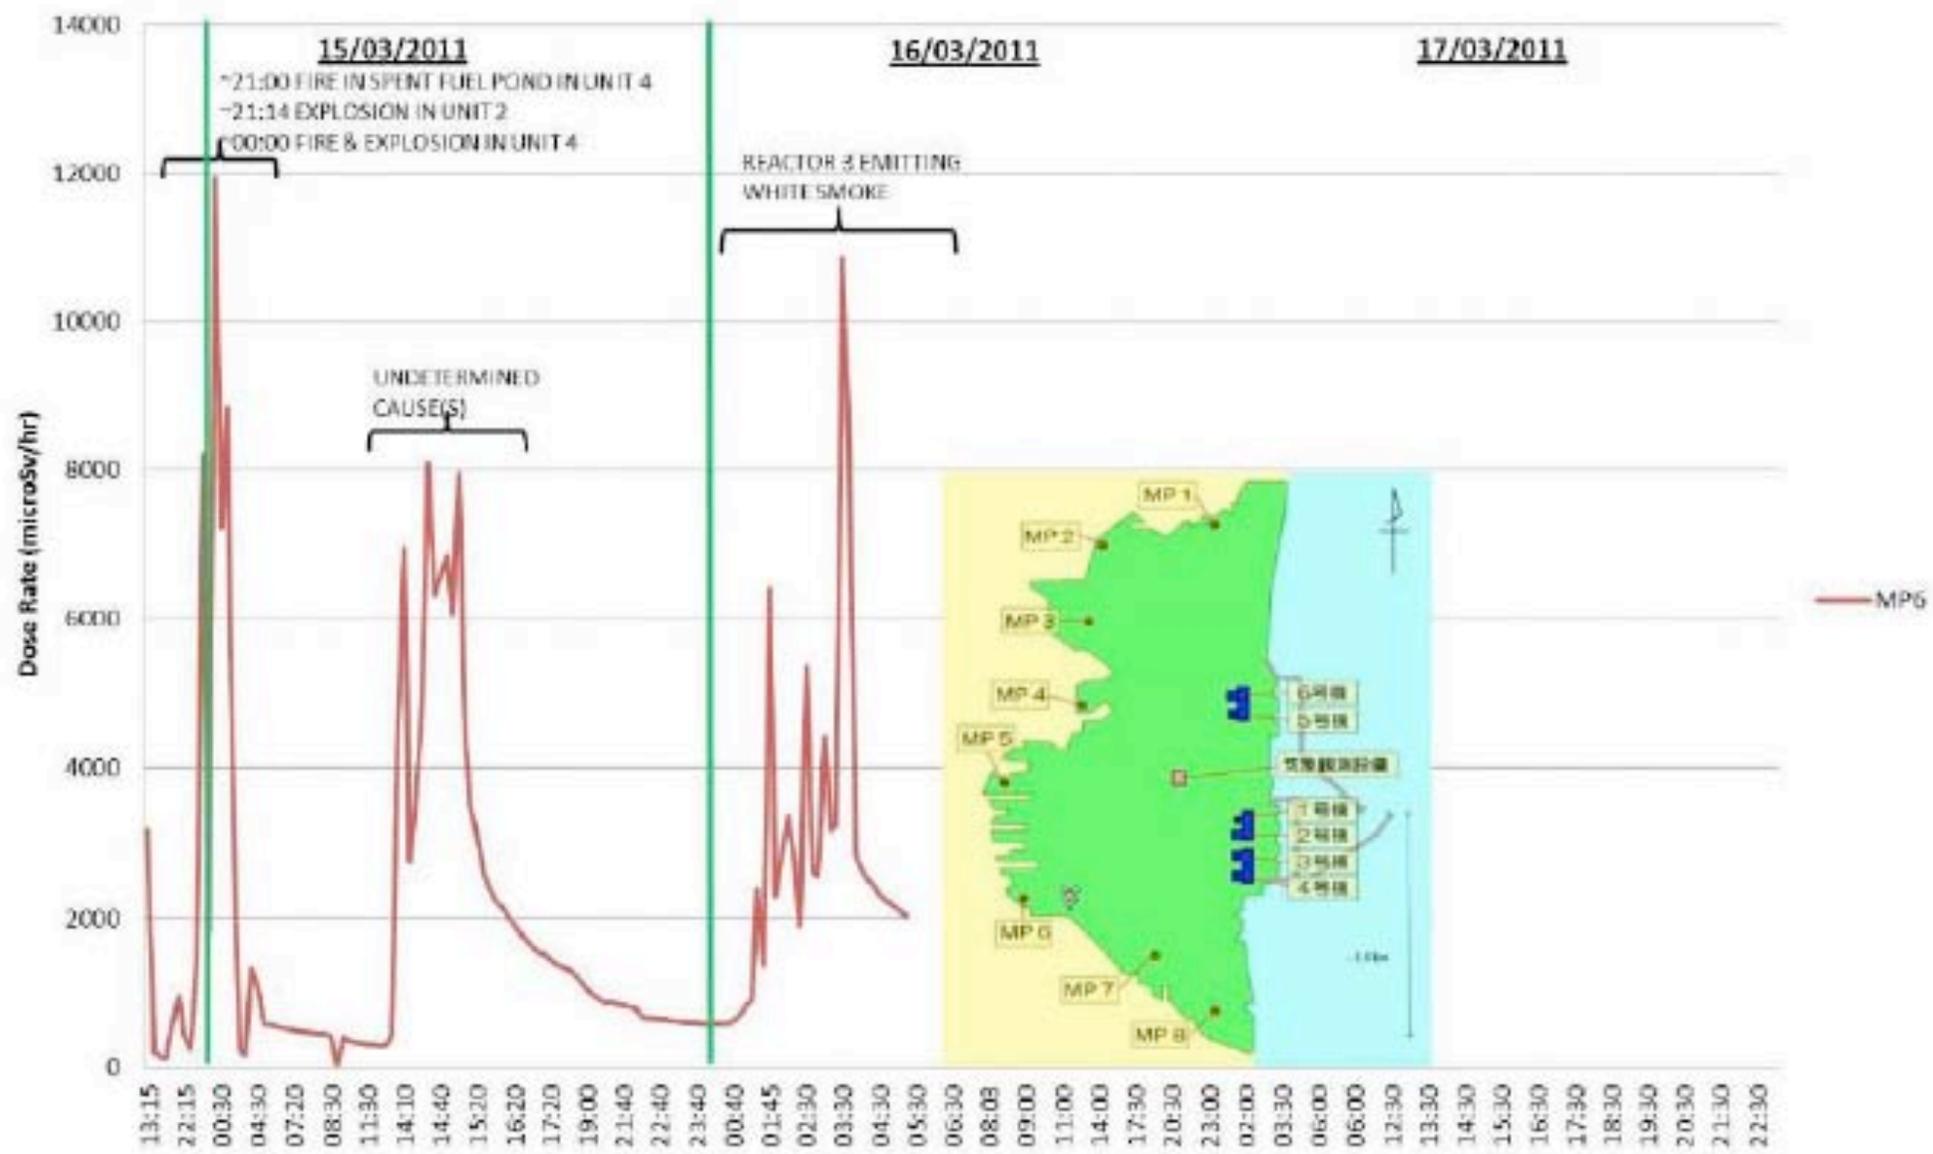
Fukushima Dai-ichi Dose Rate Measurements (microSv/hr) MP 5 and MP 6 from 14th March 2011 13:15 to 17th March 2011 06:00 UTC

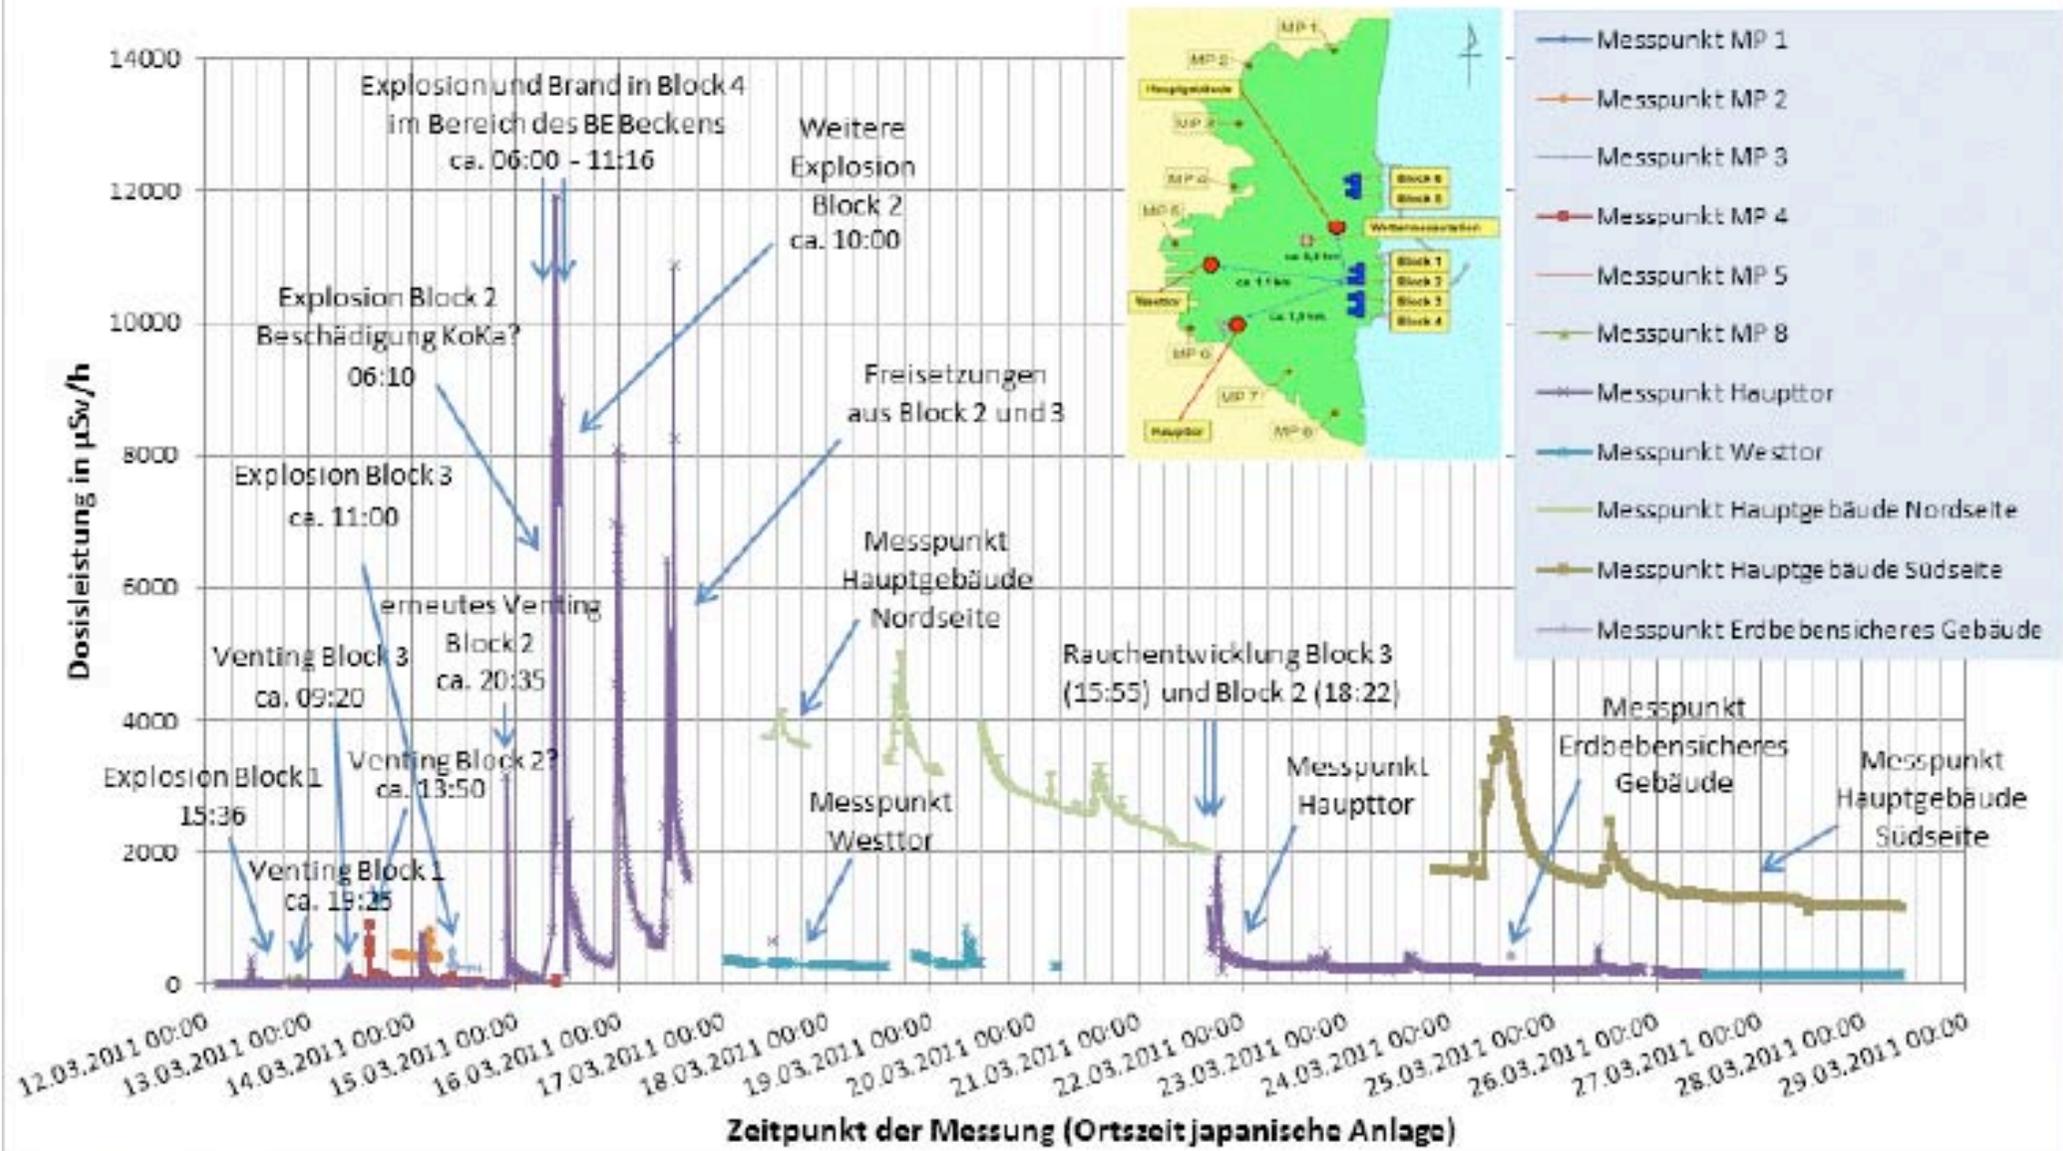
Gemessene Dosisleistungen an ausgewählten Messpunkten Fukushima Daiichi - Daten des Betreibers TEPCO

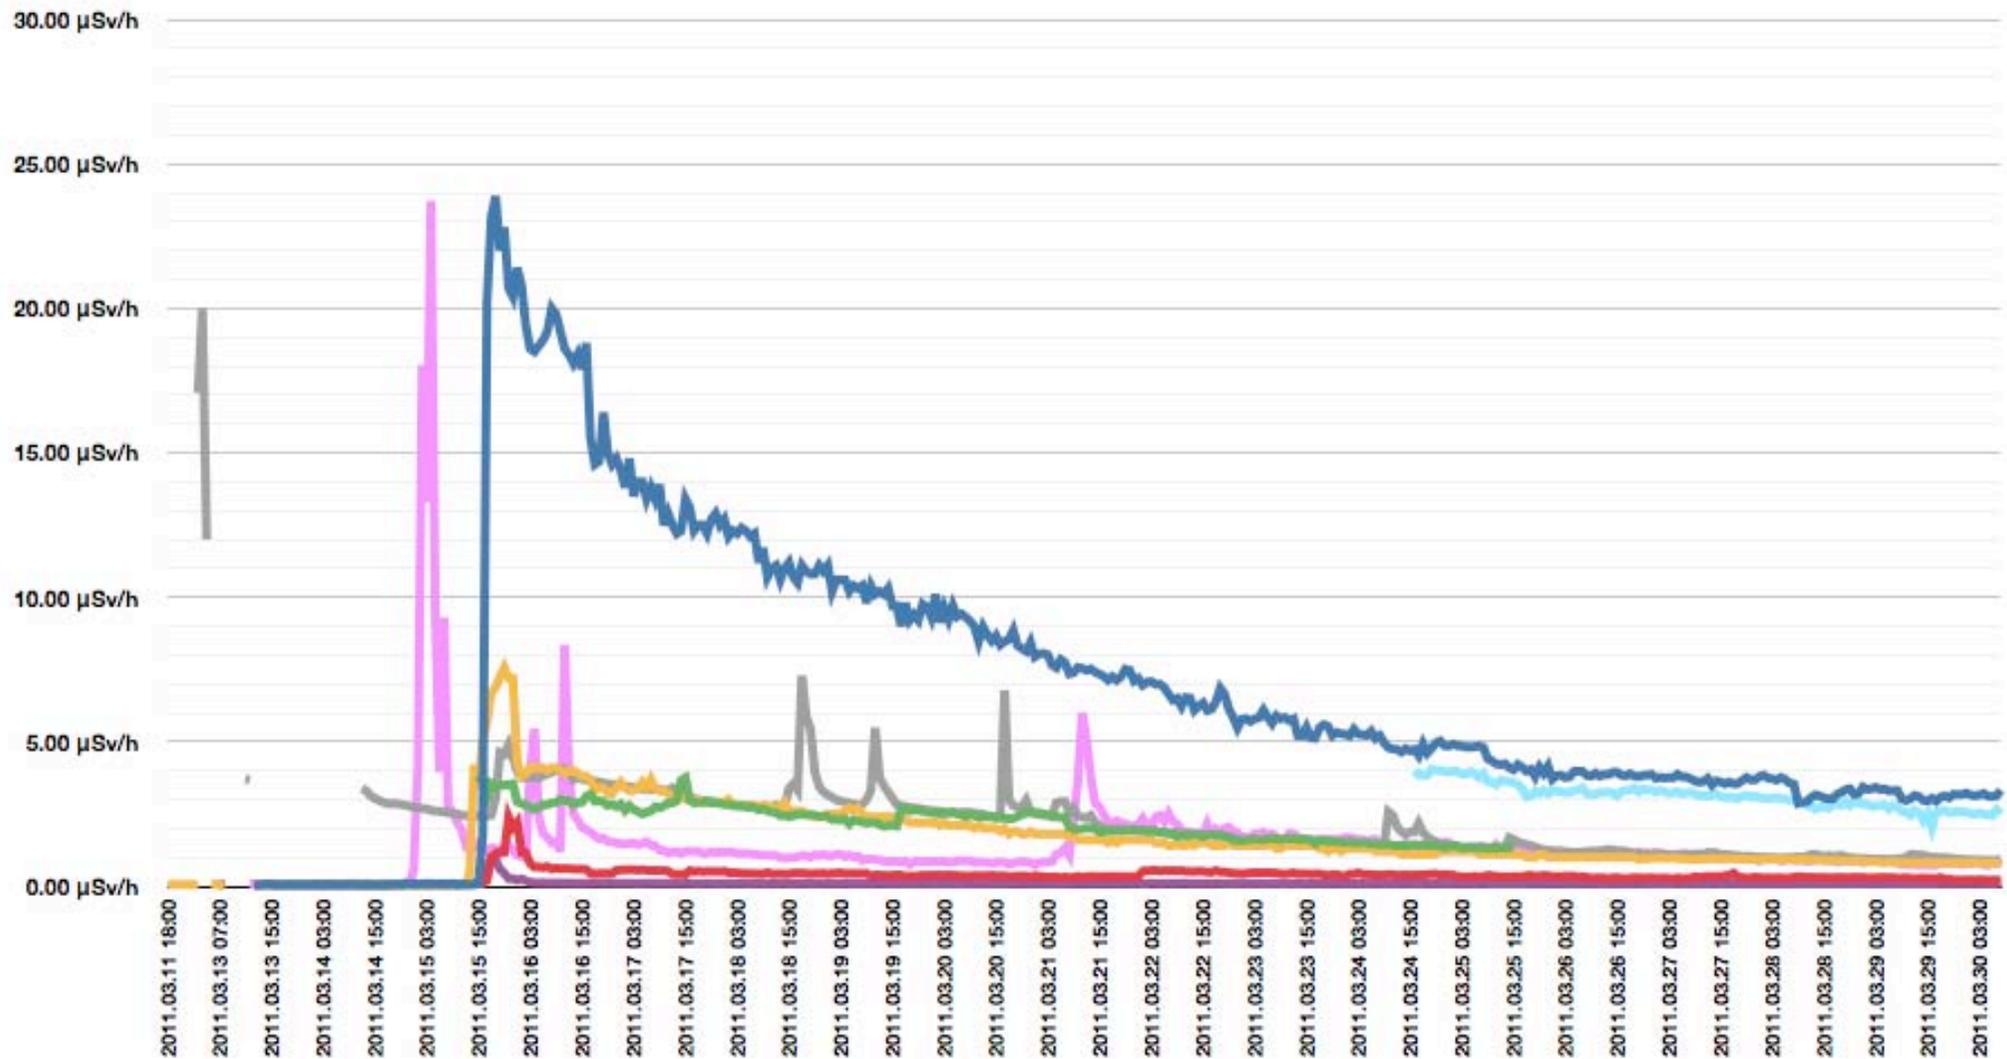
福島県の放射線量 - Fukushima Prefecture Radiation Levels

2011.03.11 18:00 ~ 2011.03.30 08:00

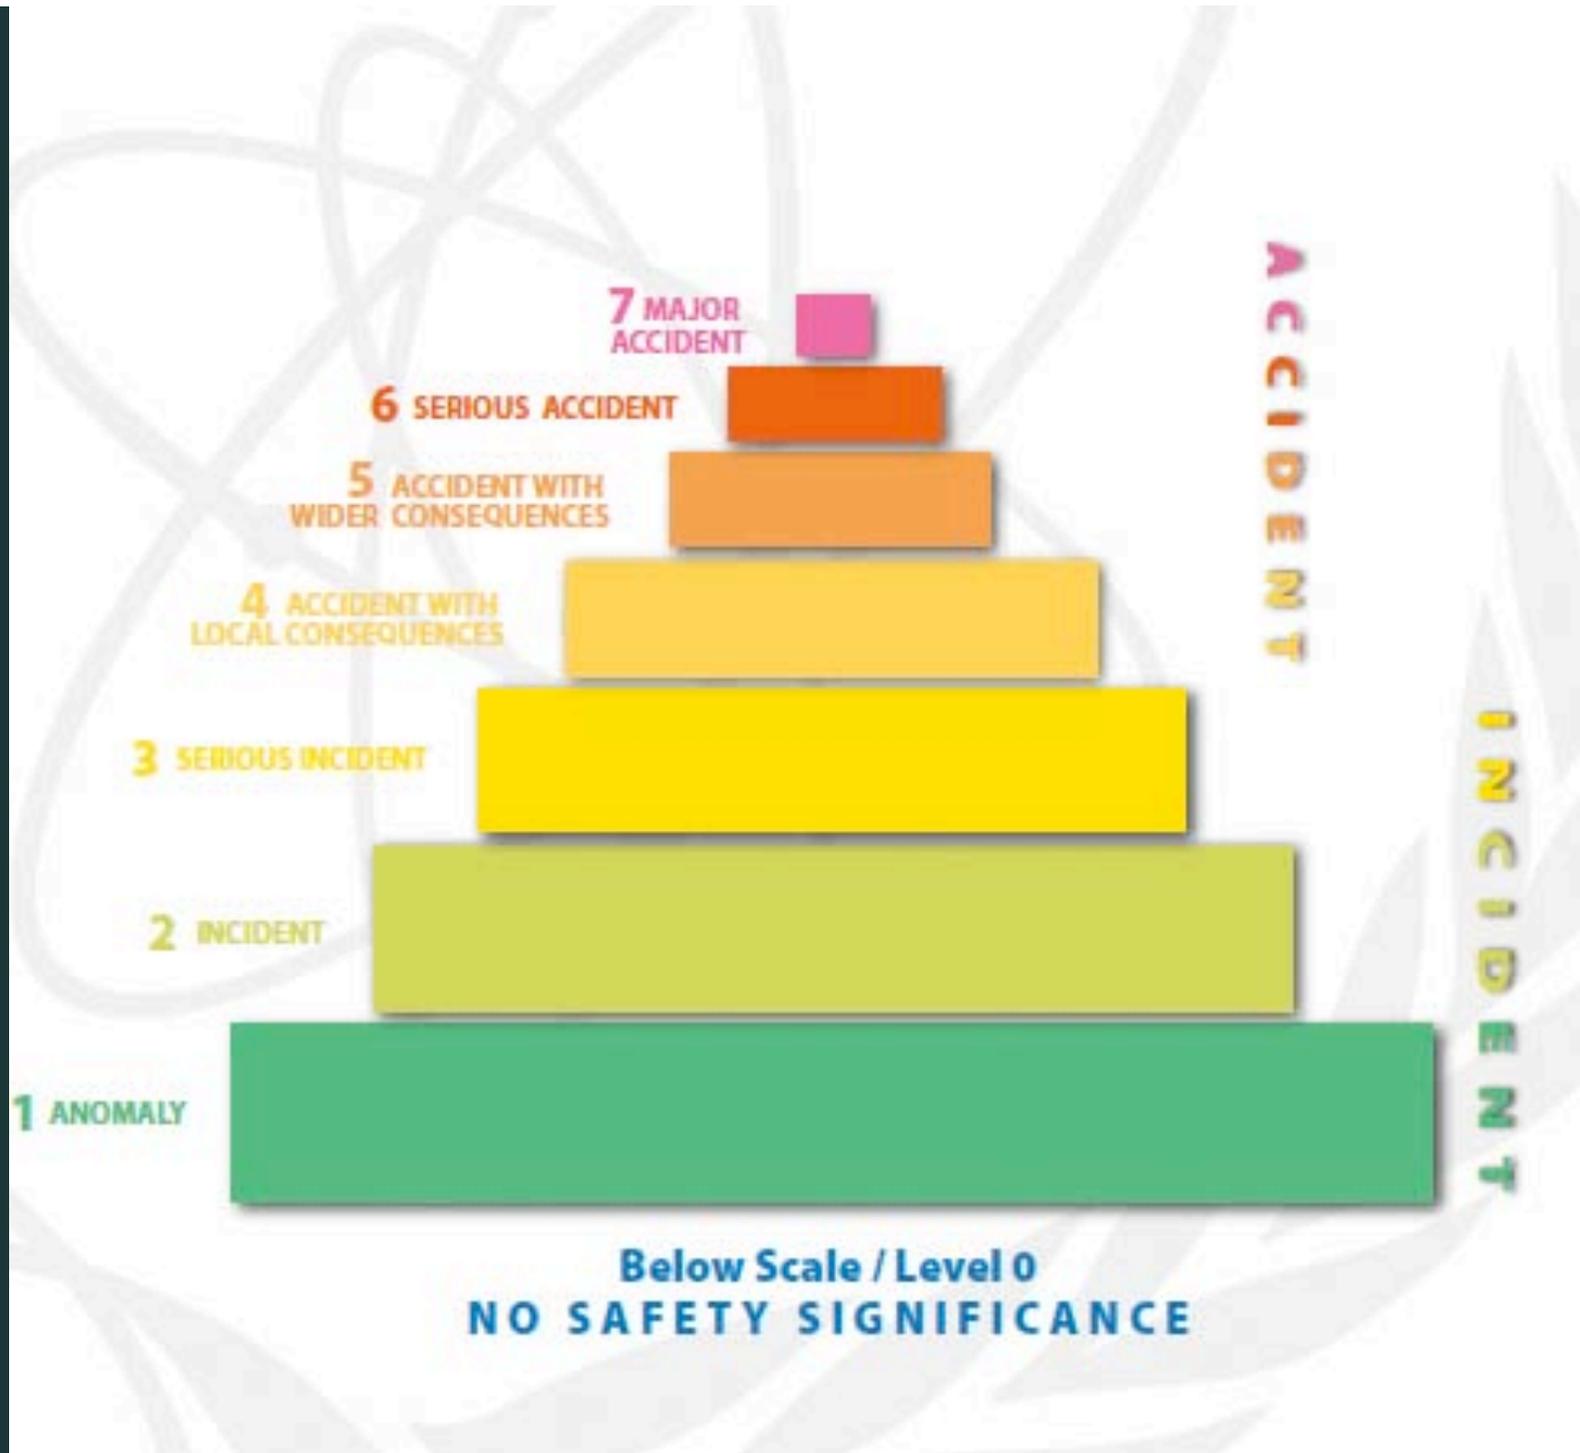
The International Nuclear Event Scale

Level, Descriptor	Off-Site Impact	On-Site Impact	Defence-in-Depth Degradation	Examples
7 Major Accident	<i>Major Release:</i> Widespread health and environmental effects			Chernobyl, Ukraine, 1986 (fuel meltdown and fire)
6 Serious Accident	<i>Significant Release:</i> Full implementation of local emergency plans			Mayak at Ozersk, Russia, 1957 (reprocessing plant criticality)
5 Accident with Off-Site Risks	<i>Limited Release:</i> Partial implementation of local emergency plans	Severe damage to reactor core or to radiological barriers		Windscale, UK, 1957 (military). Three Mile Island, USA, 1979 (fuel melting).
4 Accident Mainly in Installation either of:	<i>Minor Release:</i> Public exposure of the order of prescribed limits	Significant damage to reactor core or to radiological barriers, worker fatality		Saint-Laurent, France, 1980 (fuel rupture in reactor). Tokai-mura, Japan, 1999 (criticality in fuel plant for an experimental reactor).

3 Serious Incident any of:	<i>Very Small Release:</i> Public exposure at a fraction of prescribed limits	Major contamination, Acute health effects to a worker	Near Accident. No safety layers remaining	Vandelllos, Spain, 1989 (turbine fire, no radioactive contamination). Davis-Besse, USA, 2002 (severe corrosion) Paks, Hungary, 2003 (fuel damage)
2 Incident	nil	Significant spread of contamination, Overexposure of worker	Incidents with significant failures in safety provisions	
1 Anomaly	nil	nil	Anomaly beyond the authorised operating regime	
0	nil	nil	No safety significance	
Below Scale	nil	nil	No safety relevance
