Ultime da Fukushima

Stato delle unità all'11 marzo

On Thursday, 2 June 2011, the IAEA provided the following information on the status of nuclear safety in Japan:

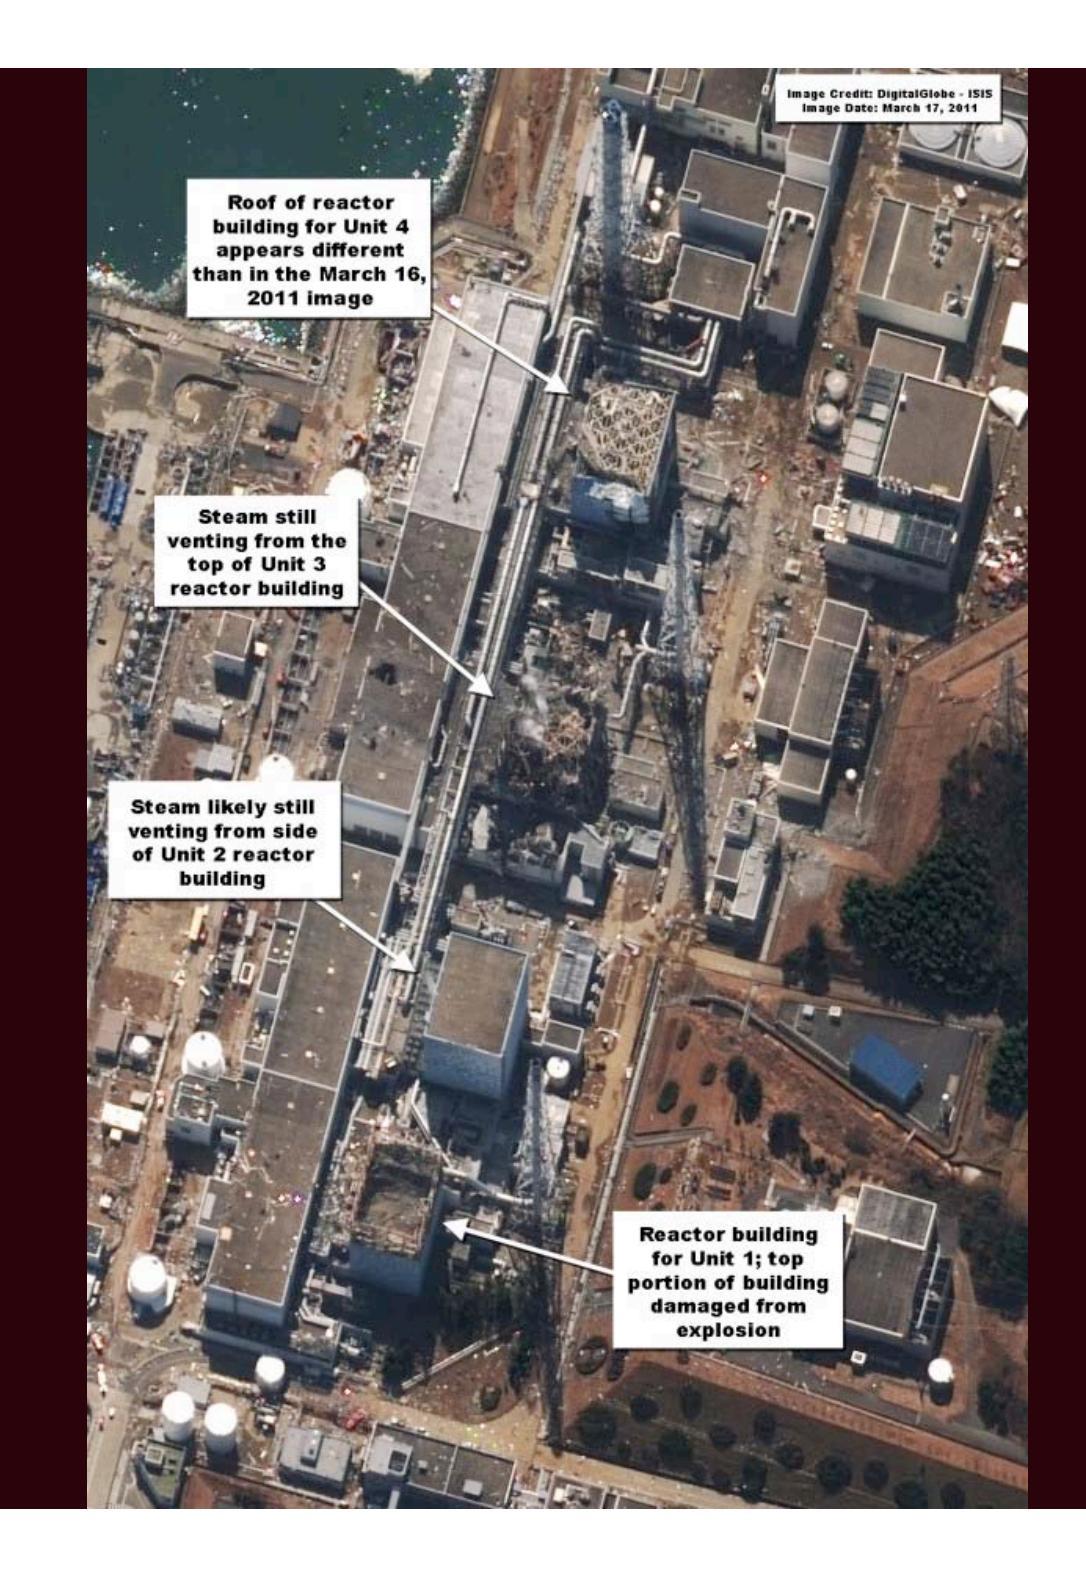
After the explosion at Unit 3, damage to the reactor building can be seen. Steam can be seen venting out of the reactor building

> Steam venting out of the building

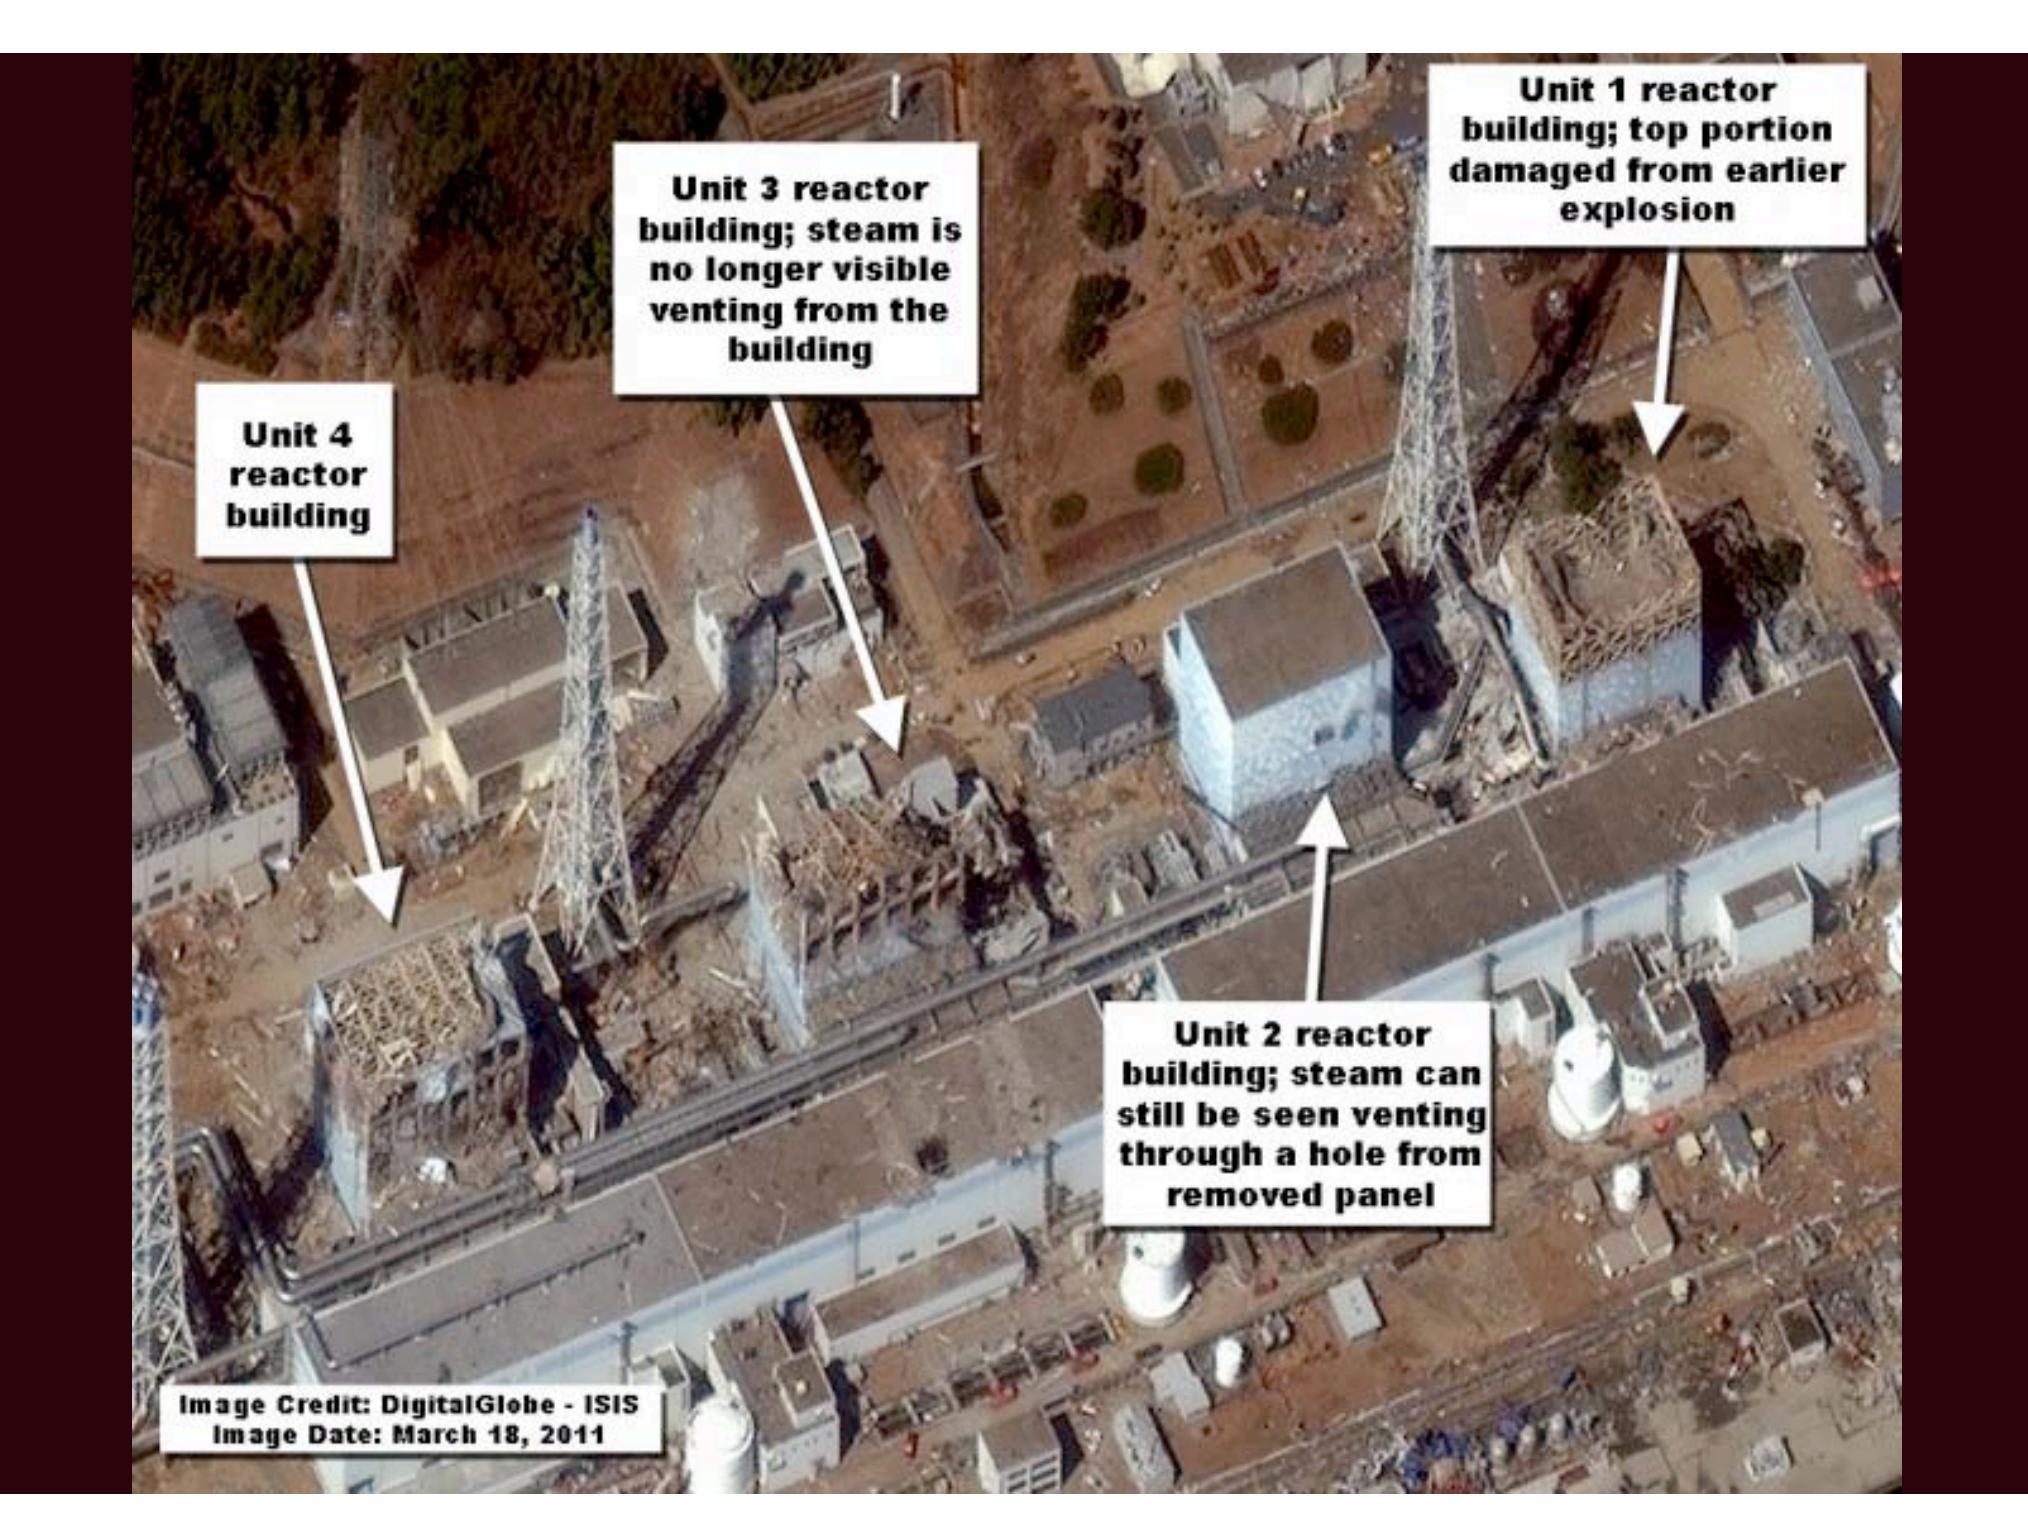
After the explosion at Unit 1, the top of the reactor building is damaged

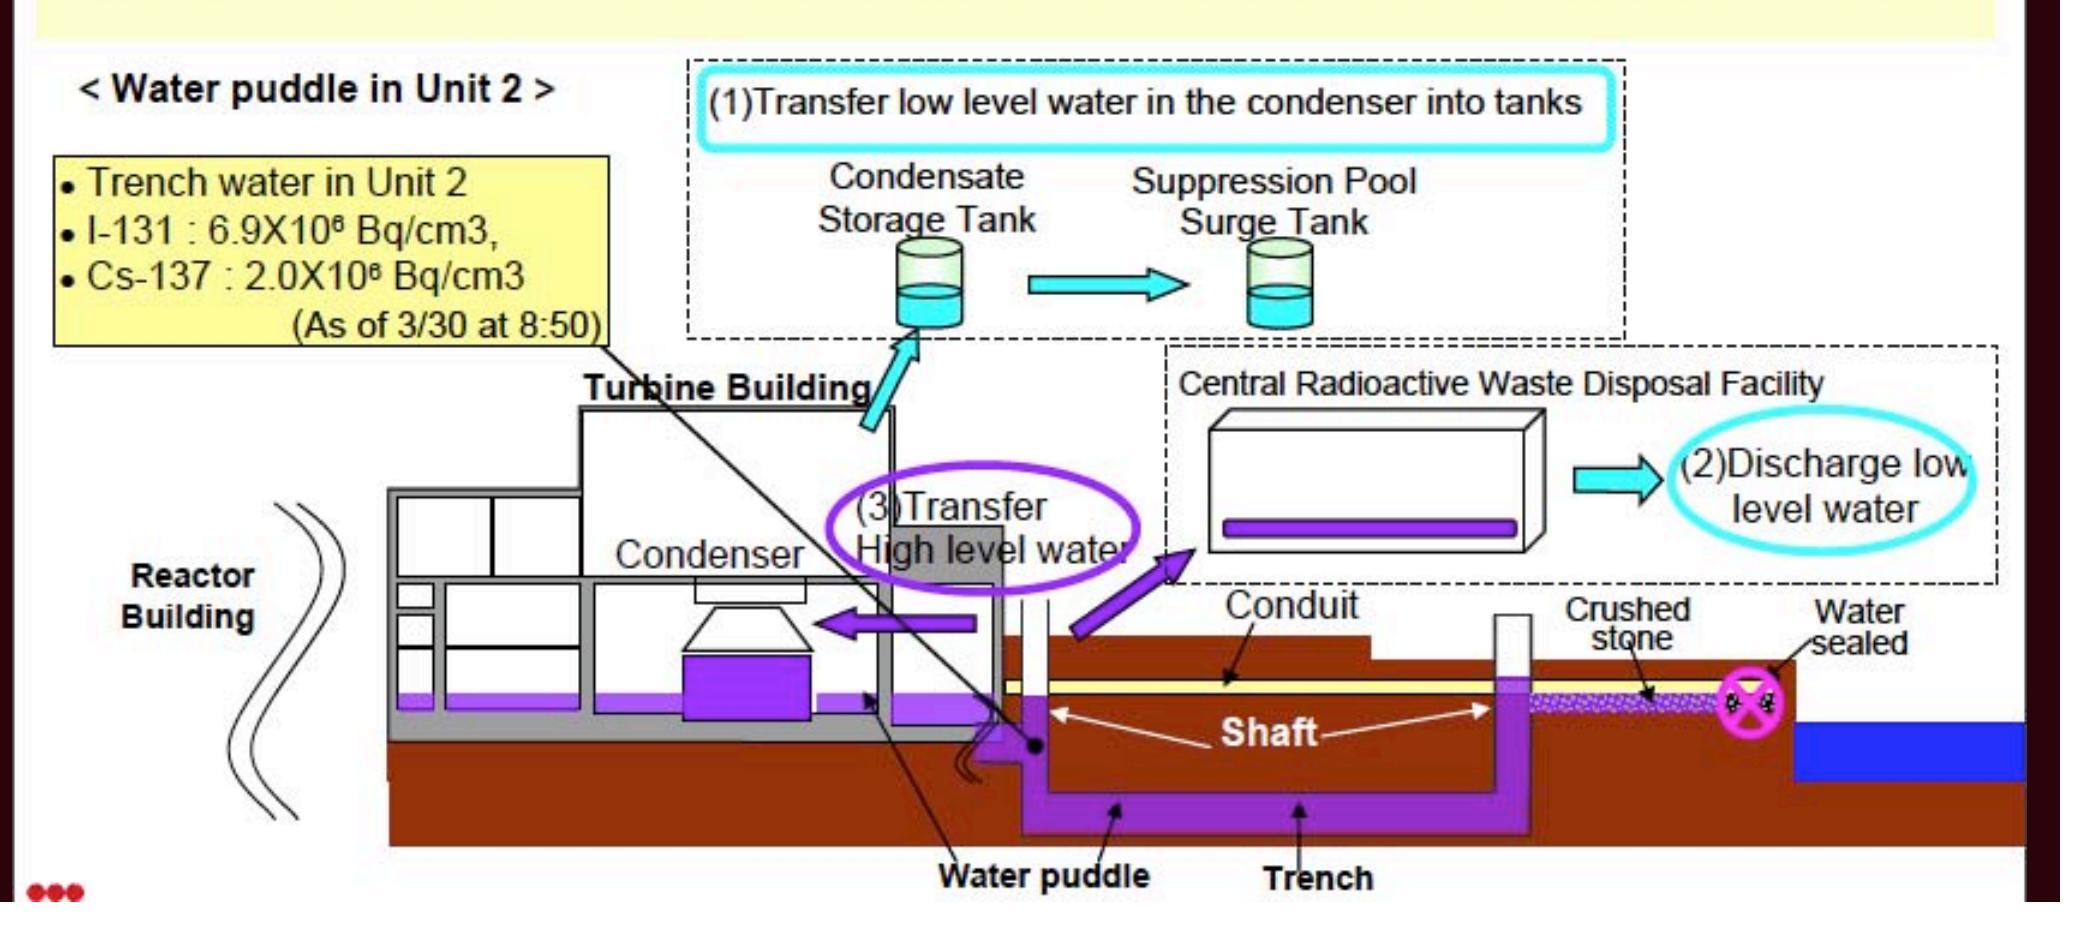
Measures against Water Puddles at Fukushima Daiichi

- Contaminated water with high radioactive materials has been found in large quantity in turbine buildings of Units 1-3 etc. Following measures will be taken to store them safely.
- Transfer the water to the condenser or Central Radioactive Waste Disposal Facility (CRWDF) and store them safely to prevent it from running off outside the boundary.
 - Transferred low level radioactive waste water stored in the condenser to the tanks outside (1).
 - ✓ Discharged 10,000 tons of low level radioactive water stored in CRWDF into the sea (2).
 - (Radioactivity in 10,000 tons of the low level water is equivalent to 10 litter of high level water in Unit 2.)
 - Transferred high level water into the condenser. Begun transferring the water in the trench to CRWDF in Unit 2 (3).
